"SUBBALLAST CONSIDERATIONS FOR HEAVY AXLE LOAD TRACKAGE"

by David Read and Dingqing Li

TD 95-028

Association of American Railroads
Research and Test Department

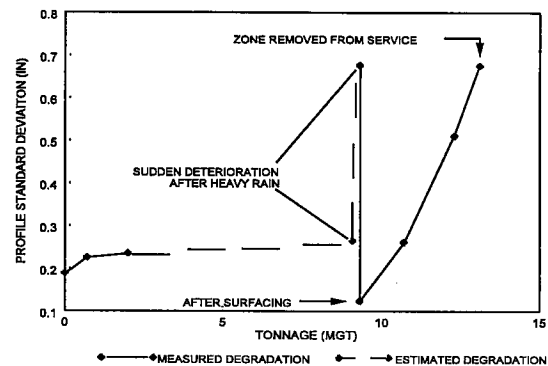
Exhibit 1. LTM Profile Degradation

The profile standard deviation of the inside rail is plotted as a function of tonnage in Exhibit 1 to indicate geometry behavior before and after the rain. The degradation rate between 0 and 2 MGT is typical of newly surfaced track and indicates a stable structure. Since geometry data was not taken between 2 MGT and the rain at 9 MGT, the estimated behavior is shown as a dashed line in the plot.

The degradation measured after surfacing is obviously more severe than that measured during the initial 2 MGT. The Exhibit 1 data after 9 MGT indicates an unstable track structure, necessitating its removal from service.

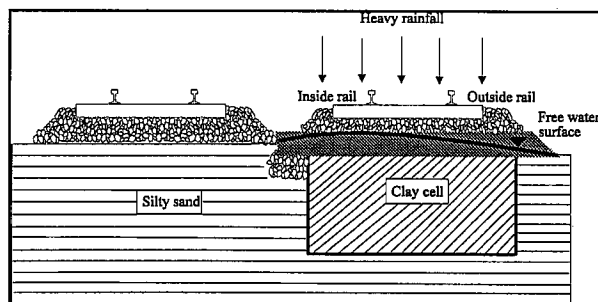
Exhibit 2. Cross Section of LTM Showing Subballast Free Water and Drainage Path

As shown in Exhibit 2, the combined effects of the adjacent HTL bypass track, the impermeable clay layer beneath the subballast and the relatively low permeability of the compacted subballast material and surrounding silty-sand native soil forced the water to drain to the outside ballast shoulder, allowing water to accumulate under the inside rail. Highway pavement research has indicated that the presence of free water in a granular layer designed for structural purposes greatly limits the ability of the layer to distribute applied stresses to underlying layers.⁶

In the case of the LTM failure, excessive free water in the subballast may have caused increases in train induced subgrade stresses. The increased stress would initiate plastic deformation of the clay surface resulting in geometry deviations. Once initiated, the deformation process becomes self-sustaining as water collects in pockets or ruts formed on the subgrade surface. Surfacing the track in this condition provides only short term improvement as the cause of the support instability has not been corrected. LTM geometry was out of specification within 5 MGT of surfacing the zone.

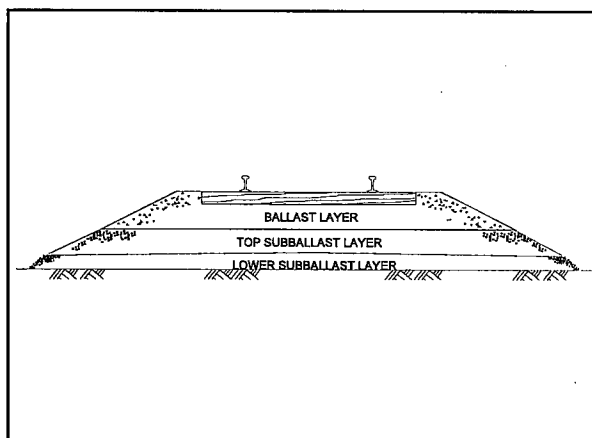
Exhibit 3. Cross Section Showing Granular Layers

AAR has identified granular layer thickness design as an effective method of reducing stresses in subgrades under HAL traffic.⁷ The design allows most of the granular layer thickness to be made up of subballast material rather than the more expensive ballast aggregate. However, as the LTM experience suggests, a thick subballast layer of low permeability may be a source of ongoing track instability if excessive free water is allowed to accumulate within the layer. To facilitate drainage, consideration may be given to designing a subballast layer greater than 6 to 8 inches as a two-layer structure as shown in Exhibit 3. The top layer would consist of coarser sandy-gravel material of higher permeability. The bottom layer would have lower permeability and be shaped to shed water entering from the top.
