TESTING AN 89-DEGREE CROSSING REBUILT WITH PREMIUM COMPONENTS UNDER HEAVY AXLE LOADS

by Joseph LoPresti, Duane E. Otter,
and David D. Davis
TD 96-015

Association of American Railroads
Research and Test Department

June 1996

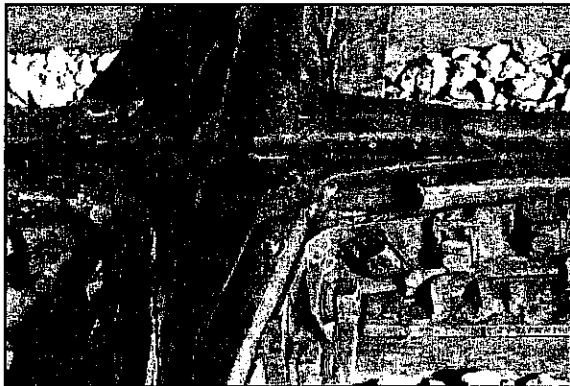
Exhibit 1. Broken Wing Rail After 15.2 MGT

The broken wing rail was on the crossing route, not in traffic. This break did not interfere with FAST train operations but would have caused removal of a similar crossing in revenue service had it not been repaired. If another piece of the wing rail broke loose, there was also concern that it could end up in the flangeway.

The crossing was removed because of the broken wing rail, but other components were also failing:

- ▶ Bolts were breaking almost daily.
- ▶ Several of the beveled bolt locks had broken.
- ▶ There were cracks in the plate work.
- ▶ Batter at the crossing gaps was about 3/8-inch, and weld build-up was needed.

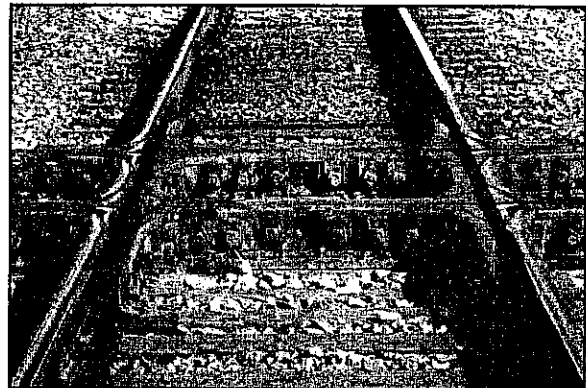
The original 89-degree standard component crossing survived 1.9 MGT of HAL traffic at FAST before it was removed from track.² The castings were then explosion hardened and reversed. Once the original wing rails were replaced with premium rail, the crossing was again installed at FAST (Exhibit 2).

Exhibit 2. 89-Degree Crossing at FAST

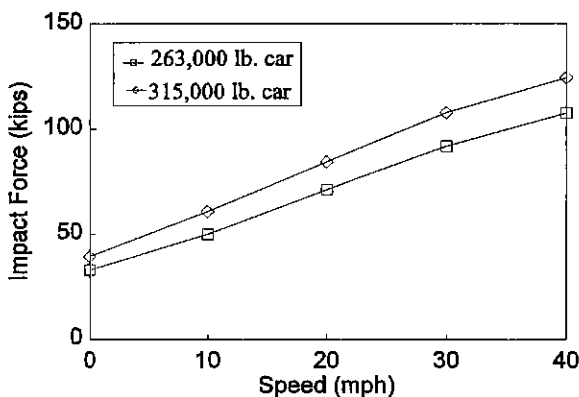
Instrumented wheel sets were used to measure impact forces in the crossing from 263,000-pound cars and 315,000-pound cars at various speeds. Exhibit 3 shows a comparison of the wheel impact forces. The 315,000-pound car produced impacts about equal to those produced by the 263,000-pound car operating 5 to 10 mph faster. At 40 mph, average impacts were more than three times the static wheel load for both cars. These impact forces are higher than tolerated by wheel impact detectors (85 to 100 kips).

Exhibit 3. Average Impact Forces on 89-Degree Crossing

The impact forces, which generally increase linearly with speed through 40 mph, also may be a function of the amount of batter present on the crossing at the time of measurement (about 1/4-inch after 3.2 MGT).

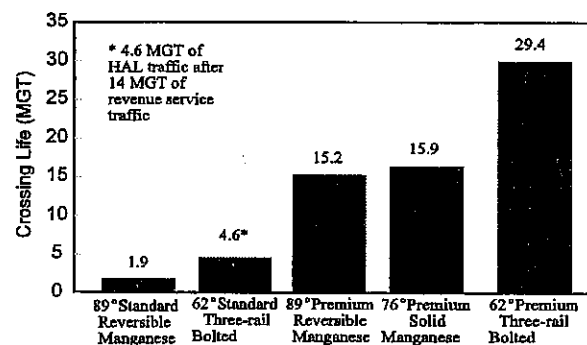
Four other crossings have been tested at FAST. Exhibit 4 shows the total HAL tonnage carried by each of the crossings before they failed. Results of the other crossing tests have been previously reported.¹

Exhibit 4. Life of Various Crossings Under HAL Traffic at FAST
