### THE EFFECTS OF CROSS GROOVES IN FLANGE-BEARING FROGS

TD 97-032

Association of American Railroads  
Railway Technology Department

August 1997

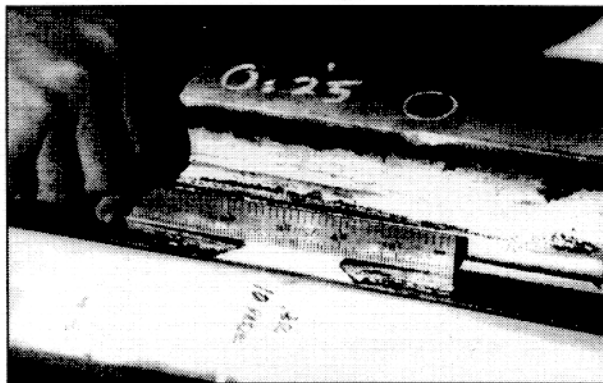
Exhibit 2. Worn 0.25-Inch-Depth Groove

an 8-inch-diameter wheel. Exhibit 2 shows one of the 0.25-inch-deep grooves in the worn-edge condition.

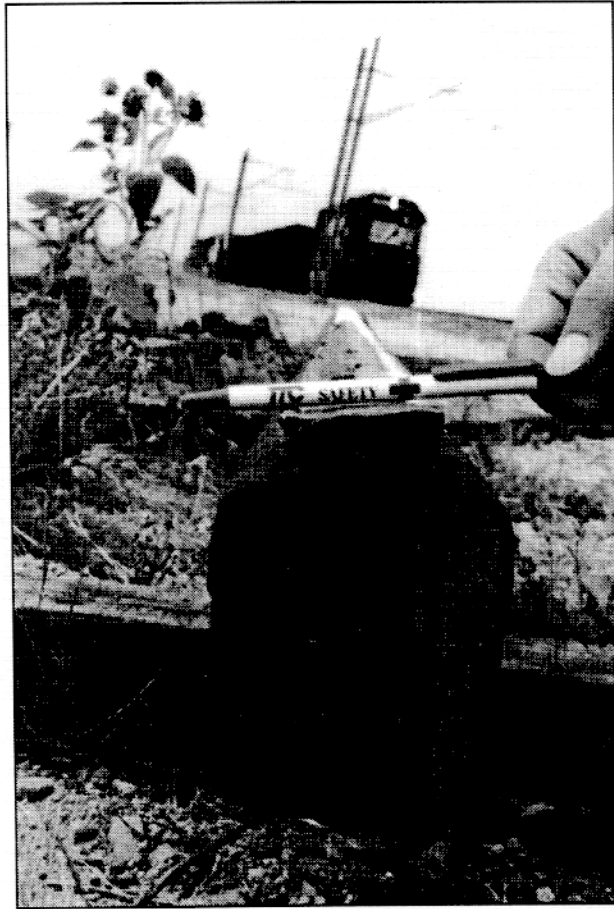
Exhibit 3. FBF Test Frog Running Surface Cross-Section Profile

Flange Bearing Testing at FAST under locomotives and HAL cars has shown that a fairly wide groove will develop from a limited number of cars (See Exhibit 3). The shape and depth of grooves worn in service will depend on the characteristics of the running-surface material, the wheel-flange shapes and the relative amount of traffic on the two crossing

lines. Based on the back-to-back tolerances for wheels allowed in North American freight cars, we expect to see a wear band of at least 1.25 inches in revenue service. Also, the initial shape of the running surface will affect where the wheels first wear a groove. Subsequent wheels will tend to follow that groove.

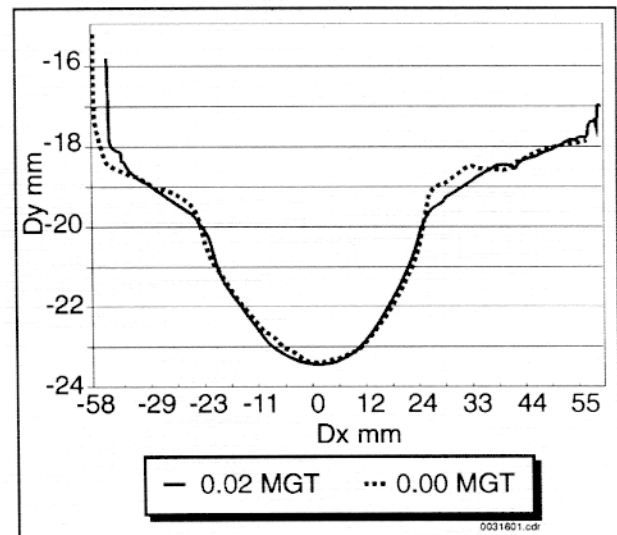
This test provided limited data on the deformation rates of cross grooves under flange-bearing conditions. Rates of groove deformation have been established for the soft running-surface material used. The material is a 1040 steel with an initial hardness of 240 HB. Previous train operations over the frog have hardened the surface to around 290 HB. Exhibit 4 shows the groove-dimension changes with tonnage.

Exhibit 4. FBF Cross-Groove Profiles at 0 and 0.02 MGT
