COBALT ALLOY CLADDING TO REDUCE WHEEL WEAR

by Kevin Sawley, Jian Sun, and Daniel Stone
TD 97-037

Association of American Railroads
Railway Technology Department

September 1997

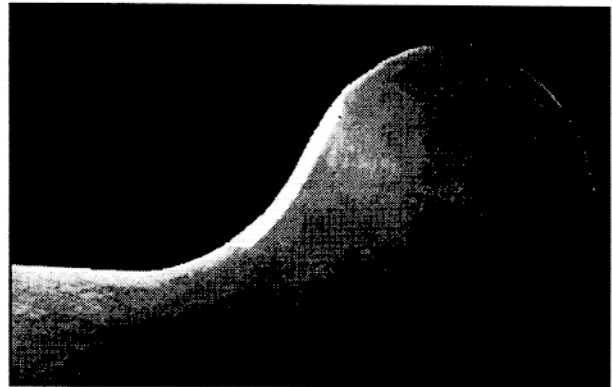
Exhibit 1. Section through a Clad Wheel, Showing a 0.08-Inch-Thick Cobalt Alloy Layer at the Wheel Flange

Exhibit 1 illustrates the thickness of the cobalt alloy layer produced in the trial wheels. A few small inclusions aside, the interface was free of defects. There was no evidence of significant interdiffusion of the cobalt alloy and wheel steel, and no oxide layer or lack of fusion at the interface.

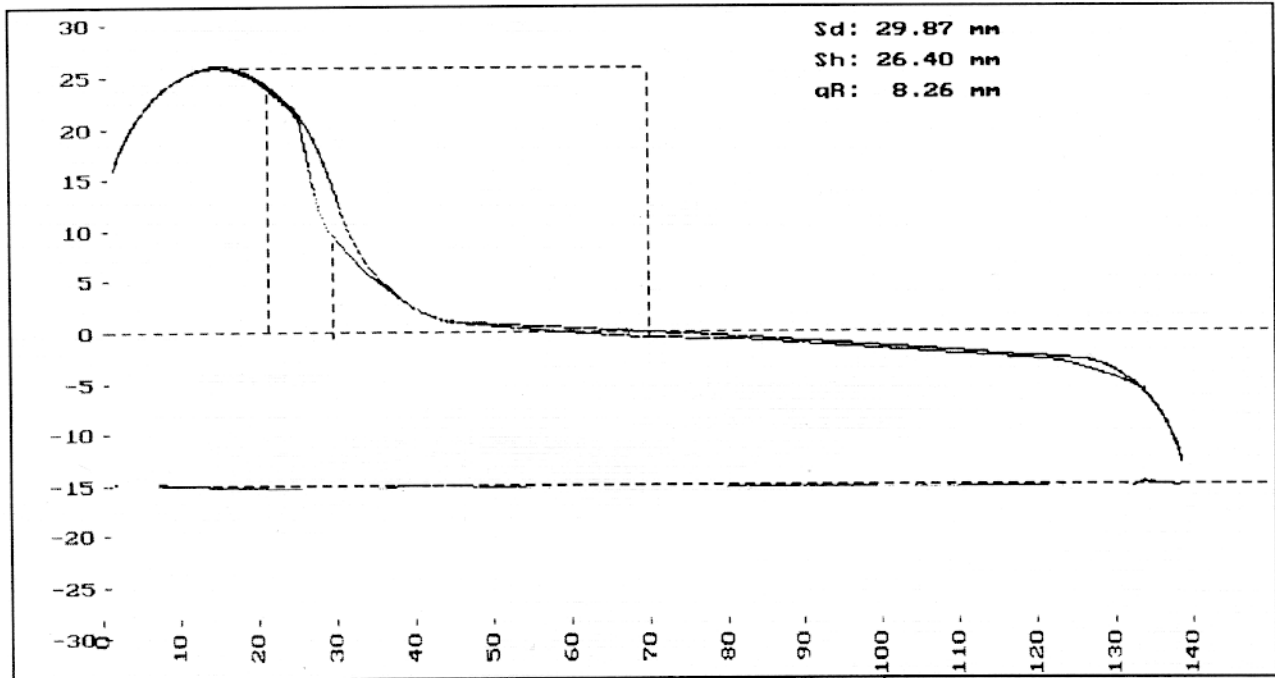
Exhibit 2. Comparison of New Clad Wheel Profile with Profile after 3,567 Miles Running

At the first inspection (3,567 miles) it was clear that two of the clad wheels had suffered high

flange wear. Both wheels were on the left side of the locomotive and had lost about 0.08 inch from the flange (refer to Exhibit 2), about the entire thickness of the cobalt alloy layer. At the next inspection (8,640 miles), the two clad wheels on the right side were seen to have worn more than 0.08 inch at the flange.

Therefore, after just 8,640 miles running, the major part of the cobalt alloy coating had been removed by wear from all four clad wheels. (There was no evidence of the cobalt alloy layer debonding from the wheel substrate.)

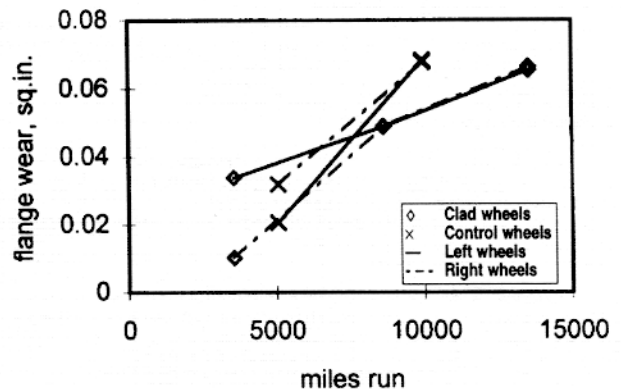
Exhibit 3. Effect of Mileage on Average Left and Right Wheel-Flange Wear

The difference between the new and worn profiles in the flange area was calculated (in square inches) to quantify the wear. It was found that, at low mileage, the left side wheels had much different wear patterns from the right side wheels. Because of this, Exhibit 3 shows the relationship between average left and right wheel-flange wear and miles run.

Exhibit 3 appears to show that after about 7,000 miles the clad wheels have a better wear performance than the control wheels. This may be misleading. First, as already noted, the cobalt alloy layer had all but worn away from the clad wheels after 8,640 miles. Second, the method of operation of the locomotive (turning and reversing), with the initial problems with the control wheel profiles, led to uneven wear of the eight trial wheels.

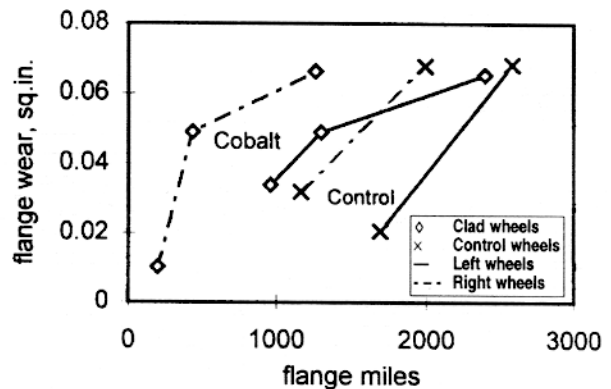
Exhibit 4 gives the average left and right wheel-flange wear as a function of "flange miles," and seems to show that the left and right clad wheels had higher flange wear rates than the left and right control wheels. The cause of the apparent difference in left and right wear rates is unclear.

Interpretation of the flange wear data was complicated by the way in which the FAST train was operated during the trial. Intermittent lubrication may have also clouded the results. However, it is clear that the cobalt alloy-clad layer did not significantly reduce wheel flange

Exhibit 4. Effect of 'Flange Miles' Mileage on Average Left and Right Wheel Flange Wear for the Cobalt and Control Wheels

wear. This result contradicts the findings in earlier Swedish trials.

A possible cause for these contrasting results may be the different wheel steels used in the two trials. The composition of the wheels used in the Swedish trial was not stated, but European wheels are typically softer than the Class C wheels used in these AAR tests, and have lower carbon level. Since strength and carbon content control wear resistance in pearlitic steels, European composition wheels are likely to have a natural wear resistance inferior to North American Class C wheels.
