"THE EFFECTS OF WHEEL BRAKING ON FLANGE BEARING FROGS"

TD 97-042

Association of American Railroads
Railway Technology Department

October 1997

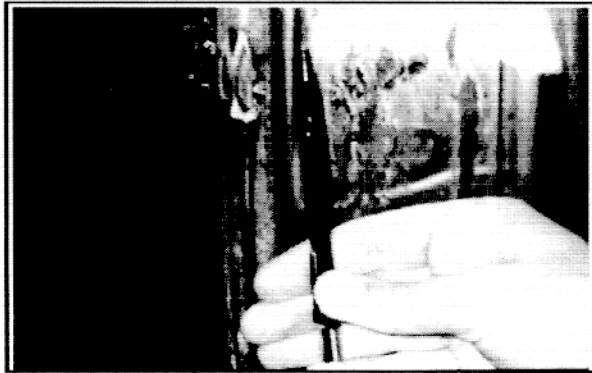
Exhibit 3. Flats Generated by Dragging a Wheel over the FBF

included at least one wheel that had a thin and/or high flange. These wheel sets were installed in empty or lightly loaded cars for testing. Due to the non-conformality of the wheels and brake shoes, it was difficult to slide wheels under any normal braking regime. However, slid flats were produced by tightening the hand brakes on the cars just prior to running over the FBF. This caused the wheels to slide on their treads, up onto their flanges, over the frog, and back to their treads. Visible flats were produced on both tread and flange with this process.

Edgewater, Griffin, and Standard also examined one wheel set each. Exhibit 3 shows the thin flange wheel examined by AAR.
