CRACKS IN WELDED GIRDERS OF THE FAST BRIDGE

by Duane E. Otter, Diana Oliva, and Richard Joy

December 1998®

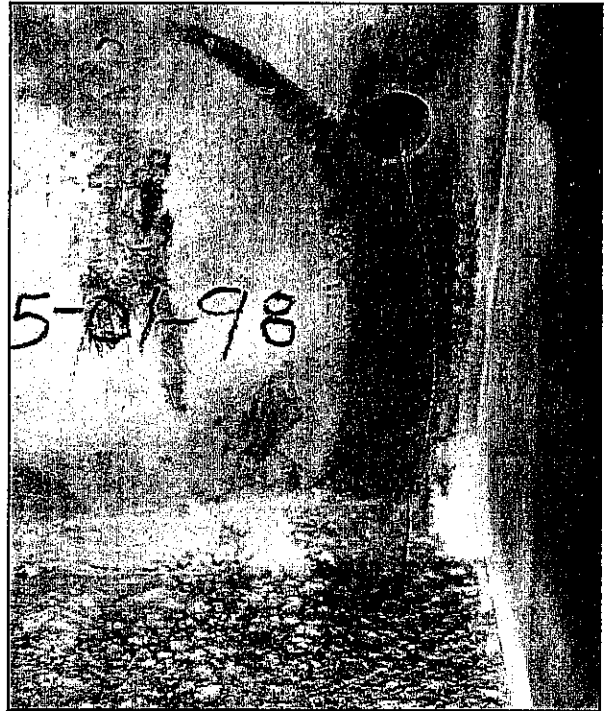
Exhibit 1 shows the crack propagating through the flange-to-web weld and into the tension flange of the girder. The crack is nearly 7 inches long. A $\frac{1}{8}$ -inch hole was drilled at the top of the crack to stop crack growth in the upward direction. The crack was first detected during a bridge inspection after 37 MGT of HAL traffic. The hole was drilled at that time. During an inspection after 55 MGT of traffic, crack propagation into the tension flange was not yet noted. During inspection after 82 MGT, it was noted that the crack ran completely through the weld and into the tension flange. At that point, the crack in the tension flange was about $4\frac{1}{2}$ inches long and up to $\frac{3}{16}$ inch deep. It appears that this crack initiated near the area where the flange-to-web weld and the web-to-stiffener weld intersect. This crack is

Exhibit 1. Crack Propogating into Tension Flange of Welded Girder

near intermediate stiffener No. 6 on this girder. Intermediate stiffener No. 7 is at midspan.

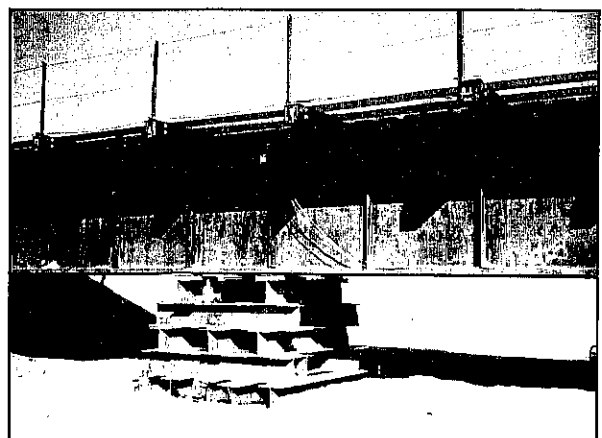
Exhibit 2 shows the helper crib that was constructed to support the 65-foot DPG span beneath intermediate stiffeners Nos. 6 and 7. The crib was constructed using steel H-piles. As settlement occurs, shims are added as necessary.

Exhibit 2. Helper Crib Supporting Cracked Span

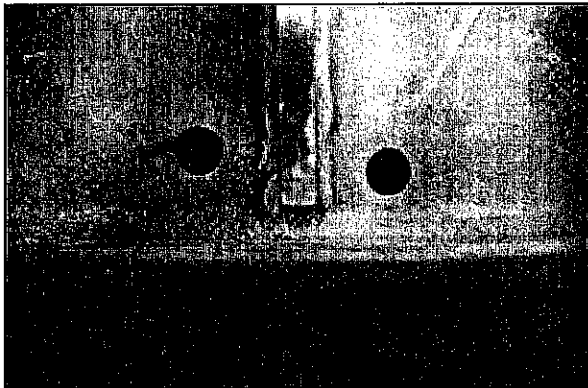
Exhibit 3 shows the crack near intermediate stiffener No. 7 in the same girder. This crack is very typical. Several similar cracks have been found in both girders of this span. The cracks appear to initiate in the area where the flange-to-web weld and the web-to-stiffener weld intersect. This particular crack has been drilled at both ends with $\frac{3}{8}$ -inch diameter holes. So far no growth has been noticed in any of the cracks that have been drilled. Some of the smaller cracks which are not yet big enough to drill properly have continued to grow. These cracks have been noted at intermediate stiffeners that have bracing attached as well as at those with no bracing.

Exhibit 3. Typical Crack in 65-Foot Welded-Steel Bridge Girder with Poor Weld Detail

the tension flange is 2 $\frac{1}{2}$ inches thick by 18 inches wide. The flange-to-web weld is $\frac{1}{2}$ inch. The web-to-stiffener weld is $\frac{5}{16}$ inch and wraps around the end of the stiffener. Due to the small amount of clearance and the weld wrapping around the ends of the stiffeners, the stiffener weld overlaps with the bottom flange weld, as can be seen in Exhibit 3. This area is where most of the cracks appear to have initiated. Current American Railway Engineering and Maintenance of Way Association (AREMA) recommended practice calls for a distance of four to six times the web thickness between welds, which would be 2 $\frac{1}{2}$ to 3 $\frac{3}{4}$ inches for this span.

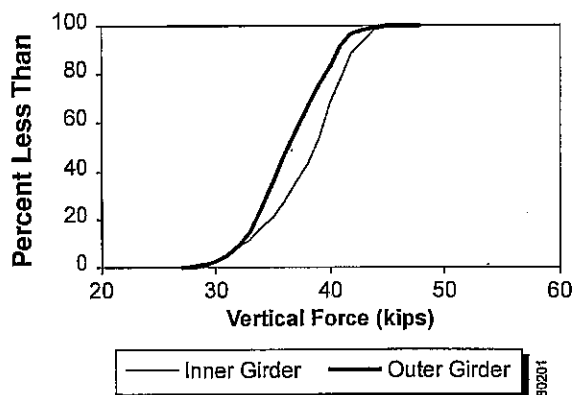
The load environment at FAST is particularly severe, consisting of primarily HAL cars with 315,000-pound gross rail load. All tonnage is due to the fully loaded FAST train, whereas in revenue service, there is often mixed-freight traffic and empty trains as well. The vertical wheel load environment is summarized in Exhibit 5. Certainly the heavy load environment is responsible in part for the cracking of the 65-foot span.

Exhibit 5. Vertical Wheel Load Environment at FAST
