INITIAL PERFORMANCE EVALUATION OF FLANGE-BEARING FROG CROSSING DIAMONDS AT FAST

by D.D. Davis, D. Guillen, R. Reiff, and S.F. Kalay

April 1999[©]

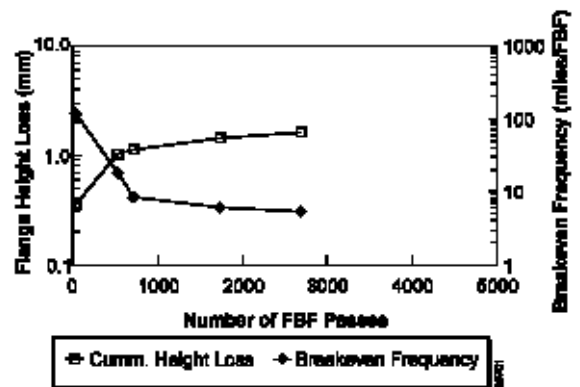
Exhibit 1. Average Wheel Flange Height Loss vs. Cycles

The average test wheel has lost 1.63 mm (about 1/16 inch) in flange height since the beginning of the test. Exhibit 1 shows the average flange-height loss vs. passes. Flange height loss rate continues to decline with additional tonnage. Currently, one FBF pass is equivalent to about 5 miles of operation at FAST (in tread wear). Thus, at FAST, average wheel flange height can be kept constant by operating over the FBF diamond at the one per 5 miles “break-even” frequency. Exhibit 2 shows a time series of wheel-flange profiles taken on one of the test wheels. The height loss and shape change is greatest on the new 1B wheels. This is expected as they are not work-hardened. And, they are wearing to a FAST worn profile on the tread.

rate of tread wear. This situation was causing concern about setting minimum flange-height limits. FAST instituted a minimum flange-height removal criterion at 13/16 inch. However, this is not expected to happen in revenue service, even if FBF diamonds replace all conventional diamonds in the North American freight system since the rate of diamond occurrence is much less than the one per 2.7 miles at FAST. The rate of flange-height loss has decreased with loading cycles of more than 31 MGT. The rate appears to be reaching a steady-state value. Currently, one FBF pass is roughly equivalent (in flange height loss) to 5 miles of running (in tread height loss). This is shown in Exhibit 1.

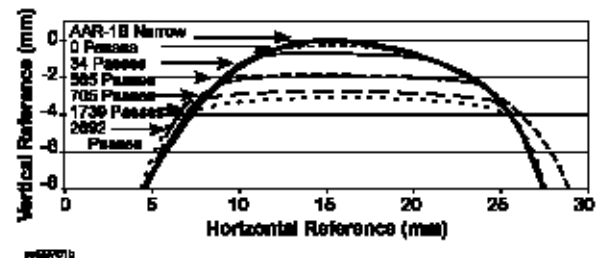
Exhibit 2. Close-Up View of Flange-Tip Profiles

Profiles have been taken on a group of 32 wheels. In general, the sample wheels have flattened on the flange tip, losing height and gaining width in the contact area. The flow of metal can be seen in the widened tip and sharpened corners. As was seen at the Track Lab tests, the rate of height loss is rapidly approaching a steady state with load cycles.

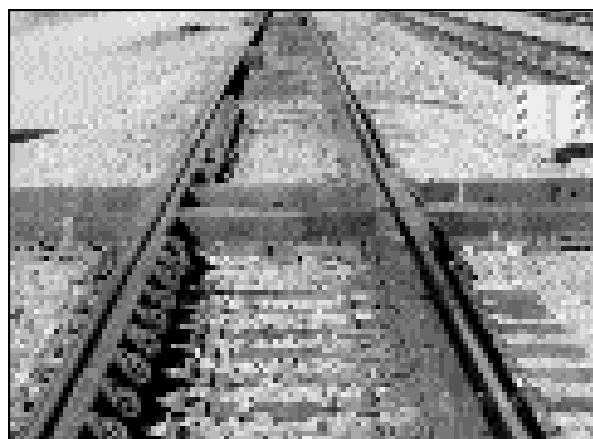
Exhibit 3. Nortrak FBF Diamond in FAST Service

The Nortrak FBF diamond design has performed well with the lone exception of pumping at one set of joints. This pumping is related to the abrupt stiffness change resulting from the particular joint design used in this diamond. The large stiffness change is the result of TTCI's desire to have more easily replaceable ramp rails. This detail can easily be remedied on future crossing diamonds; the FAST diamond has been retrofitted with an improved joint. Replaceable ramp rails were provided out of concern about high wear rates, but so far it has not been necessary to replace ramps. The wear rates on the heat-treated rail (ramps) and austenitic manganese steel (AMS) castings have been very low. The projected wear life of each component is about 1,000 MGT.

The diamond has been noisier and has caused a rougher ride than was expected. The flange-bearing ramp to casting joints and the flangeway intersections are believed to be the sources. One flangeway intersection was finished poorly with the cross flangeway ground about 0.04 inch deeper than the mainline flangeway. The joints are pumping under load due to the stiffness change. The casting ends are beginning to batter. The ramps appear to be performing well.
