EVALUATION OF A PROTOTYPE FLANGE BEARING FROG FOR HEAVY HAUL SERVICE

by David D. Davis, Don Guillen, and Joseph LoPresti

TTCI
Transportation
Technology Center, Inc.

August 1999®

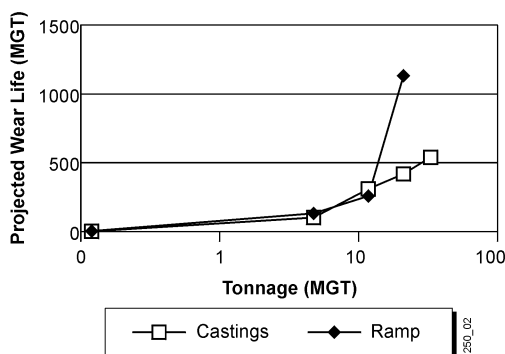
The performance of the running surface materials has been good, with the exception of the joint areas where pumping has been a problem. With flat running surfaces and rounded wheel-flange tips, the initial wear rates of both the frog and wheel running surfaces were quite high. As the frog running surfaces work-hardened and wore to a more conformal shape, the wear rates decreased. Exhibit 2 shows the projected wear life vs. tonnage for the FBF ramp rail and the frog castings. The wear life projection is based on the tonnage needed to reach a cumulative 0.25 inch of running surface height loss at the current wear rate. At this point, the shortest flanges in service would remain tread-bearing through the diamond. The

increase in projected life vs. tonnage reflects the constantly decreasing wear rates. Of course, the service life of the components could be extended by building up the running surface or by removing material from the tread bearing running surface to provide clearance.

Exhibit 2. Projected Wear Lives of Flange Bearing Diamond Running Surfaces

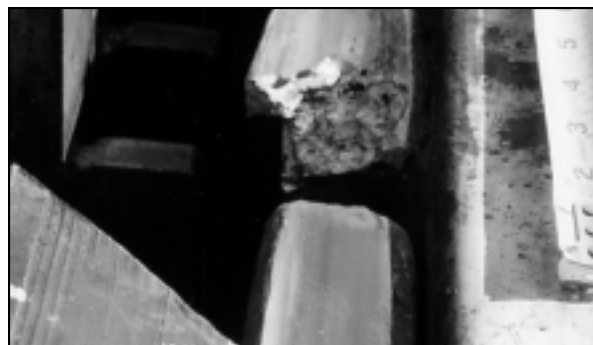
The casting failure is shown in Exhibit 3. The running surface sheared laterally at the end of the casting. This area is weaker than the rest of the casting in that there is a flangeway wall on only one side of the running surface. The other side has a separate guardrail. The running surface had been repaired by grinding and weld buildup on two occasions. The failure initiated from cracks originating in the heat-affected zones of the previous repairs. It was deemed impractical to repair the casting again, and testing was halted until the

Exhibit 3. Casting Cracking That Caused the Diamond Removal

The pumping at one set of casting ramp joints necessitated the frequent weld repairs. There were considerable problems in keeping the ramp rail elevation and the casting flangeway bottom elevation the same under load. This resulted in height mismatches that lead to impacts and running surface batter. The ramp rails were not affixed securely to the casting or its baseplate. They tended to lift off the baseplate between passing wheels.

A broken axle derailment occurred at FAST after about 30 MGT of traffic had been accumulated over the FBF diamond. The derailment did considerable damage to the diamond. While the derailment was unrelated to the diamond, it may have affected its subsequent performance. The diamond was bent out of alignment in the derailment, causing wheels to move sideways at the joints that failed 6 MGT later.

The long-term solution is to better align the ramp with the casting under load. This can be accomplished by welding the two together or providing a direct mechanical fastening. A pattern change will be needed to allow flash-butt welding of the ramp rail to the casting.

A pair of replacement castings is being made of J9 (medium-carbon) bainitic steel. The diamond will be reinstalled in the HTL with these castings and the modified joints for further evaluation.

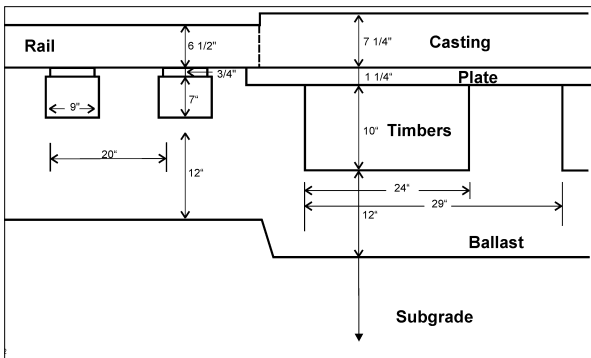
Exhibit 4 shows the diamond structure as modeled. The casting side was modeled as a casting sitting on a 1.25-inch plate with 10x24-inch crossties spaced at 29 inches. The ballast was an

American Railway Engineering and Maintenance of Way Association No. 4 gradation traprock over a sandy silt subgrade. The ramp side was modeled as the ramp and tread-bearing rail sitting on 9-inch-wide plates with 7x9-inch crossties spaced at 19.5 inches.

The significant stiffness change at the casting/ramp rail joint is not unusual for crossing diamonds in service. The fact that the diamond has an angle of 90 degrees, putting the joints side by side, makes this a worst-case situation. Exhibit 5 shows the predicted loads and deflections for the ramp rail and casting structures.

The model predicts that the rail side will experience about 10 percent more deflection under load than the casting side. This may create a discontinuity in the running surface at the ramp rail/casting butt joint. Furthermore, the ballast pressure is more than 50 percent higher on the rail side than the casting side (about 46 psi vs. 28 psi). This will result in long-term differential settlement of the diamond. In the case of FAST, the

north casting/ramp joints required tamping on a very frequent cycle (i.e., about 2 MGT). The north joints were “pumping” severely, resulting in high impacts, loss of surface, running surface batter, and many broken fastener components.

Exhibit 4. Crossing Diamond Modeled Structure

A parametric study of the effects of various rail side structure parameters was conducted. Tie cross-section and spacing were varied to determine their effects on maximum deflection and maximum ballast pressure. For example, changing tie spacing from 20 to 14 inches on the ramp side will decrease the maximum deflection to the level seen on the casting side.

Shortening tie spacing and increasing tie height both appear to be reasonably effective at lowering the maximum deflection of the rail side. At FAST, the joints were modified by shortening tie spacing, butting the first tie against the longitudinal timbers under the castings, and installing a two-tie plate under the rail side of the joint. The modified joint performed better, alleviating the pumping, but running surface problems remain.
