WHEEL-FLANGE SHELLING UNDER UNLUBRICATED CONDITIONS AT FAST

by David Davis, Joseph LoPresti,
Dan Stone and Semih Kalay

TTCI
Transportation
Technology Center, Inc.

December 1999[©]

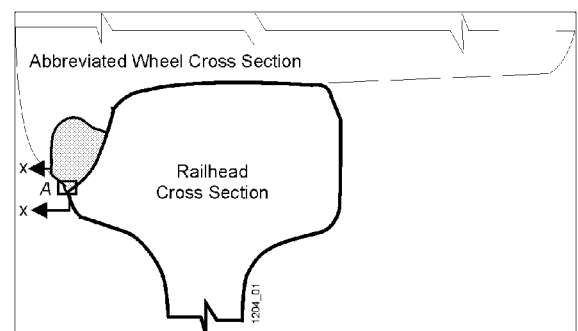
Wheel-flange tip shelling has occurred at FAST throughout the HAL experiment and during the previous 33-kip wheel load experiments.¹ Exhibit 1, taken from Gray's 1981 report covering the initial FAST wheel experiments, shows the location of the typical flange shell as well as the typical wheel and rail profiles that produced them. A conclusion from this report is that unlubricated train operation caused excessive plastic deformation that resulted in fatigue-cracking of the flanges. Exhibit 2 shows a typical shell from HAL Phase III (lubricated rail and pre-FBF diamond) and a typical shell from Phase IV (dry rail and post FBF diamond). The

Exhibit 1. FAST Wheel Flange Crack from the 1970s

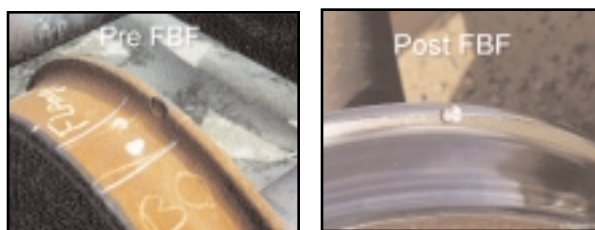
Exhibit 2. Typical FAST Wheel-Flange Shells from HAL Phase III and IV

shells occur on the side of the flange facing the rail. They range in size from 0.25 to 1.50 inch in length and do not span the width of the running surface of the flattened flange tip. The shells are fatigue defects that originate at aluminum-oxide inclusions in wheels. Shells are found by normal train visual inspections after they “pop out.” They are not considered to be an immediate safety hazard. A wheel with a shell, running on its flange tip, is not creating large impact forces.

Several flange shells were examined visually to determine the likely failure mechanisms. Additionally, a detailed examination of a typical shell removed during the dry operations was conducted. Visual examination of the defects gives the appearance of a small shattered rim defect. The fracture surfaces are ellipsoidal with fatigue bench marks originating at the center of the fracture.

Examination of the defects with a scanning electron microscope revealed the remains of a particle of aluminum oxide. As is the case with these flange defects, larger, shattered rim defects are initiated at alumina or silica inclusions. Aluminum oxide inclusions are either the remains of aluminum additions made at the end of the liquid phase of steel processing or exogenous inclusions that are the remains of eroded refractories that were part of the furnace or ladle linings.

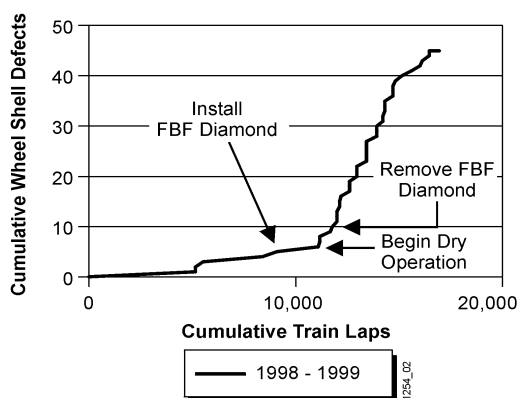
Exhibit 3. FAST Wheel-Flange Shelling Occurrence

The rate of shelling changed dramatically in 1999 as several experiment changes were made. The biggest change was the “dry” (unlubricated) operation of the FAST train. Exhibit 3 shows the rate of wheel-shell defect occurrence in 1998 and 1999 to date. The sharp kink in the curve corresponds to the start of dry operation. Installation of the FBF diamond preceded the start of dry operation by about 31 million gross tons (MGT) or 2,700 laps. In 1998, under lubricated operations, six shells were found in 120 MGT of operation. The rate of shelling remained constant until near the end of operation, when it decreased somewhat. In 1999, 40 shells have been found in about 50 MGT of dry opera-
