THE EFFECT OF WHEEL/RAIL PROFILES ON WHEEL PERFORMANCE AT FAST

by N. Wilson, D. Maal, D. Davis, J. LoPresti and S. Kalay

TTCI
Transportation
Technology Center, Inc.

December 1999[©]

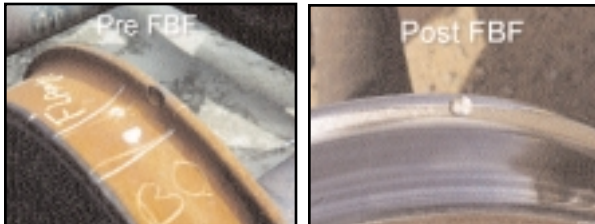
Wheel flange tip shelling has occurred at FAST throughout the HAL experiment and during the previous 33-kip wheel load experiments.¹ A conclusion from Gray’s 1981 report on early FAST wheel experiments is that train operation on dry rail caused excessive plastic deformation resulting in fatigue cracking of the flanges.

Exhibit 1 shows more recent flange shells from HAL Phase III (lubricated rail) and Phase IV (dry rail). The shells occur on the side of the flange facing the rail. They range in size from 0.25 to 1.50 inch in length and do not span the width of the flange tip. The shells that were inspected using electron microscopy are fatigue defects originating at aluminum-oxide inclusions in the wheels.

Exhibit 1. Typical FAST Wheel Flange Shells from HAL Phase III and IV

The rate of shelling increased dramatically in 1999 as several experiments were changed. The biggest change was the dry-rail operation of the FAST train. In 1998, under lubricated operations, six shells were found in 120 million gross tons (MGT) of operation. In 1999, 40 shells have been found in about 50 MGT of dry-rail operation.

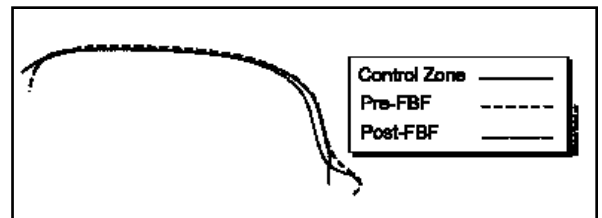
The grinding experiment, combined with the limited range of flange heights in the FAST train fleet, has created a rail profile with a significant lip or shelf. The profile was very conformal to a wheel shape seen prior to installation of a flange bearing frog (FBF) crossing diamond at FAST. Exhibit 2 compares measurements of the following three high-rail profiles from Section 25 at FAST:

Exhibit 2. Comparison of Section 25 High-Rail Profiles, in Control and Gage Corner Grind Zones

Note that heavy gage face wear is evident in the grind zone, with a resultant prominent lip well down the gage face. This lip is largely the rail metal in its original location. Metal removal on the gage face and a small amount of metal flow forms the lip. In the plot, the three profiles are aligned at the rail centerline track. This view shows the relative gage face wear in each section.

Note that the gage face angle on all three profiles is essentially the same, indicating that the FBF flange profile is not affecting the shape of the flange above the tip. After dry test runs using wheels with flattened flange tips, the lip is still present; but the corner radius between the lip and the gage face has become much smaller.

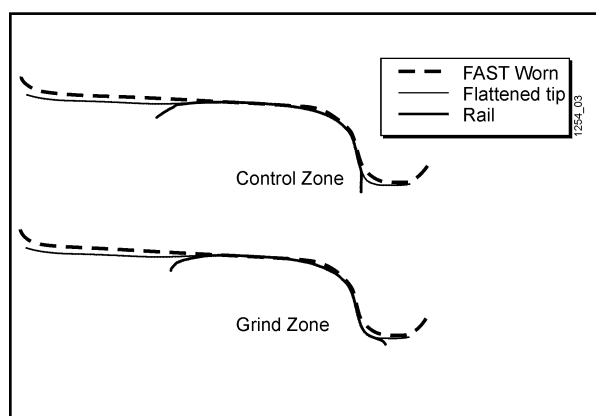
Exhibit 3 shows how a wheel with a flattened flange tip and a normal FAST wheel contact the high rail in both the grind zone and the control no-grind zone. Note that wheels with flattened flange tips contact the grind zone rail in the sharp corner of the lip, leading to the potential for stresses significantly higher than normal due to the small radius of contact. When the rails were lubricated, this contact condition apparently did not adversely affect flange shelling. However, when flange lubrication was

eliminated, the flange shelling increased dramatically. It was hypothesized that when running dry, the large rolling radius of the flange tip contact point generated large longitudinal steering forces that contributed to the shelling.

Exhibit 3. Contact Geometry of FAST Worn and Flattened Flange Tip Wheel Profiles on Control and Grind Zone Rails

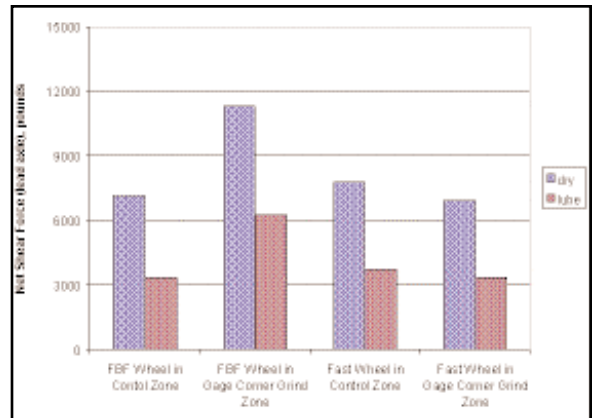
NUCARS predictions indicate that the highest contact stresses are generated with the flange tip wheel in the grind zone. The shear forces shown in Exhibit 4 are the combination of longitudinal and lateral forces in the contact plane. The dry condition is predicted to generate higher flange tip shear stress than the lubricated condition. Under dry conditions the large (wheel) rolling radius of the flange tip can generate large longitudinal steering forces.

These predicted stresses are well above the tensile yield stress of heat-treated wheel and rail steels and would be expected to lead to flow in the presence of large shear forces in the contact patch. Since the model does not account for plastic deformation, the predicted contact stresses are approximate. However, they do give an indication of the relative effects of wheel and rail profile. These large shear forces in combination with the very high contact stress could lead to the generation of flange shells.

Exhibit 4. Effects of Wheel and Rail Profile on High-Rail Contact-Patch Shear Forces

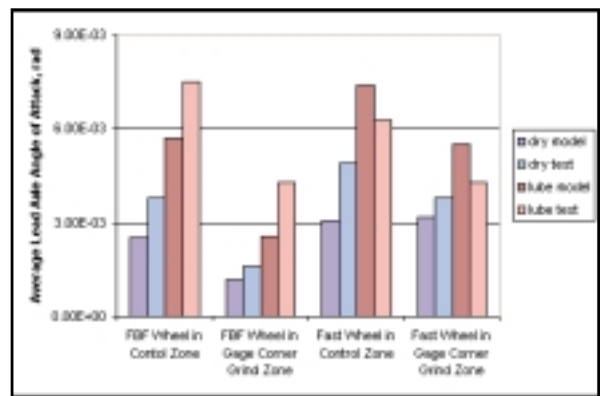
NUCARS simulations are corroborated by test results shown in Exhibit 5, demonstrating that the increased longitudinal steering forces caused by dry running result in lower angles of attack (AOA) for all four combinations of wheel and rail profiles. Much lower AOA occurs in the gage corner grind zone for the flattened flange tip wheels running dry, due to the very large longitudinal steering forces.

Exhibit 5. Effects of Wheel and Rail Profile on Lead Axle Angles of Attack
