## Axle Fatigue: 315,000-pound Capacity Cars at FAST

by Kevin Koch and Duane Otter

### Summary

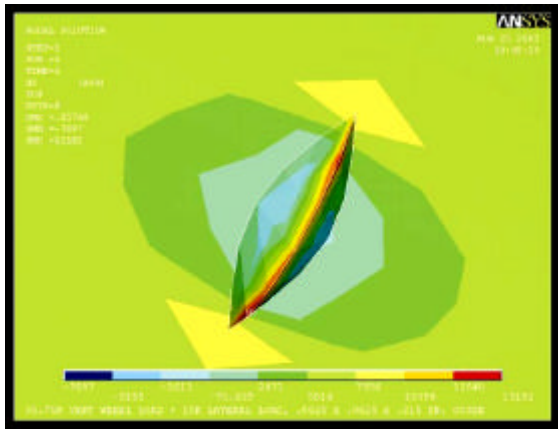
Figure 2. Typical Notch Geometry

- A semi-circular "V" notch on the surface: 0.125 inch wide by 0.125 inch deep by 0.43 inch long. The bottom of the notch has no radius (see Figure 2 for typical configuration).
- A semi-circular "V" notch on the surface: 0.0625 inch wide by 0.0625 inch deep by 0.22 inch long. The bottom of the notch has no radius.
- A 0.125-inch deep depression on the surface of the axle simulating the removal of a 0.125-inch deep defect by grinding and blending. The depression was 1.9 inches long by 1.5 inches wide and had a 2.5-inch radius about an axis that is perpendicular to the rotational axis of the axle (see Figure 3).

The stress concentration factors due to surface defects calculated by finite element analysis are shown in Table 1. The maximum stress was at the base of the notch. These factors are similar in magnitude to those estimated using approximation techniques listed in mechanical engineering literature.<sup>2</sup>

Type of Surface Feature	Stress Concentration Factor
“V” notch – 0.125” deep × 0.125” wide × 0.43” long	2.66
“V” notch – 0.0625” deep × 0.0625” wide × 0.22” long	2.02
“Blend” – 0.125” deep × 1.5” wide × 1.9” long	1.25

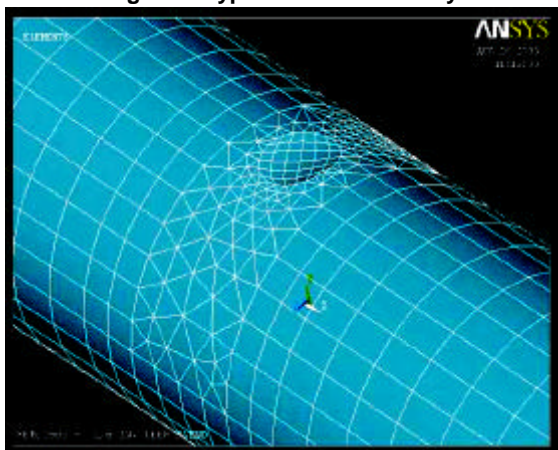
Figure 3. Blended Repair

As shown in the table, the “repair” of a damaged axle surface by a blend and grind operation can return the estimated fatigue life of the structure to the essentially infinite range. An increase in travel speed to 50 mph would result in a decrease in fatigue life of about 17 percent if a surface notch was present and about 80 percent if a surface repair were present. The reason for the significant decrease in predicted life for the surface repair is that many cycles that did not cause fatigue damage at 40 mph have increased enough in stress level to cause damage at 50 mph.
