The work described in this document was performed by Transportation Technology Center, Inc.,
a wholly owned subsidiary of the Association of American Railroads.

Fatigue Evaluation of Welded Steel Bridge Girders at FAST

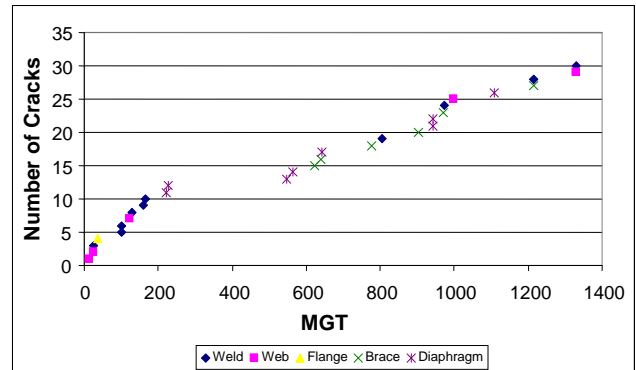
Figure 1. History of Cracks Noted in 65-foot Welded Girder Span

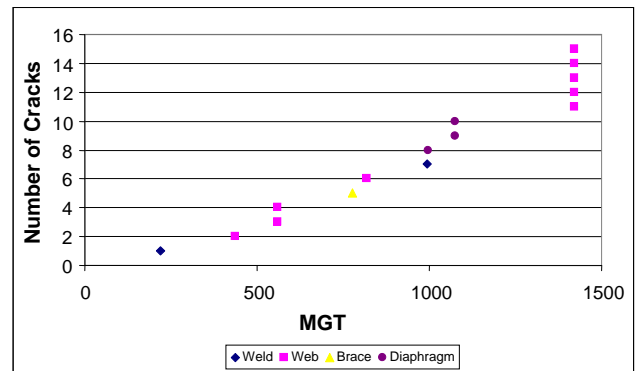
Figure 2. History of Cracks Noted in 55.5-foot Welded Girder Span

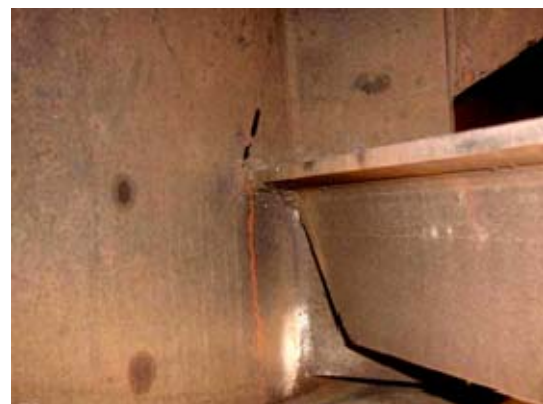
Figure 3. Crack in Web near Bottom Lateral Brace Connection, Inside of 55.5-foot Welded Girder

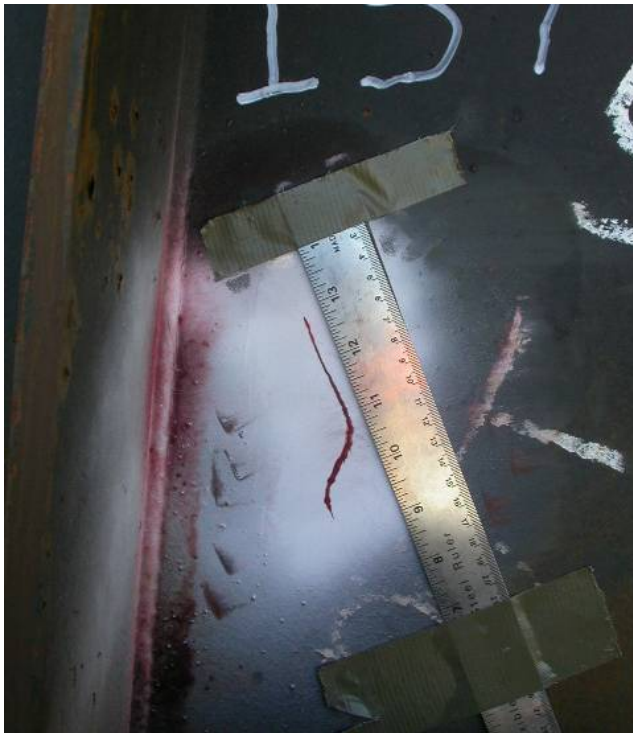
Figure 4. Crack in Web near Bottom Lateral Brace Connection, Outside of 55.5-foot Welded Girder

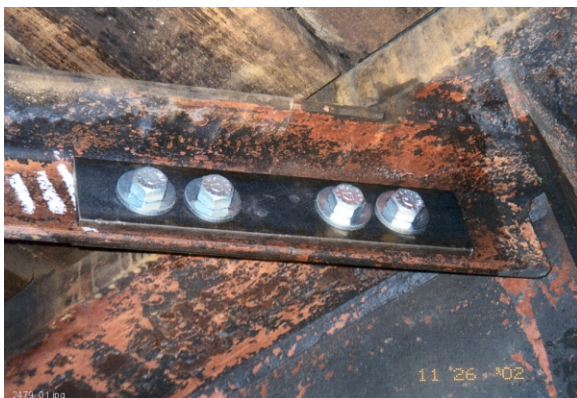
Figure 5. Typical Bolted Splice Repair of Broken Top Lateral Brace in 65-foot Welded Girder

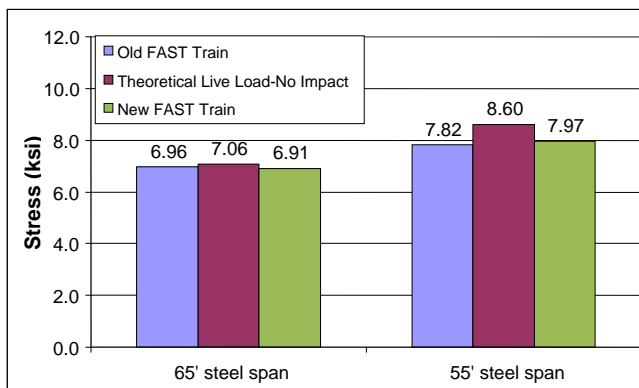
Figure 7. Comparison of Typical Maximum Stresses for FAST Train

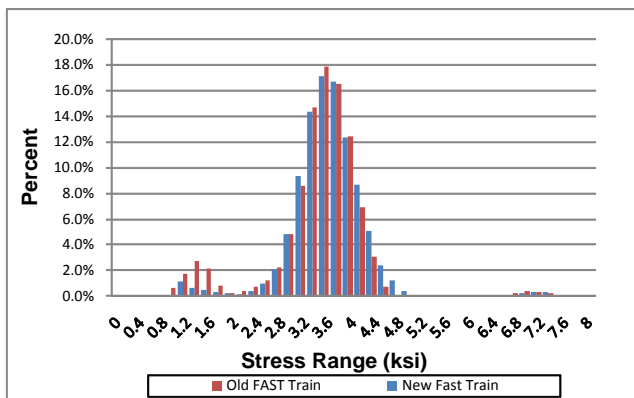
Figure 8. 65-foot Welded Girder – Cyclic Stress Range Histogram
