The work described in this document was performed by Transportation Technology Center, Inc., a wholly owned subsidiary of the Association of American Railroads.

Monitoring of Sub-Surface Fatigue Cracks in Railway Wheels using ACWDS

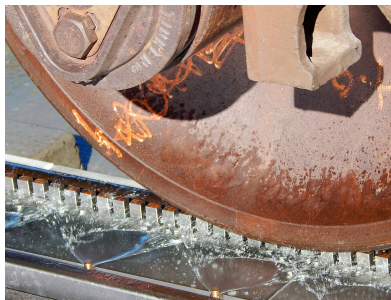
Figure 1. Newly installed outboard UT probe array in the field side of the rail/wheel

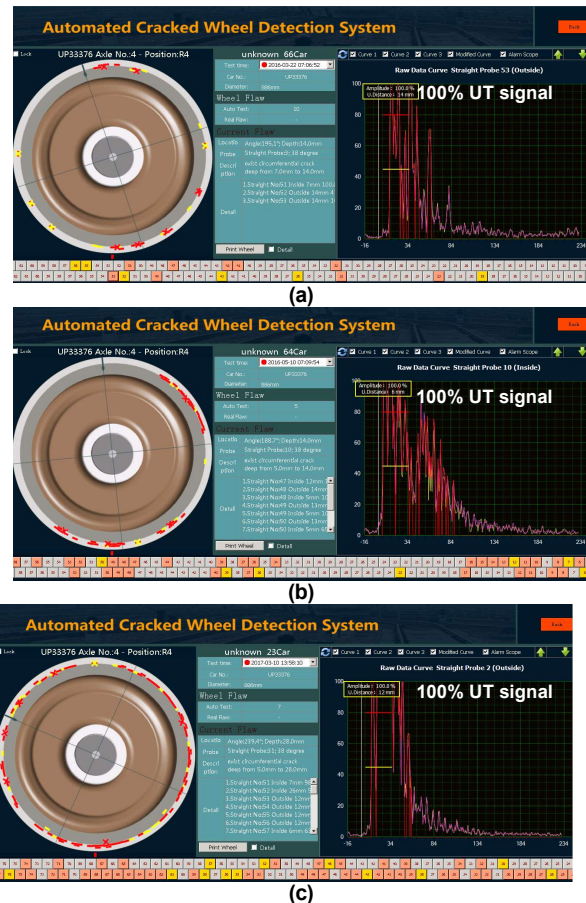
Figure 2. Subsurface fatigue cracks severity monitoring in FAST train wheel: (a) 03/2016; (b) 05/2016; (c) 03/2017

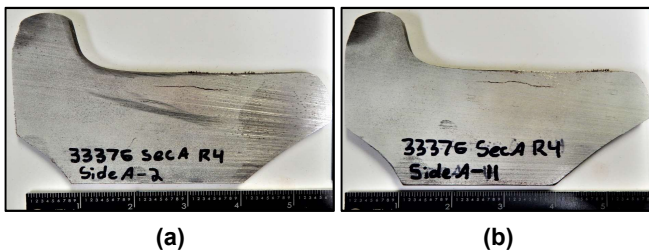
Figure 3. Cut-out view of the wheel slice showing subsurface fatigue cracking at different locations

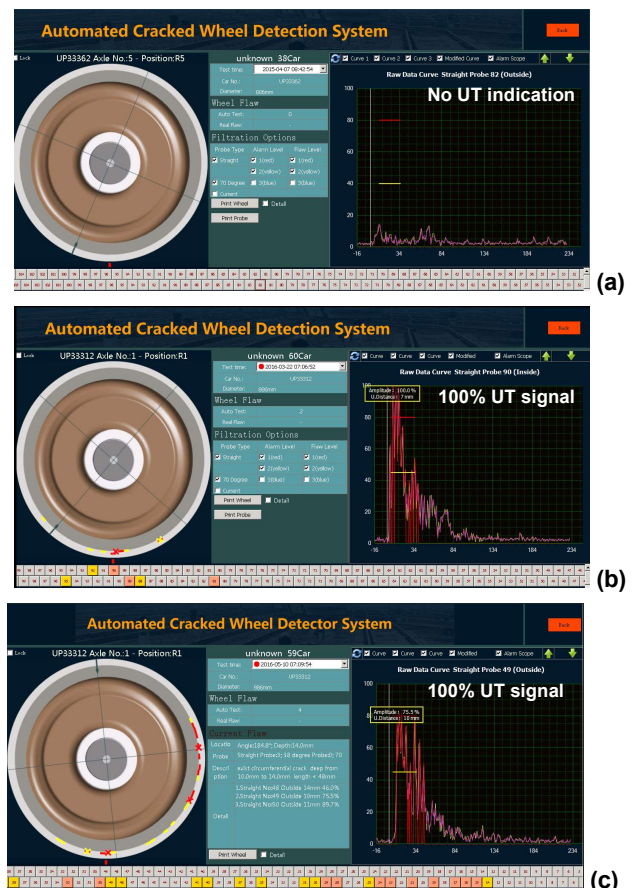
Figure 4. Subsurface fatigue cracks severity monitoring in FAST train wheel: (a) 04/2015; (b) 03/2016; (c) 05/2016

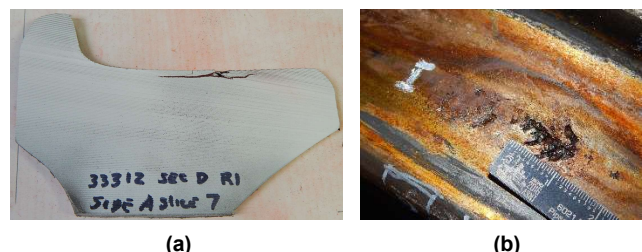
Figure 5. Cut-out view of the wheel slice showing subsurface fatigue cracking and spalling on the tread

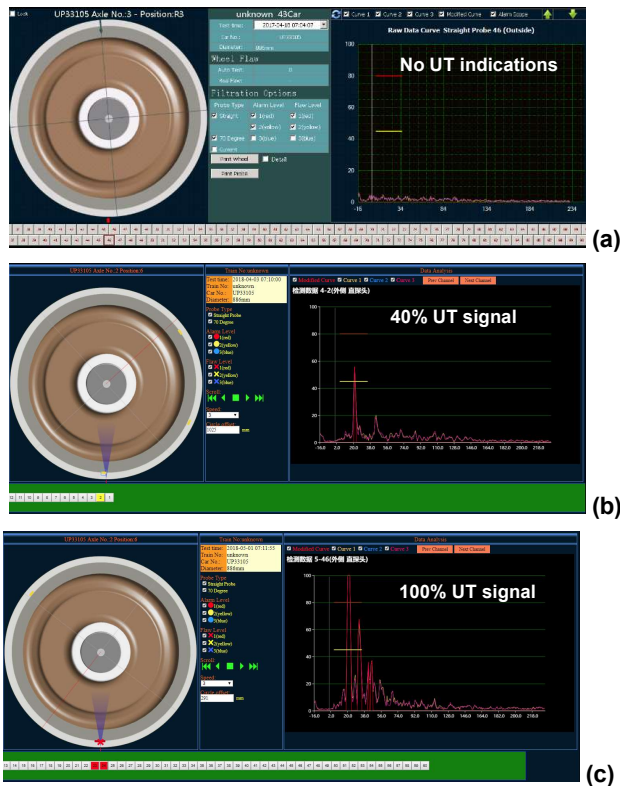
Figure 6. SRC severity monitoring in FAST train wheel: (a) April 2017; (b) April-2018; (c) May-2018. Wheel was removed from the FAST consist on May 2018

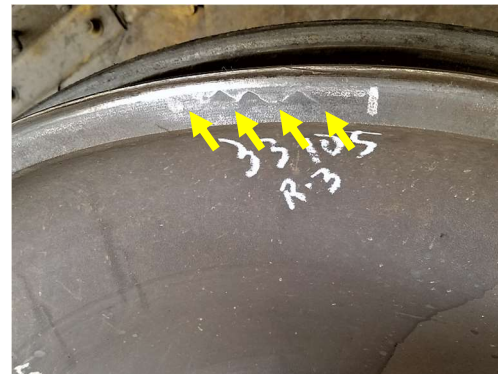
Figure 7. Picture showing the early stage of shattered rim crack in the removed wheel.
