FIELD PERFORMANCE OF TWO ALTERNATIVE BROKEN RAIL DETECTION SYSTEMS

by Richard P. Reiff

TTCI
Transportation
Technology Center, Inc.

January 2000[®]

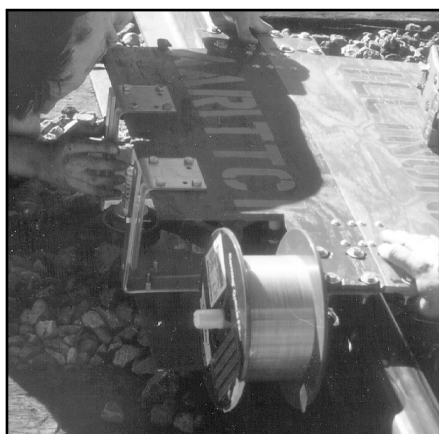
Exhibit 2. Prototype Fiber Strand Applicator Cart

The fiber optic system consisted of a light transmission source adjusted to a wavelength of 1550 nanometers. The 62.5-micron-diameter fiber is bonded to the rail using epoxy. The initial installation utilized a hand application process requiring several days to complete the entire segment. A prototype production applicator fixture has been designed and built under contract by the University of Illinois/Urbana, as shown in Exhibit 2. This cart facilitates the application of fiber along the rail by metering out fiber and a bonding tape as the unit is pushed along the rail. Regardless if epoxy or tape is utilized, the rail surface over which the fiber is attached must be cleaned of loose rust, dirt, grease and other surface material to ensure a firm bond.

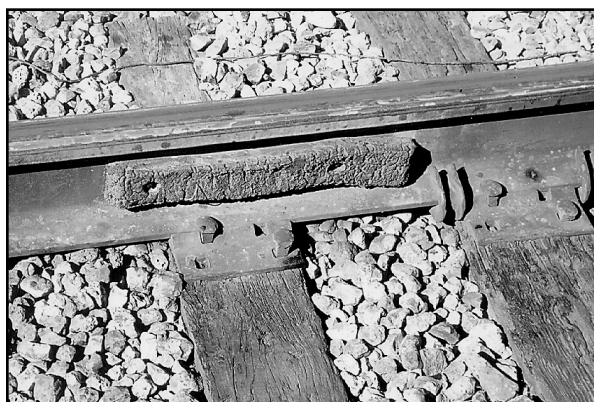
Exhibit 5. Heat Damaged Strain Gage Sensor Cover

from work equipment, including rail heating operations. Exhibit 5 shows a sensor module damaged from a rail heater that was inadvertently operated too slowly past the site. The polling cycle selected is needed to obtain an extended battery life; however, the time between polling is dead time, and, depending on how much before the next poll, a delay between the broken rail event and notification of a broken rail will occur.

Unless a sensor is damaged by the broken rail event, the strain gage system is available for detection immediately after the rail is repaired. Should the repair utilize a bolted plug, however, any free play in the joints may reduce sensitivity. Strain gage modules are susceptible to damage
