Body-Mounted Brake Rigging Efficiency Losses in Service

by Fred Carlson

TTCI[™]
Transportation
Technology Center, Inc.

©October 2002

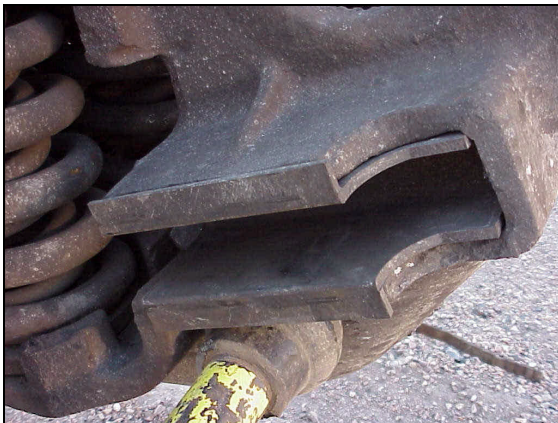
Figure 2. Brake Beam Pocket with Plastic Wear Liner showing Smooth Wear Surfaces with No Gouges or Ridges — Car 97405

Two trucks, one from a car equipped with lever bushings and one without bushings, were disassembled to inspect the brake components. No abnormal wear patterns were found in any of the rigging pins, lever holes, brake beam end extensions, brake beam struts, or in the plastic brake beam wear liners. However, the low-friction coatings in the bushings were flaking off or worn off to the point where little of the original coating remained. Figures 2 through 5 show some of the wear conditions found.

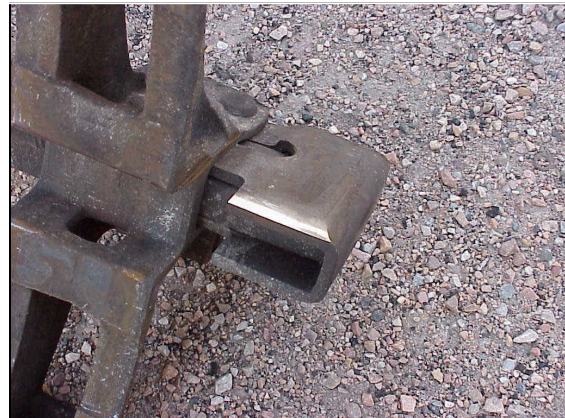
Figure 3. Brake Beam End Extensions Showing Typical Normal Wear Patterns — Car 97405

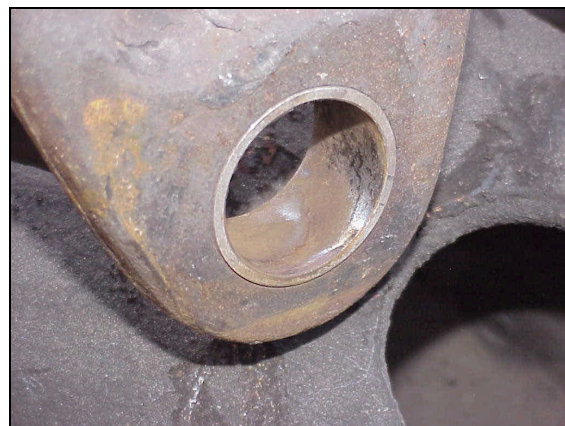
Figure 4. Bushed Brake Beam Live Lever from Car 97542.

The Low friction coating still remaining is impregnated with rust particles, and much of the coating has been worn away after 226,000 miles.

The initial installation of the low-friction bushings in the brake levers was a tedious and expensive proposition. Because of the tight tolerances required, the holes had to be reamed to final size prior to pressing the bushings into the levers. While the initial shoe force tests showed a marginal improvement, the durability of the bushings and their performance after 240,000 miles of service cannot justify the original cost.

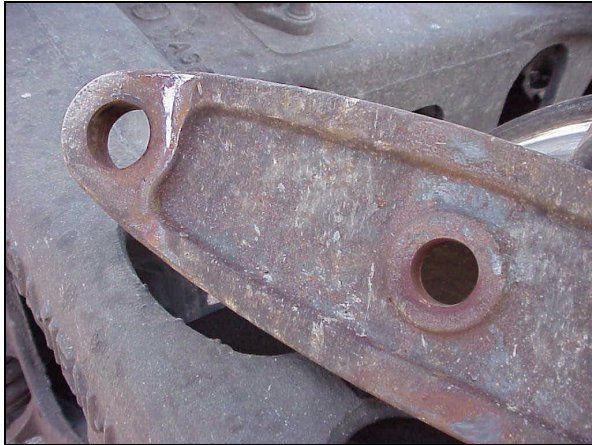
Figure 5. Live Truck Lever showing almost no wear after 240,000 miles — Car 97405
