Work performed by Transportation Technology Center, Inc., a subsidiary of the Association of American Railroads.
Contact **Dave Davis, (719) 584-0754** with questions or concerns regarding this *Technology Digest*. E-mail: david_davis@ttci.aar.com.

An Update on Revenue Service Tests of Bainitic Steel Rail Crossing Diamonds

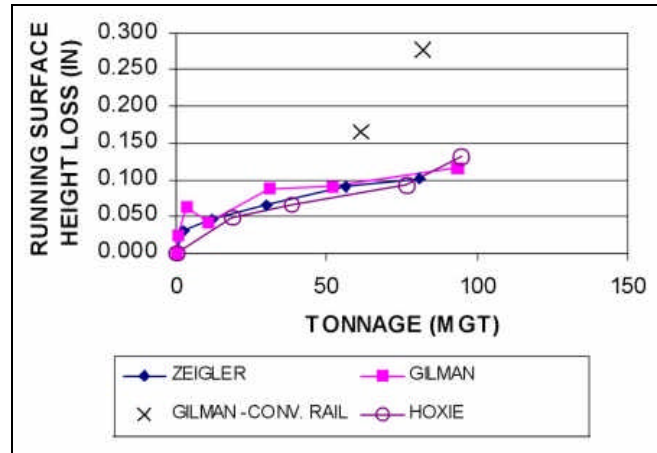
Figure 1. Running Surface Height Loss vs. Tonnage for Bainitic Rail Crossing Diamonds

Figure 1 shows the average running surface height loss versus tonnage for each test diamond at each site. Running surface height-loss measurement—an indication of combined metal flow and wear—was made 1 inch from the flangeway of each common corner. The height-loss rates are declining with tonnage as the running surfaces become harder due to deformation. For comparison purposes, the measured height-loss values from the two previous diamonds at Gilman are shown. These were conventional head hardened pearlitic TW rails.

tracks' traffic. The three crossing diamonds are performing very similarly with average deformations of about 0.12 inch on the common corners.

As of November 2002, each crossing diamond has accumulated about 100 MGT of traffic. The common corners show the most deformation due to having both

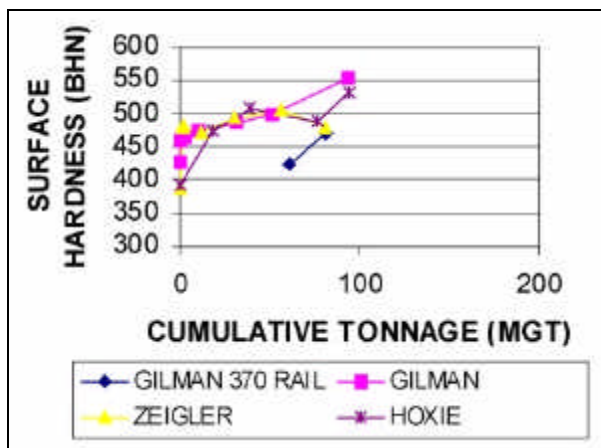
Figure 3 . Running Surface Hardness vs. Tonnage for Bainitic Rail Crossing Diamonds

A corresponding increase in surface hardness has been measured with running surface height loss. Figure 3 shows average running surface hardness with tonnage for the test sites. The significant increase in average hardness at Gilman during the last measurement came with an increase in surface cracks and spalls.

The running surface hardness values will be watched closely because they may be a predictor of surface cracking and rolling contact fatigue. It is not known how hard the bainitic rail running surface can get with dynamic loading. However, pearlitic rail and AMS both reach a characteristic hardness level beyond which they are likely to crack rather than flow. This “ductility exhaustion” value is around 500 Bhn for pearlitic rail and 600 Bhn for AMS castings. To date, the bainitic rails are still work hardening under traffic.

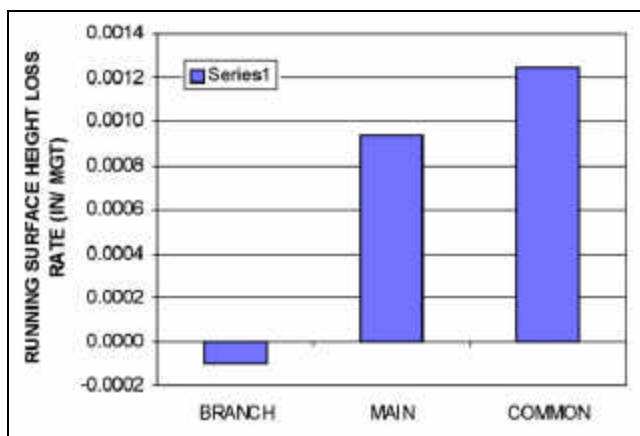
Figure 4. Comparison of Running Surface Height Loss by Frog Corner Location

diamonds tested at FAST. Tests at FAST are conducted under higher wheel loads and similar speeds. Diamonds at FAST had no crossing traffic. Previous analysis has shown that a small amount of cross traffic contributes to a large increase in wear rate for the common corners.³ Further analysis with the latest data also shows that the common corners have a significantly higher height-loss rate than the other running surfaces. Figure 4 shows these rates for each crossing.

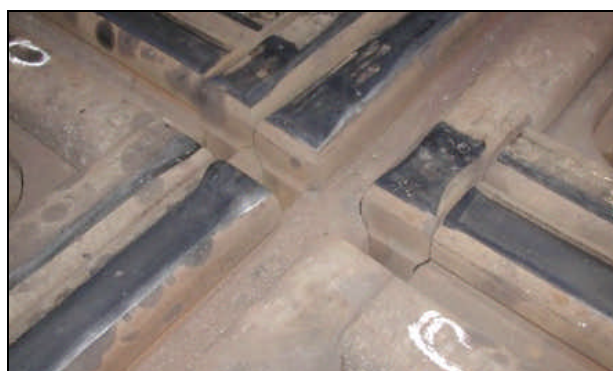
Figure 5. Bainitic Rail Crossing Diamond Common Corner

The bainitic rail crossing diamonds have required much less initial maintenance than the conventional three-rail and AMS casting diamonds previously in place at these locations. Having less running surface deformation appears to be benefiting the rest of the diamond resulting in lower dynamic loads, fewer loose fasteners, thus requiring less surfacing. This is not to say that the diamonds are not deteriorating under traffic. Figure 5 shows a deformed common corner on one of the test diamonds. Hollow worn wheels are deteriorating the running rails and easer rails.

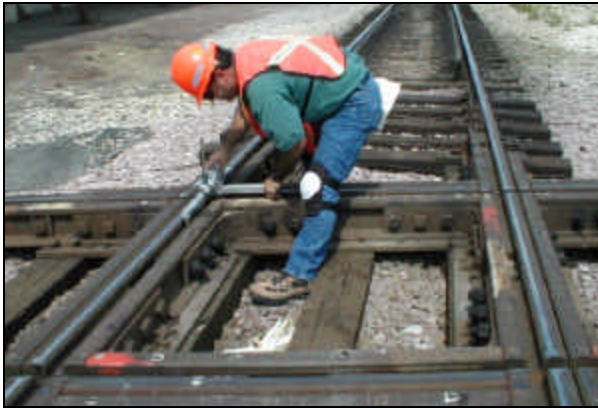
Figure 6. TTCI Measurements of Running Surface Elevation

TTCI is measuring the performance of the crossing diamonds through frequent inspections. Measurements made include running surface elevations, profiles, and hardness. Maintenance and component replacement records are also being monitored. Figure 6 shows a TTCI engineer measuring the running surface elevation of the mainline rails. With this device, the running surface height loss from wear and metal flow can be determined.

Running surface wear and deformation are calculated from the change in elevations with tonnage. Non-running surface points are also measured to serve as reference marks. Comparison to the previous two pearlitic rail crossing diamonds can be made since similar measurements were taken when these diamonds were removed from track.
