## **TLV Vertical Track Strength Follow-up Testing Using TTCI's Cone Penetrometer**

by **Randy Thompson, Dingqing Li, and Previn Marquez**

### **Summary**

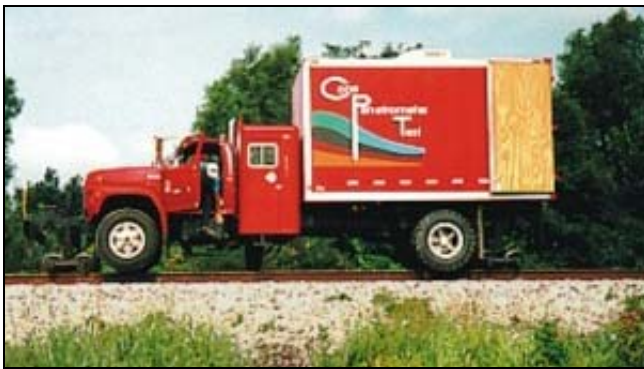
Figure 1. The CPT Vehicle

TTCI's CPT vehicle is uniquely designed to perform extensive measurements through the ballast and deep into the subgrade (Figure 1). Typical measurements are taken to a depth of 15 feet. The CPT uses hydraulic actuators to push an instrumented cone attached to a drill rod down through the ballast and into the subgrade (Figure 2). The instrumented cone was specially designed to withstand the high penetrating stresses from the granular layer with high durability while retaining the sensitivity necessary to measure soft subgrade conditions.

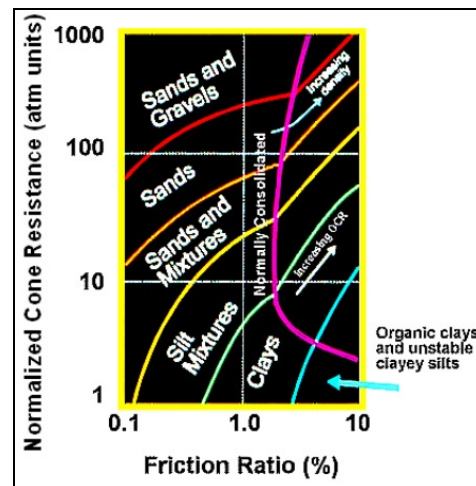
Figure 3. - CPT Soil Identification Chart

resistance is related to soil strength and stiffness (Table 1); thus, its distribution with depth directly indicates layer strength characteristics. Using results of both tip resistance and the friction ratio, estimation of soil types can be made based on available CPT soil identification charts (Figure 3).

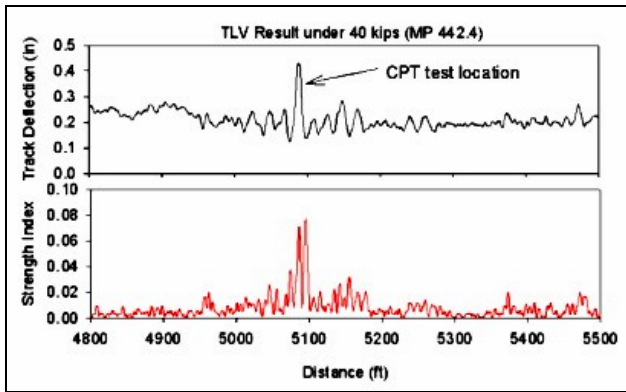
Figure 4. TLV In-Motion Test Results

The CPT locations were picked based on the earlier TLV vertical track strength tests. The TLV uses a measure known as the *Vertical Strength Index* to monitor the strength variation along the track.<sup>1</sup> When this measure exceeds a specific threshold, a paint spray system marks that particular location. Figure 4 shows an example of an exception where the peak deflection of 0.4 inch occurred at the same place as the peak in the vertical strength index.

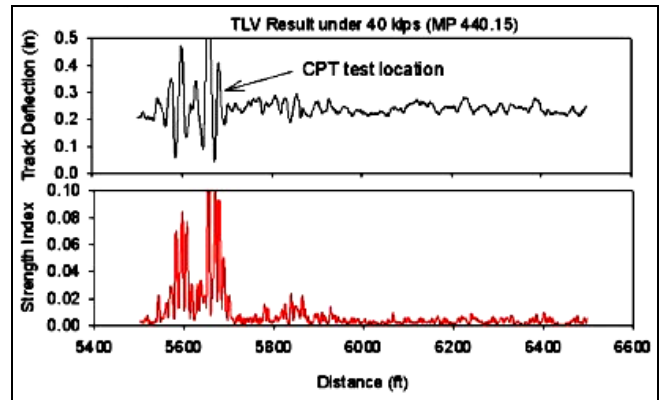
Figure 7. TLV In-Motion Test Results

Another CPT test site was chosen at a TLV paint spot. This location is only about 25 feet from a road crossing and it had visible mud pumping from underneath the ties. As can be seen from the TLV test results in Figure 7, large deflections (greater than 0.5 inch) were found, as were large variations in vertical strength index.

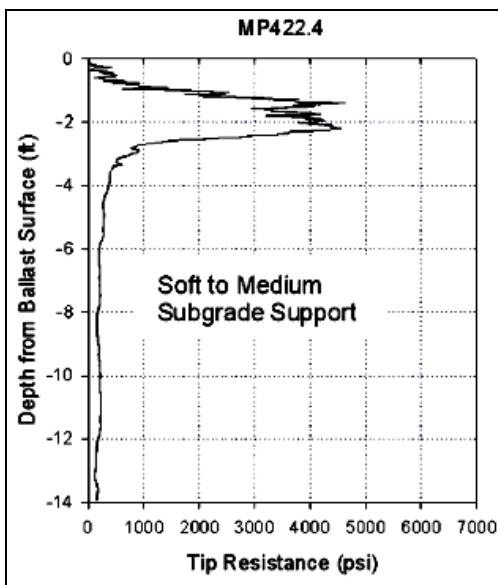
Figure 5. CPT Test Results

The results of the CPT measurements at this location showed a large depth of soft to medium subgrade support (Figure 5). The resulting friction ratio showed that the soil was made up of clay (Figure 6).

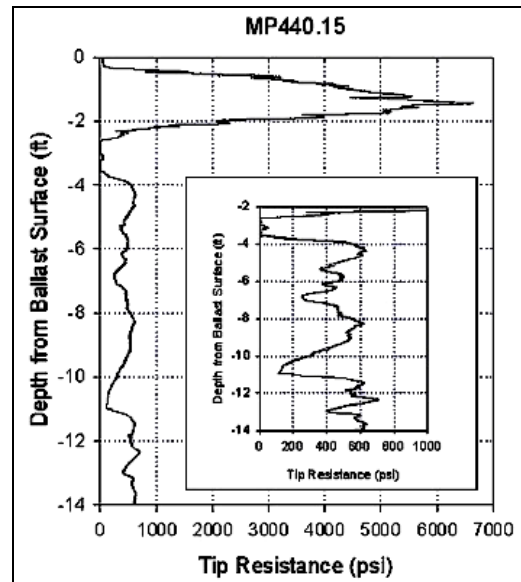
Figure 8. CPT Test Results

CPT results showed a thin but very soft subgrade layer roughly 1 foot deep (Figure 8). The tip resistance in this area was only about 10-20 psi.

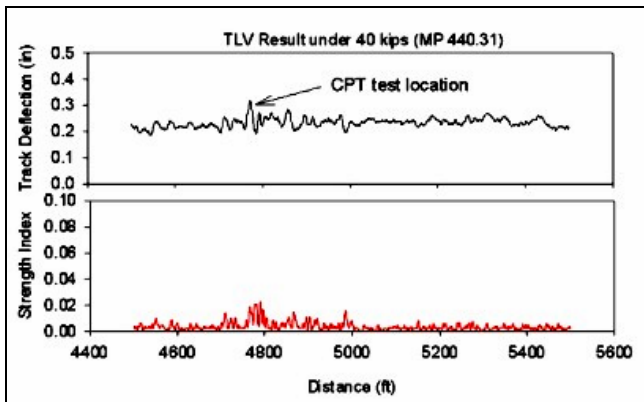
Figure 9. TLV In-Motion Test Results

Figure 9 illustrates a third example. This is an area that had neither a vertical deflection nor a strength index large enough to be an exception. Therefore, the TLV data suggests that this area is of medium track support.

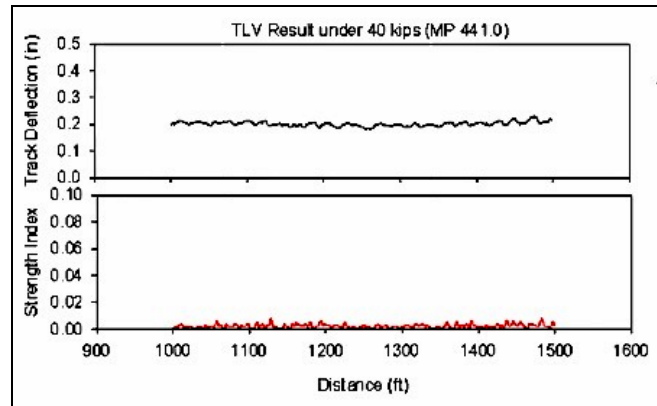
Figure 11. TLV In-Motion Test Results

To illustrate the track substructure condition for strong track support as shown by the TLV results (Figure 11), a CPT test was performed at this location. Figure 12 shows that the tip resistance indicated medium to stiff subgrade support with an adequate granular layer thickness.

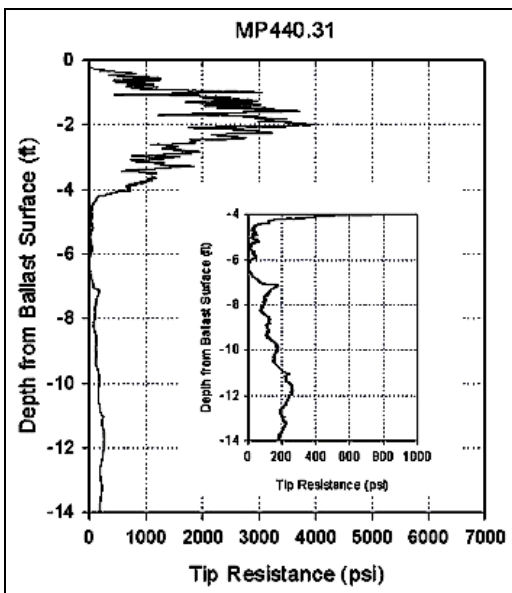
Figure 10. CPT Test Results

Examining the CPT data in Figure 10, there are a few points that should be noted. First, the data shows that there is almost four feet of granular layer thickness. Just below the ballast, there is an area of considerable weakness. The large granular layer thickness might be one of the reasons why the track showed a medium support. The other contribution might come from cross drains and shear keys installed in this area. This was an area that was worked on in 1997 to address weak subgrade conditions.
