## Effects of Reducing the Number of Gage Rod Switches under Heavy Axle Load Service

### Summary

Transportation Technology Center, Inc. (TTCI) conducted a preliminary analysis of the effects of reducing the number of gage rods on No. 20 switches in heavy axle load service. The effects of switch maintenance, switch design, number of spreader rods and traffic were assessed. Initial findings include:

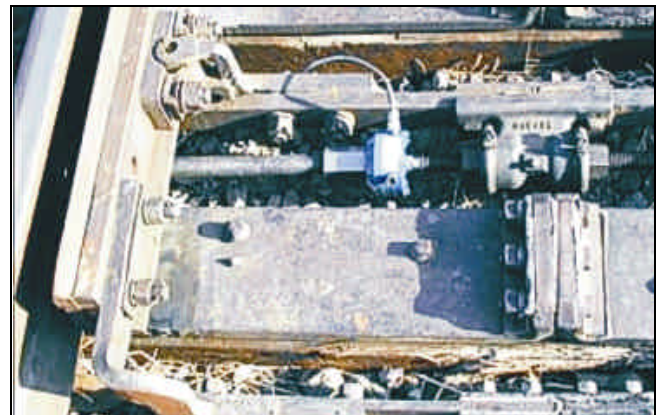
Testing was done on No. 20, 136RE switch turnouts on the High Tonnage Loop at FAST and the Railroad Test Track. Testing consisted of an instrumented gage rod that temporarily replaced the No. 1 head rod to measure force during switch throws (Figure 1). Foot-locks and switch rollers were removed to determine their effects on throw forces. Also, switch gage rods were sequentially removed to determine their contribution to switch throw forces. Service worn or a normal maintained switch verses a fully adjusted and lubricated switch were measured for their switch throw differences and switch torque action under load.

Figure 1. 10-k Load Cell Throw Rod

Ed Kohake, Methods & Research, Union Pacific Railroad supplied information related to their field tests. Ira Kalb, Instrumentation Technician, TTCI, designed the load cell gage rod used in these tests.

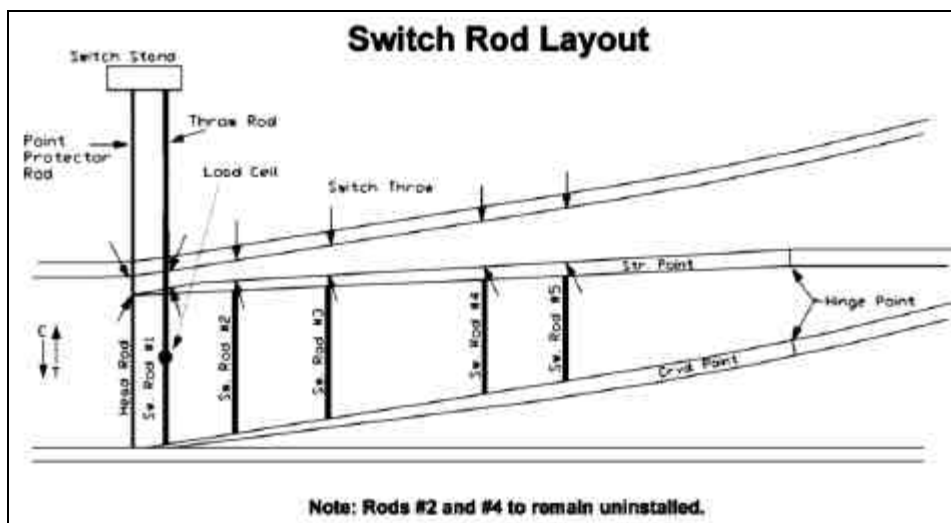
Long-term performance will be monitored with two of the five gage rods removed to determine long-term effects on rail corrugation, gage widening, increased maintenance, and switch components breakage and wear (Figure 2).

Figure 2. Sketch of Switch Turnout Gage Rods and Load Cell Throw Rod

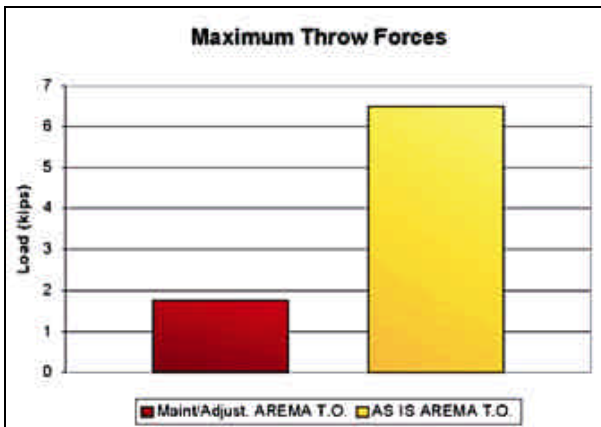
A properly adjusted and lubricated switch decreases throw force by 4.7 times of a normal service worn switch (Figure 3), which suggests that switches should be maintained to their minimum specifications on a regular preventative maintenance schedule.

**Figure 3. Throw Force**

- A key factor affecting switch throw force is switch maintenance. The throw force required for a typically maintained switch at FAST was about 4 times higher than the force required to throw the same switch after lubrication and adjustment.

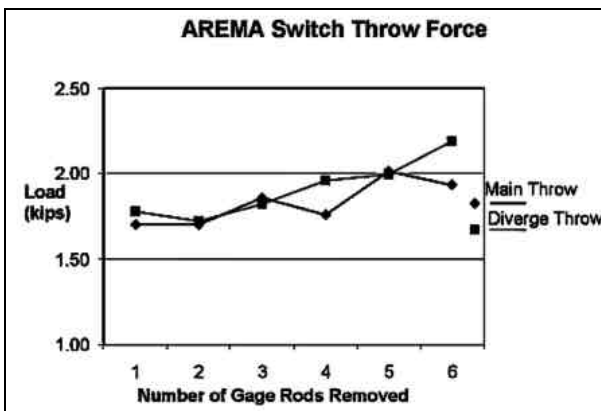
Removing switch rods had minimal effect on switch throw force for a properly adjusted and lubricated turnout (Figure 4). The increase in force required to throw switches is negligible with the reduction of gage rods.

**Figure 4. Minimal Effect with Gage Rods Removed**

- For a properly adjusted and maintained switch:
  - Reducing the number of gage rods from 5 to 3 increases the throw force by a negligible amount.
  - Switch point helper rollers and foot-locks decrease the required throw force by a negligible amount.

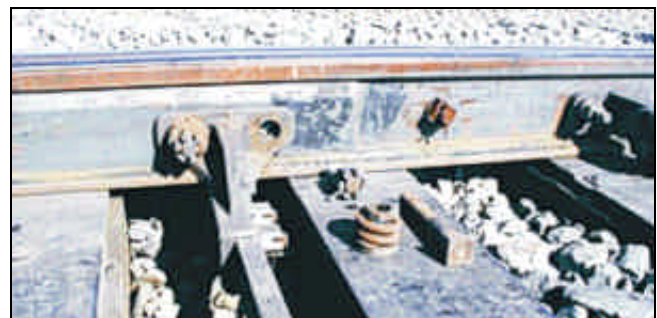
A slight increase in switch maintenance was noticed when several gage rods were removed from the turnout. Several broken and loose transit clip bolts, on the curved switch points, were noted (Figure 5). Two rivets in one of the curved switch point’s reinforcing D-bars sheared off at the button head. These two types of fastener failures have never been identified before in the maintenance log books at FAST prior to removal of the gage rods for this test. TTCI cannot contribute these fastener failures to gage rod removal, because one of the two curved switch points received some damage in a previous derailment at FAST. The derailment caused an impact at the point-of-switch section that may have warped or twisted the point. Inspections for broken components and wear are scheduled at close intervals.

**Figure 5. Broken Transit Clip Bolt**

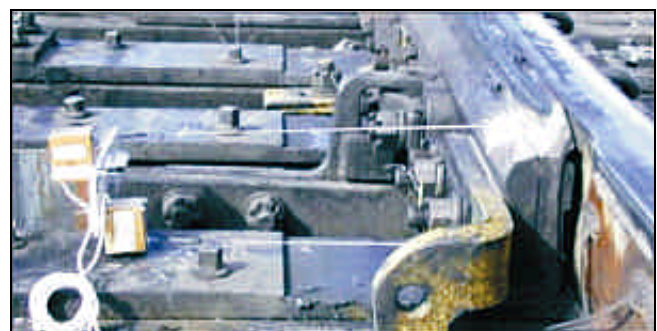
To quantify switch point roll under load, measurements were taken to determine the amount of roll movement with all five gage rods installed and with two of the gage rods (numbers 3 and 5) removed. Roll was determined near the point of switch by measuring lateral movement at the head and base of the switch point, as Figure 6 shows. Under traffic the switch point rolled: 1) 0.65 degree with five rods installed and 2) 1.17 degrees with three rods installed.

**Figure 6. Measuring Switch Point Roll under Traffic**

- Displacement measurements and high-speed video shows that switch points can roll or twist under loading. The switch point's gage rods help limit the amount of switch point roll under traffic. A standard five-rod No. 20 switch had 0.65 degrees of roll at the point of switch. With two rods removed, the same switch point rolled 1.17 degrees under load.

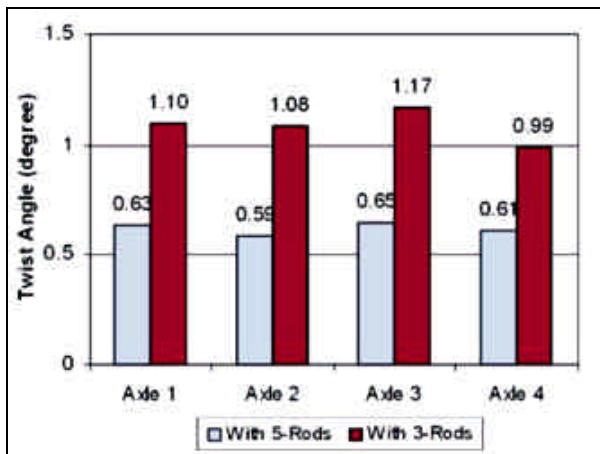
Figure 7 shows the effects of the number of axles on the switch point on switch point roll. The data shows average roll values for facing point moves.

Figure 7. AAR Prototype Switch Point Roll or Twist under Traffic

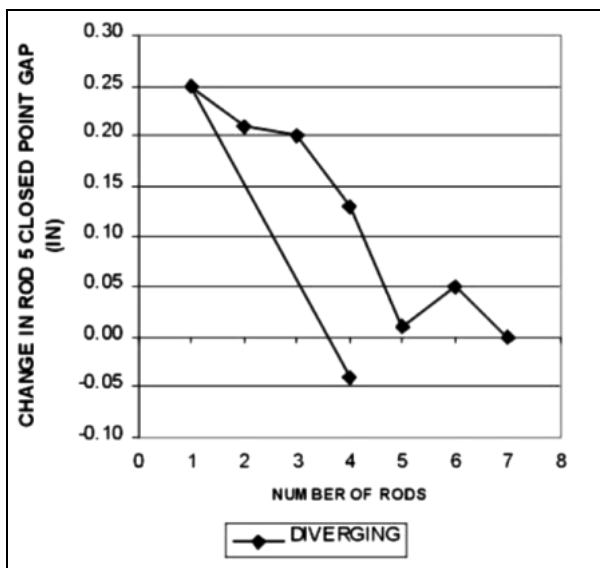
Figure 8. Switch Throw Alignment

Reducing the number of gage rods affects switch point throw alignment. Figure 8 shows throw gap alignment degradation with each gage rod removed. The gap distances shown are the measured distances from stock rail to switch point at the 5<sup>th</sup> rod location. A perfectly lined switch will have no gap between stock rail and switch point. A switch with switch point-stock rail gaps will have geometry deviations and a higher likelihood of point chipping failures.
