Bonded Insulated Joint Performance in Mainline Track

by **David D. Davis, Darrell Collard*** and **Don G. Guillen**

Summary

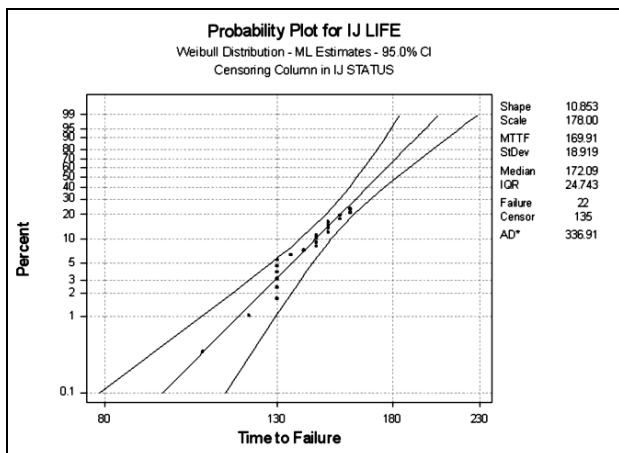
Figure 1. Mainline Insulated Joint Service Life Projection

Figure 1 shows service life data for a group of IJs that were installed during a signal-upgrading project. The joints are located in a main line that carries mostly higher speed intermodal traffic. Tonnage rates are 50-65 MGT/year/ track. The Weibull plot projects a median life of 172 MGT for the group of 150 joints. The industry committee on rail (AREMA 4) has surveyed its members about insulated joints. The average service life values returned in the survey are 280 MGT for tangent track and 230 MGT for curved track.

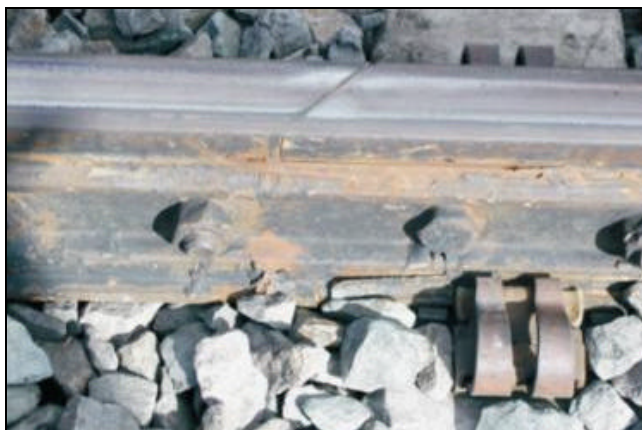
Figure 3. IJ with Running Surface Deformation due to Gap

There are also service life-reducing aspects related to the design/capacity of the joint. These occur with structural aspects of the joint or components within the joint. These situations begin with the joint being a running surface discontinuity. Figure 3 shows small deformations in the running surface caused by the IJ gap. The discontinuity generates dynamic loads at the joint. The foundation is damaged and joint deflection becomes significantly larger than deflections typically found in surrounding track.

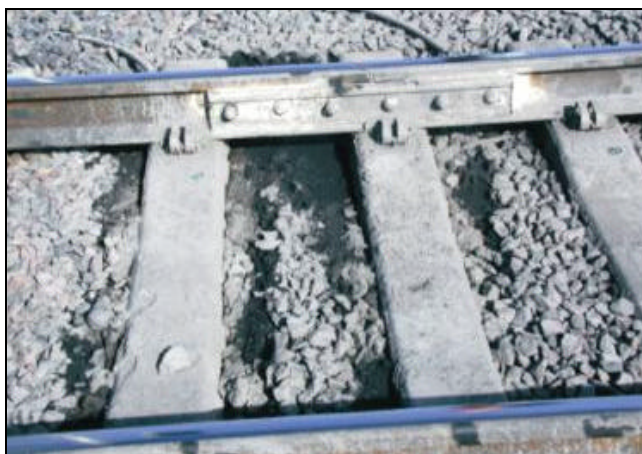
Figure 4. Distressed IJ Foundation in Good Mainline Track

Figure 4 shows a typical distressed IJ foundation in track that has generally good support. This causes cracking in the glue/epoxy at the top-center of the joint bar/rail interface. Figure 5 shows typical IJ glue cracking near the end post of the joint. The weakened epoxy bond allows moisture intrusion and larger deflections. Figure 6 shows a disassembled IJ with glue debonding and water intrusion. As the glue debonds, the joint becomes subject to “pull apart” from longitudinal forces in the rails. This damages insulating components, such as thimbles and end posts, as well as mechanical joint components such as bars and bolts. Figure 7 shows an IJ that pulled apart in track. The joints can continue to function as insulators long after the initial deterioration begins. The design has much redundancy so that several defects can be present before safety is compromised. Failure of the IJ to insulate the track circuit brings an immediate replacement. Pull aparts, with broken bolts or beyond the hole drilling tolerance, are also replaced upon detection.

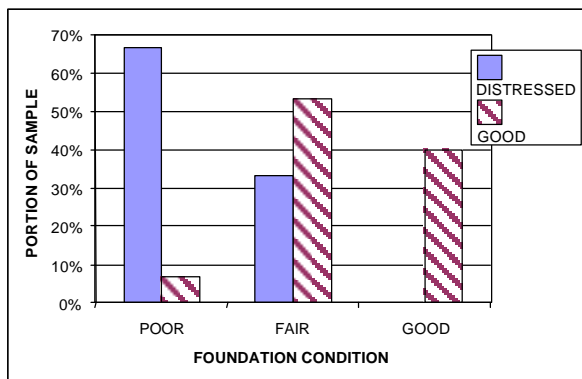
Figure 8. Foundation Condition at Insulated Joints

Low track modulus conditions were associated with IJ problems. Figure 8 shows the distribution of foundation conditions for IJs in good and distressed condition. A poor foundation was one that had mud present, fastener problems, and low ties. Track deflection at the joint can be up to 2 inches at the center of the joint. A fair foundation condition was one that had low ties.

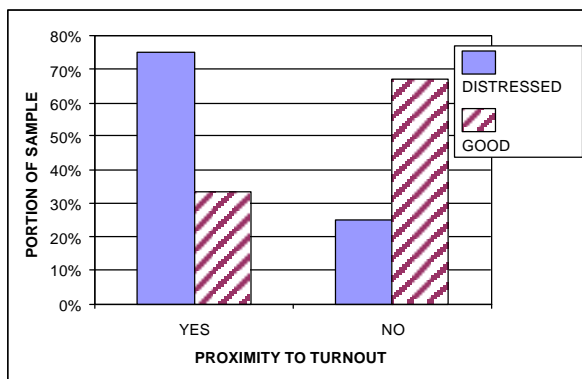
Figure 9. Effect of IJ Location on Condition

Longitudinal rail stress appears to play a role in IJ performance. It is difficult to define this role because measurements of longitudinal stress are not commonly available. However, fixed points in track are locations where longitudinal stress effects may be most evident. One such location associated with insulated joints is special track work. There is a correlation between IJ condition and proximity to turnouts. Figure 9 shows this relationship. It should be noted that the IJs on the diverging track (between switch and frog) in the turnout were not included in this analysis. These joints are in good condition. Their load environment is different from the rest of the track in that traffic is less (perhaps 10-20 percent of the straight route), train speeds are lower, and rail longitudinal stresses are generally lower.
