The Evaluation of Amtrak Thick Web Miter Rail Movable Bridge Joint Under HAL Traffic

Summary

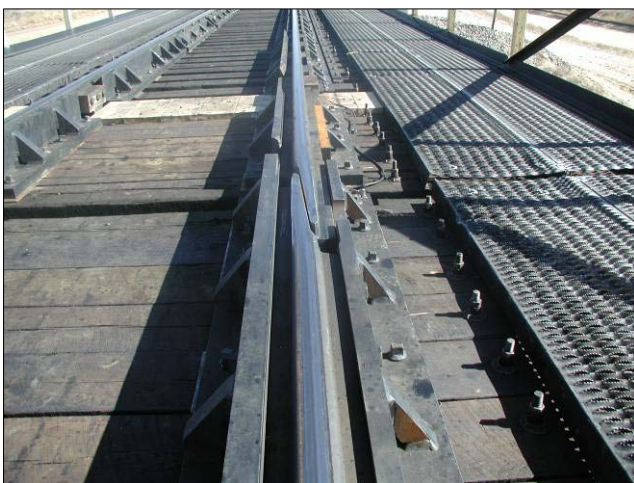
Figure 1: Amtrak Long-Point Thick-Web Bridge with Joints Installed

The approach and lift rails are made of 136-RE thick-web rail material and the rail ends are flash butt welded to standard 136-RE rail. The lift rails have no hinges and therefore the lift rails have no discontinuity in rail surface. The miter points are long and by design make the transition from approach rail to lift rail virtually seamless. The thick web rail allows for additional web material at this critical long point transition area. Figure 1 shows the bridge joint.

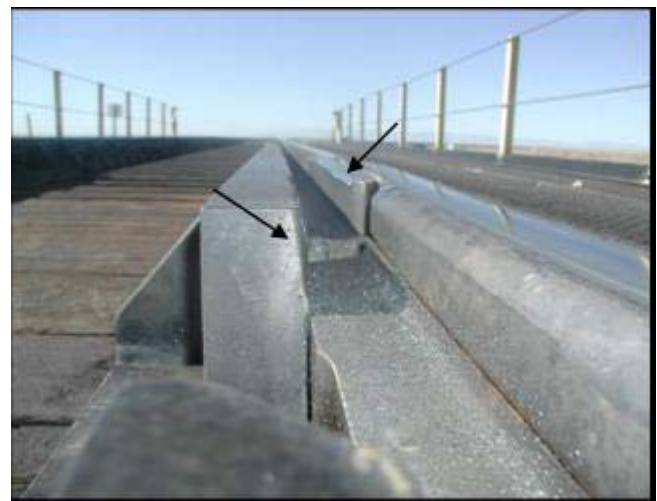
Figure 2: Location of the Flow for Point and Guardrail

All rail sections were welded providing a smooth transition over the bridge. The joints have accumulated over 140 MGT and are performing well. To date, the only maintenance issues have been a loose bolt on a weld strap and grinding of the flow on the point and guardrail of the joint (Figure 2).

Maintenance grinding was done at approximately 3.1 MGT to remove initial flow from both the points and the guardrails. The points and guardrails were ground again at 48 MGT and 131 MGT to remove flow.

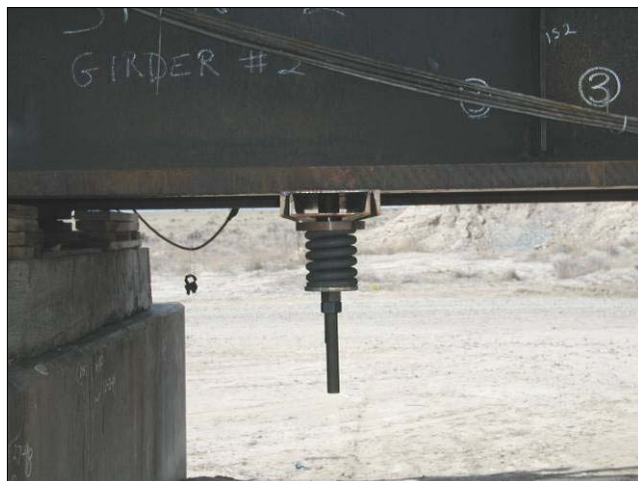
Figure 3: Hold Down for Lifting Rails

To reproduce the downward force that is applied to the lifting portion of the joint, two channels were welded together with drilled holes for the lifting rods. The lifting rods are attached to the rails and are secured to the bottom of the spans by the two channel sections, see Figure 3.

There are two nuts holding a spring against the channels compressing the springs to a specified length. The spring was attached by putting a steel plate over the spring end and double nuts on the rod. The springs were then tightened to hold the points down with approximately the same force used in revenue service. Insulated bushings are used to isolate the bridge from the signal system. The hold down fixture was designed in conjunction with Amtrak engineers. Figure 3 shows the fabricated hold down device.

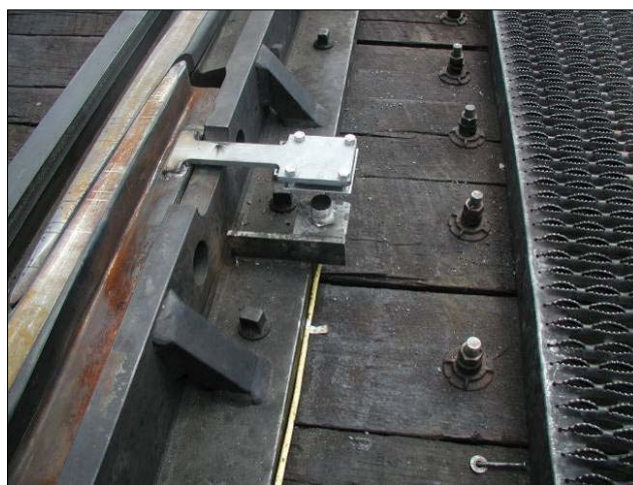
Figure 4: The Second Set of Proximity Switch Brackets

Figure 4 shows one of the three proximity switch brackets Amtrak donated for testing on their bridge joint. Specific welding instructions were also supplied with these brackets. To date two sets failed within one-night of running with approximately 1 MGT, and the third set lasted about four-nights of running with approximately 5 MGT. The welds on the brackets did not fail. The length and weight of the brackets and the vertical movement caused the fracture about an inch away from the welds and the points. TTCI will continue to test brackets of other designs.

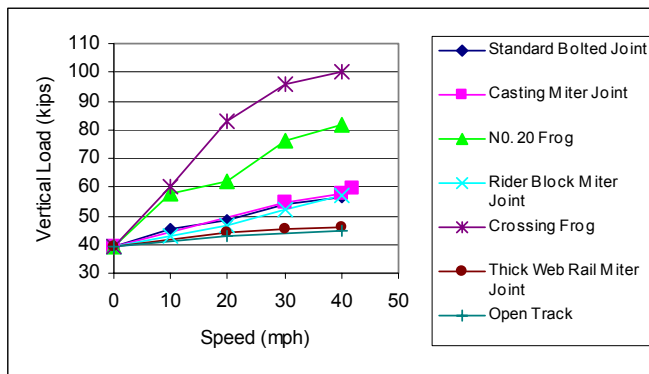
Figure 5: Average Maximum Vertical Dynamic Wheel Loads

The Amtrak joint has lower vertical dynamic loads than a typical mechanical rail joint. Figure 5 shows dynamic vertical loads from instrumented wheel set (IWS) data for the Amtrak joint, a typical mechanical joint, the other two bridge joints tested, and various other track components for comparison. The Amtrak joint had average maximum vertical dynamic loads approximately 1.1 times the static wheel load at 40 mph. In comparison a number 20 turnout frog had average maximum vertical dynamic loads 2 times the static wheel load, and a crossing diamond frog had average maximum vertical dynamic loads 3 times the static wheel load at 40 mph. The previous joints had an average of about 1.5 times the static wheel load at 40 mph. Vertical loads are nearly as low as those for open track.

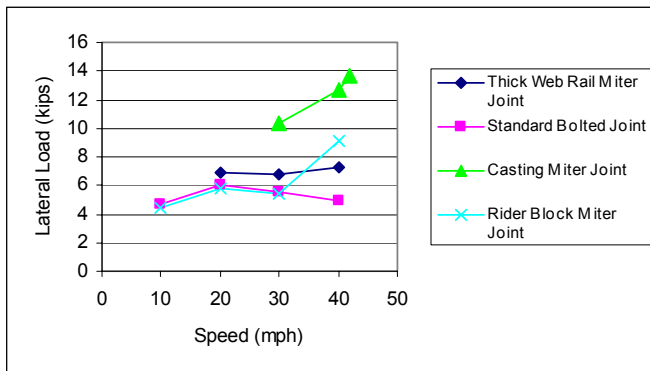
Figure 6: Average Maximum Lateral Dynamic Wheel Loads on the High Rail.

The Amtrak joint had slightly higher lateral dynamic loads of about 1 to 2 kips more than a typical mechanical joint. Figure 6 shows average maximum lateral dynamic loads for the Amtrak bridge joint, the other two bridge joints, and a typical mechanical joint.

The lateral loads do not seem to increase with speed, but stay steady at about 7 kips.
