Preliminary Performance Evaluation of Crosstie and Improved Fastener Systems at FAST

Rafael Jimenez, Joe LoPresti, and David Davis

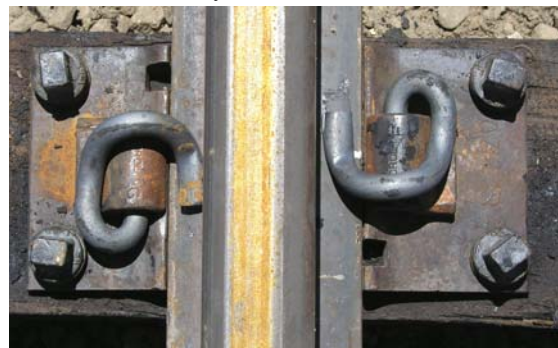
Figure 1a. Top View of the Pandrol Victor[®] Elastic Fastening System and LB&N High Strength Screw Spikes

Two elastic fastening system test zones and two control zones, consisting of 100 ties each, were installed on solid-sawn Southern Yellow pine ties. The Pandrol Victor[®] system consists of a 16-inch steel tie plate fitted with two swaged shoulders that accept the standard e-clip elastic rail fasteners. The NorFast[™] system is a 16-inch cast tie plate with cleated bottom (designed for increased gage retention) and NorFast[™] rail clips. Both tie plate types were fastened to the ties with screw spikes. The NorFast[™] test zone was fastened with No. 5760 screw spikes while the Pandrol Victor[®] zone was fastened with Lewis Bolt & Nut Company[™] (LB&N) high strength screw spikes. Spring washers were used with the screw spikes in half of the Pandrol Victor[®] test zone; the other half had no washers. Southern Yellow pine ties were used in this test to accelerate results.

NorFast[™] does not recommend making partial-curve installations where track fitted with their fasteners is immediately adjacent to track fitted with a different type of fastener. A 10-tie transition zone, where every other tie was fitted with Pandrol Victor[®] 16-inch rolled-steel plates and e-clips, was required at each approach to the test zone. Figures 1a and 1b show the top and bottom views of the Pandrol Victor[®] system. Figures 2a and 2b show the NorFast[™] system.

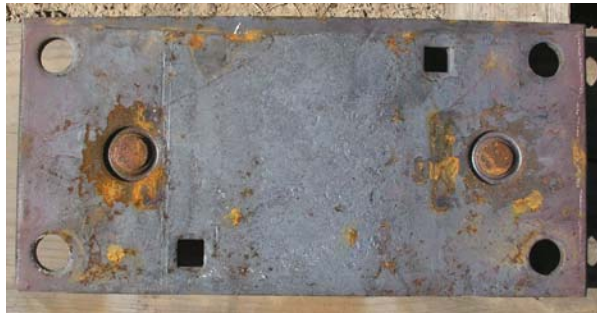
Figures 1b. Bottom View of the Pandrol Victor® Elastic Fastening System

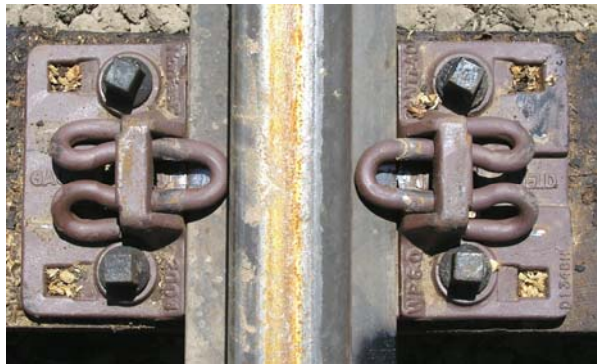
Figures 2a. Top View of the NorFast™ Elastic Fastening System with No. 5760 Screw Spikes

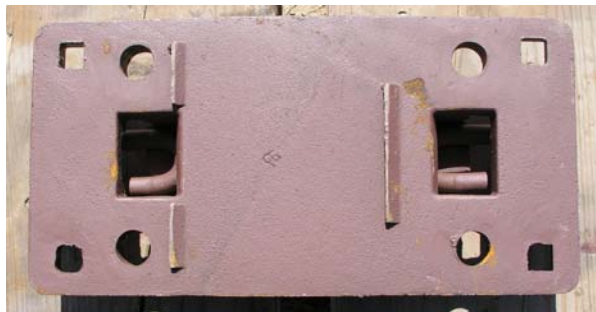
Figure 2b. Bottom View of the NorFast™ Elastic Fastening System with Cleated Plate Bottom

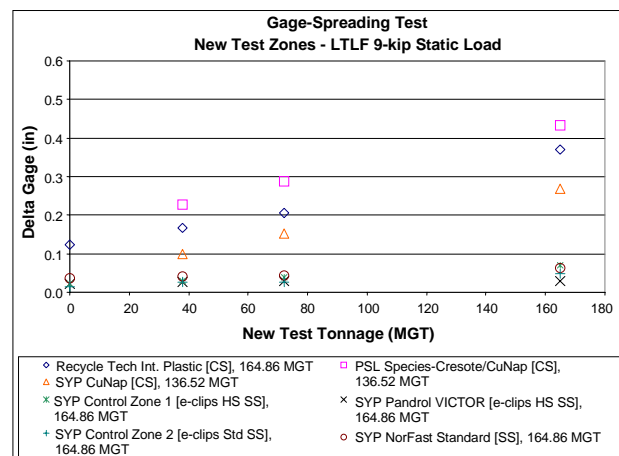
Figure 3. Gage-Spreading Strength as Determined by Change in Gage under Load. The Southern Yellow Pine Test Zones Fitted with Elastic Fasteners are Maintaining High Gage-Spreading Strength While the Cut Spiked Zones are Experiencing Reduced Strength

Measurements of change in gage under static 9 kip gage-spreading loads were taken in all the new test zones using a lateral track loading fixture (LTLF). Figure 3 shows that the Southern Yellow pine ties fitted with elastic fasteners have maintained high gage-spreading strength (low delta gage). During 160 MGT, delta gage has remained below 0.1 inch. The wood-tie and the plastic composite test zones, where the ties are fitted with cut spikes, are experiencing reduced gage-spreading strength. After 160 MGT, delta gage in the three cut spiked zones is between 0.25 inch and 0.45 inch.
