Preliminary Performance of Plastic Ties in Revenue Service at the Eastern Mega Site (Norfolk Southern)

By Rafael Jimenez and Dingqing Li (TTCI)
Russell McDaniel (NS)

Summary

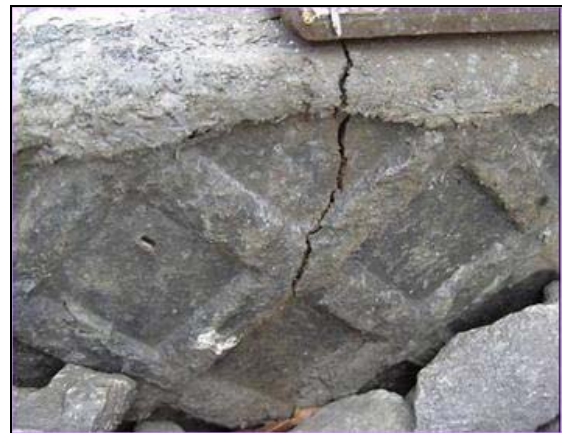
Figure 1. Typical Crack in Rail Seat Area as a Result of Spiking without Pilot Holes

The plastic composite ties were fastened using NS standard 8 x 18 inch cut spike tie plates and typical tie-gang equipment with a rapid-impact type production spiker. At the recommendation of the manufacturers, the spikes were driven into the ties without pilot holes. As a result of spiking, cracking in the rail seat area occurred in about 4.5 percent (34 of 750) of the spike locations in one manufacturer’s plastic ties, as Figure 1 shows.

Six cracks, less than 1 percent of the spike locations, also occurred in another manufacturer’s plastic ties. Nevertheless, none of the cracked ties from either manufacturer fractured.

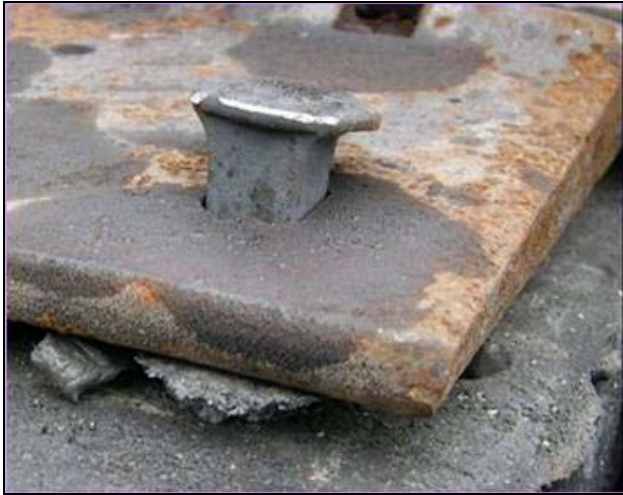
Figure 2. Plastic Material Buildup that Occurred as Spikes were Driven into Ties 1

Another issue associated with spiking without pilot holes was the plastic material flow up from the spike holes. Figure 2 shows an example of the plastic material that built up between the bottom of the tie plates and the top of the ties around the spike holes during spiking where pilot holes were not used. Note that for the nine ties replaced with pilot holes, the amount of buildup was reduced greatly.

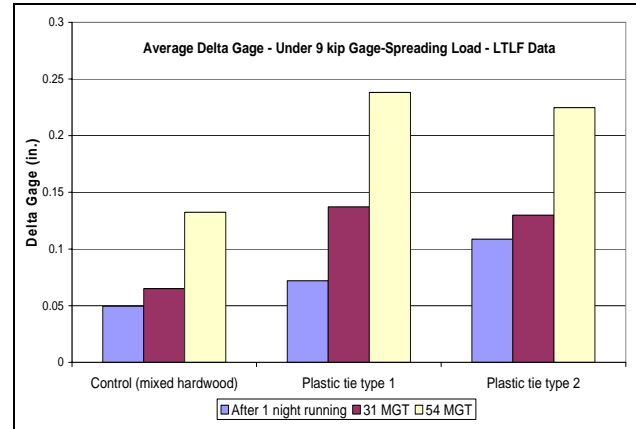
Figure 3. Gage Strength Test Results Obtained during the First 54 MGT in Service

Figure 3 illustrates the average delta gage widening at each of the three measurement cycles taken. The graph shows that resistance to the applied gage-spreading loads is higher in the wood-tie sub-zone than in the plastic tie sub-zones.

Although the average delta gage of the two plastic-tie sub-zones at 54 MGT is about 0.23 inch, the delta gage (gage widening) measured for type 2 at FAST at 52 MGT was slightly higher at about 0.28 inch. Both tests in revenue service and at FAST experienced similar increases in delta gage within the first 50 MGT (as Figure 3 shows). The degradation rate at FAST, however, reached a steady state and did not increase significantly after the 52-MGT measurement. All subsequent delta gage measurements in the test zone at FAST during more than 620 MGT have remained between 0.2 and 0.3 inch, similar to the hardwood test zone. The steady state of gage strength at FAST was also confirmed using TTCI's Track Loading Vehicle.

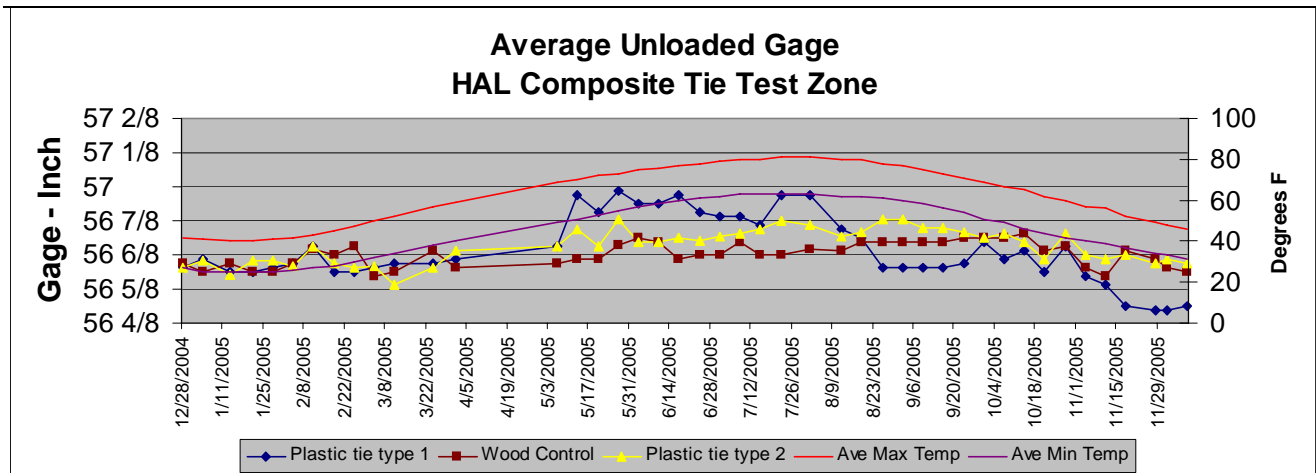
Figure 5. Effect of Temperature on Track Gage

At the NS Mega Site, the unloaded track gage was measured up to 5 times per month using a steel tape while the local ambient temperature was recorded (see Figure 5). Over the 54°F ambient-temperature range between 27°F and 81°F, the maximum change in unloaded track gage measured in plastic type 1 was less than 0.5 inch. The maximum change in gage measured for type 2 was about 0.24 inch. As expected, the wood-tie control zone experienced the least (0.16 inch) change in gage.
