Initial Results of Robotic Slot Weld and Reduced Consumption EFB Weld Testing at FAST

by Joseph Kristan*, Joseph LoPresti, and Greg Garcia

Summary

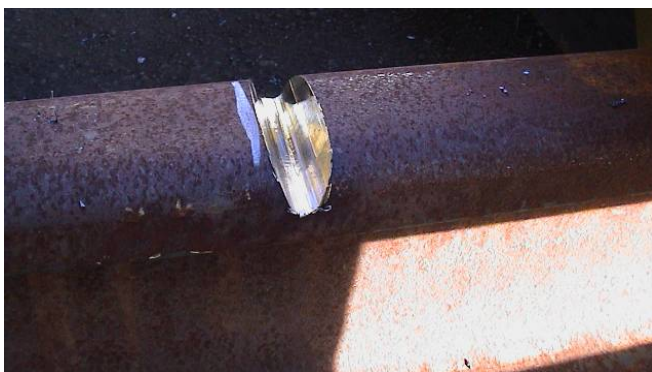
Weld specifics for the current slot weld include a maximum 1.125-inch-depth of repair below the railhead with an initial 1-inch-width gap at the rail surface. An example rail is shown in Figure 2.

Figure 2. Rail Head Milled for GMAW Robotic Slot Weld

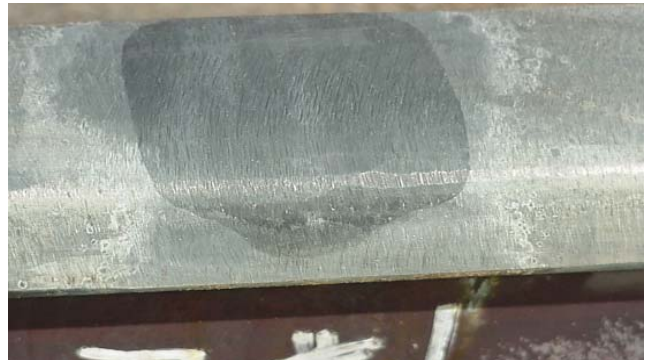
Final weld dimensions are significantly larger than the original gap due to melting of the rail at the rail/weld interface as shown in Figure 3.

Figure 3. Completed Slot Weld (etched to enhance visibility)

The depth of cut and subsequent weld repair are to be held constant independent of rail wear to ensure reproducibility in the process. Total repair time was between 35 to 45 minutes.

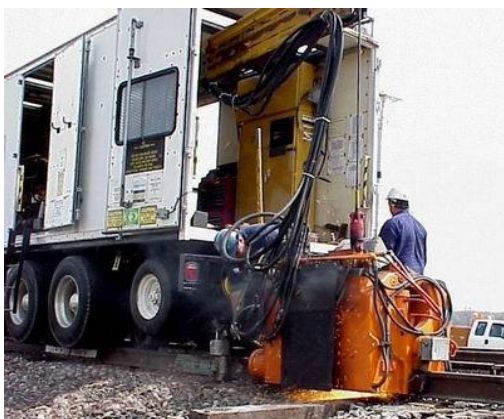
Six reduced consumption test welds were produced by Holland in RMSM OCP rail for installation in test at FAST and were installed using thermite welds to produce a CWR. These welds were installed at the same time and location as the slot welds. The reduced consumption flash butt welds have accumulated 216 MGT without issue or incident. In order to augment the evaluation of the small sample size of reduced consumption test welds, an additional 19 welds were installed by Holland, shown in Figure 4.

Figure 4. Holland Installing Reduced Consumption Test Welds in Track at FAST

These welds eliminated 27 thermite welds and five rail defects and are being monitored for performance. The reduced consumption test welds have accumulated between 31 and 76 MGT of traffic, without issue. Thus, the failure rate is zero.
