Brake Beam Fatigue Environment for Truck Mounted Brakes

Russell Walker, Darrell Iler and Lamont Smith

Summary

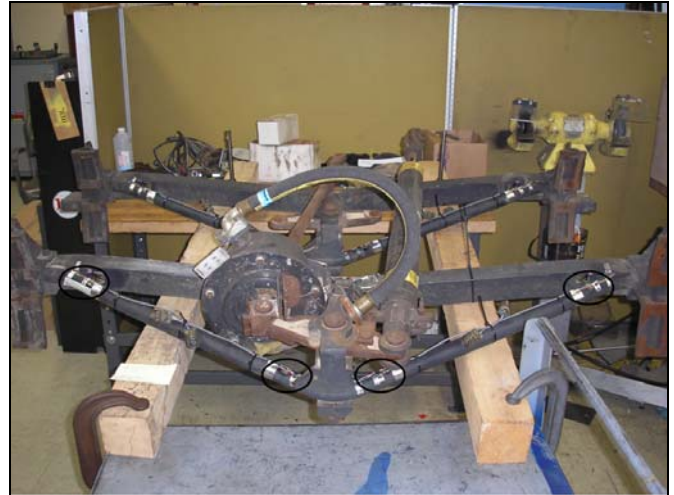
Figure 1. Strain Gages on the Tension Member of the Brake Beam

The brake beams from an aluminum gondola car equipped with truck mounted brakes were chosen for testing. The beams were instrumented with strain gages and accelerometers. The strain gages were mounted in the same positions as on the brake beams used in the 2005 tests. The exception to this was that the strain near the pinhole of the strut was not measured. Instead, the beam on which the brake cylinder was mounted was instrumented with strain gages on the center of the compression member, where the strut connects. Gages were placed at the edge of each side of the angle. Figures 1 and 2 are photographs of the strain gage layout. Vertical accelerometers were mounted near the brake head. Both the brake beams in the lead truck were instrumented.

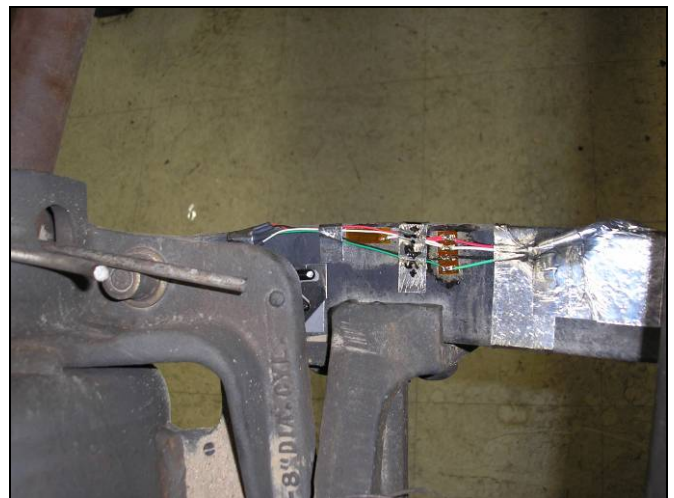
Figure 2. Strain Gage on the Compression Member of the Brake Beam

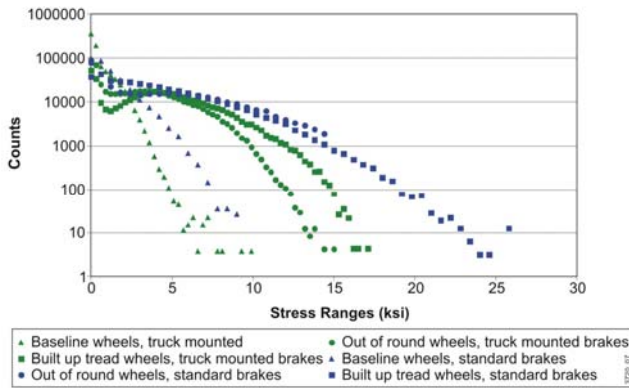
Figure 3. Cycle Counts for Test Periods with Heavy Brake Application

Data collected with truck mounted brakes was reduced in the same manner as that for the body mounted brakes. Data was cycle counted and the range of values was plotted against the number of counts. Data was segregated by the wheelsets used and by brake application. Figure 3 shows a comparison of the cycle counted data for tests with truck mounted brakes and with body mounted brakes. This plot contains data for heavy brake applications. These measurements were on the tension member near the brake head. The peak stresses for the truck mounted brakes are much lower than those measured with body mounted brakes. This was consistent for all the channels.

The reduction in stress on the truck mounted brakes compared to the car mounted brakes may be explained by the beam design. The beams used on the car mounted brakes were AAR-18 beams with a tension member approximately 1 3/8 inches in diameter. The beams used on the truck mounted brakes had a tension member approximately 1 1/2 inches in diameter.

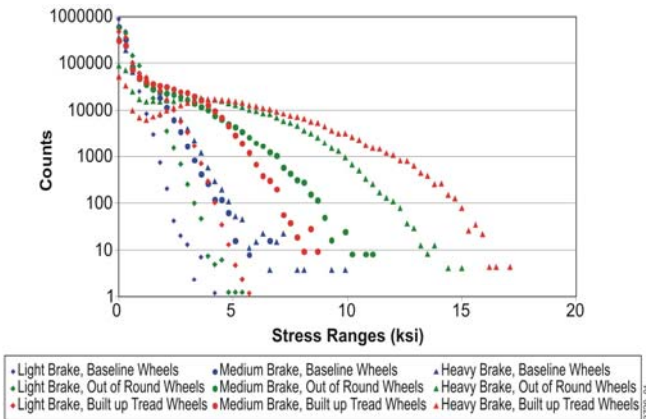
Figure 4. Cycle Counts for Tension Member on Lead Brake Beam, left side (near the brake head, truck mounted brakes)

Figure 4 shows cycle counted data for the truck mounted brake test. Data is for the strains on the tension member of the beam near the brake head. The braking and wheel conditions are separated to show the influence of each one. The data shows trends similar to the previous test, with high impact wheels showing much higher stresses than baseline wheels. It is also apparent that applied brakes couple the brake beam to the input from the track, producing higher stresses.

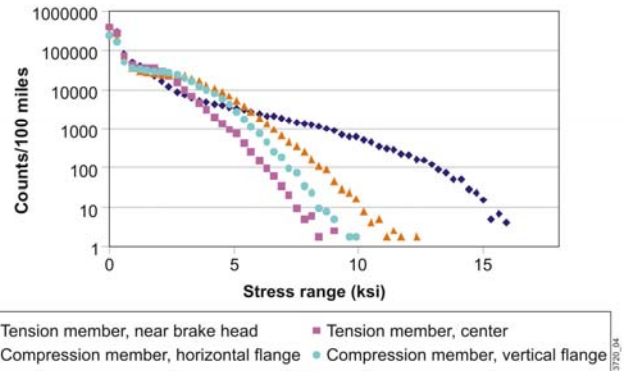
Figure 5. Cycle Counts for Four Locations on the Brake Beam Truck Mounted Brakes

Data for several strain locations on the same beam is plotted together in Figure 5 for truck mounted brakes and in Figure 6 for body mounted brakes. The data in these figures is for built up tread wheels, and all brake application conditions. The plots show that the highest stresses measured are on the tension member near the brake head. This is consistent with the location for most brake beam failures.

It was expected that the beams used with truck mounted brakes would have higher stresses in the center of the brake beam, but the data does not show this. The peak stresses on the beams with body mounted brakes are about 22.5 ksi near the brake head and about 15 ksi in the center. The peak stresses on the beams with truck mounted brakes are about 17 ksi near the brake head and about 9-10 ksi in the center. The absolute difference is about the same in both cases, but proportionately the difference is actually larger for truck mounted brakes.

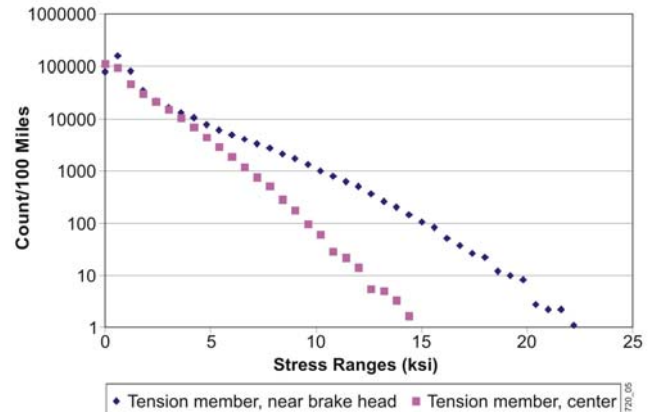
Figure 6. Cycle Counts for Two Locations on the Brake Beam Body Mounted Brakes
