Preliminary Performance of Elastic Fastening Systems in Revenue Service at Eastern Mega Site

Rafael Jimenez, Dingqing Li, and Russell McDaniel (NS)

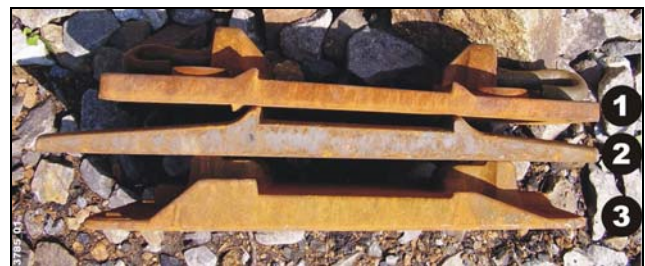
Although the tie plates of the three systems differ in material thickness, as Figure 2 shows, all three provide a 1:40 rail cant. While the AirBoss and the NS standard plates have a flat bottom, the bottom of the NorFast plates has cleats designed to provide increased resistance to gage widening (see Figure 1).

Figure 2. Profile View of the Three Fastening System Tie Plates installed: (1) NorFast, (2) NS-Standard, (3) AirBoss

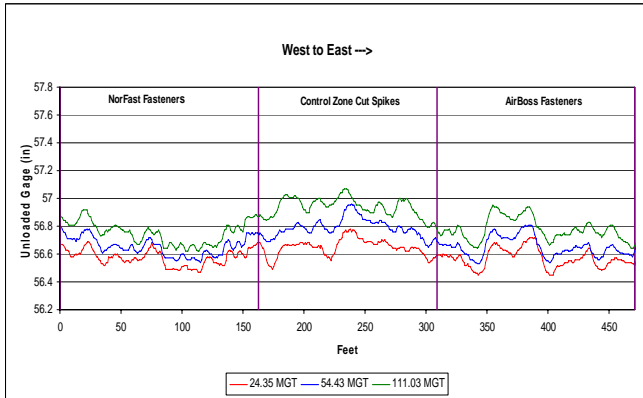
Figure 3 shows the gage widening that has occurred during the period of performance as defined by the unloaded track gage. The first measurement was taken 24 MGT after the test zone was installed and again after 54- and 111 MGT using the Federal Railroad Administration’s T-18 gage restraint measuring system (GRMS) car. The data indicates the cut-spike system zone has widened more than the elastic system zones.

Figure 3. Unloaded Track Gage (T-18 Car)

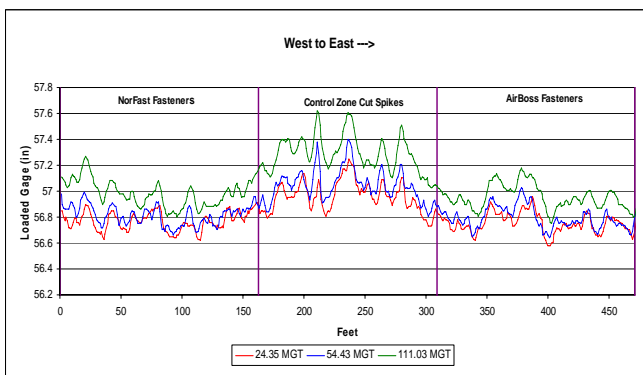
Figure 4 shows the differences in the track gage-spreading strength of the three fastening systems as defined by the measured increase in gage resulting from the applied load (loaded gage). The loaded gage measurements were taken with the T-18 GRMS car (under a lateral load 14,000 lb and vertical load 21,000 lb) at 30 mph. The results show higher track gage strength with the elastic fastening systems.

Figure 4. Loaded Track Gage (T-18 Car)

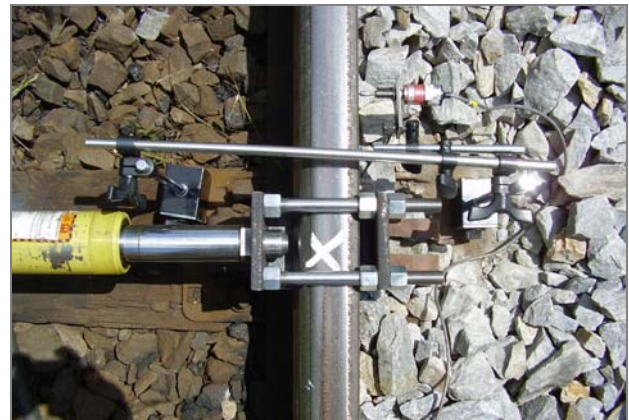
The Rail Rollover Restraint Test was performed to quantify the resistance that each fastening system provides. The test setup, Figure 6, consists of a load-cell equipped hydraulic cylinder used to apply the 10-kip gage-spreading load. The

load is applied 5/8 inch below the top of the rail on the gage face. Displacement transducers were used to measure the resulting lateral high and low railhead displacement relative to the tie plate. Six locations were measured in each test subzone and five gage-spreading (loading and unloading) cycles were performed at each location. The data acquisition system captured the force and displacements. The results are shown as the average force required to displace the railhead laterally 0.02, 0.03, and 0.04 inch.

Figure 6. TPCI's Rail Rollover Restraint Fixture

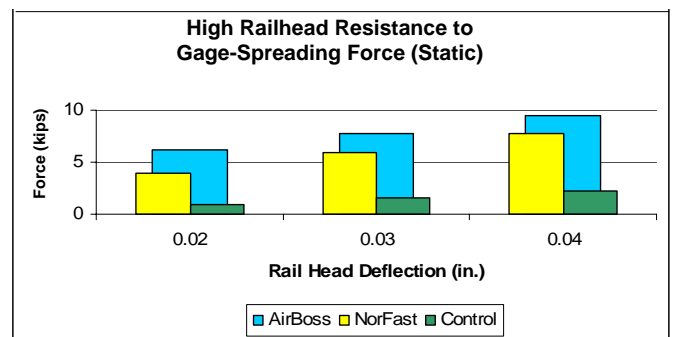
Figure 7 shows the rail rollover restraint that each of the systems provide. Data indicates the force required to roll the high railhead 0.02 inch in the gage-spreading mode was about three times higher in the NorFast subzone than in the cut-spike subzone. In the AirBoss subzone the 6.2-kip force required to roll the railhead 0.02 inch was about six times higher than in the cut-spike subzone. To roll the railhead 0.04 inch, the NorFast subzone provided about three times more resistance, and the AirBoss provided about four times more resistance than the cut-spike subzone.

Figure 7. Results of Rail Rollover Restraint Test
