Update on Bridge Deck Fastener Performance on the FAST Steel Bridge

Summary

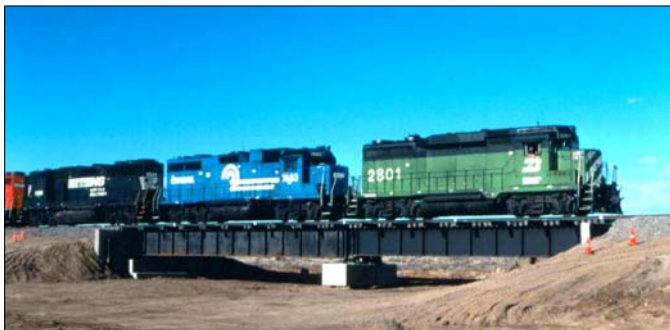
Figure 1. Conrail Open Deck Steel Bridge at FAST

In 1997, a 121-foot two-span steel bridge was added to the test loop at FAST. Figure 1 shows the bridge. The bridge is on a tangent alignment between reverse curves. The test bridge has welded deck plate girder spans, with an open deck. The girders were designed in the 1950s and 1960s, according to the American Railway Engineering Association and Pennsylvania Railroad practices at that time. The 55.5- and 65-foot span girders were fabricated in 1968 and 1957, respectively. Both spans have two girders spaced at 6.5-foot centers. The second-hand girder spans were donated by Conrail. The bridge deck is currently a Conrail open-deck design with dapped oak ties. The girders have smooth top flanges. As Conrail donated the spans, the first deck and fastener system to be tested were to their specifications.

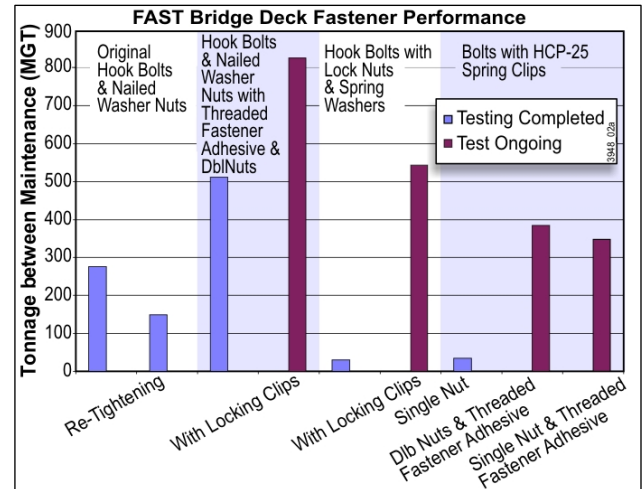
Figure 2. Deck Fastener Maintenance Intervals at FAST

The systems with the best performance have withstood more than 500 MGT of HAL traffic with no maintenance required. The poorest-performing systems withstood less than 40 MGT before numerous fasteners were loose, turned, or broken.

Figure 2 summarizes the performance of the eight systems tested to date.

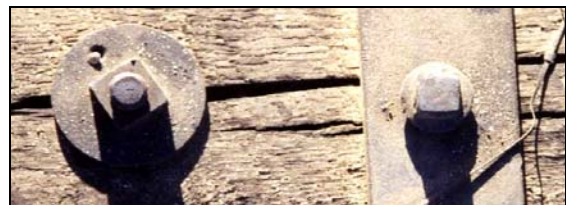
Figure 3. Original Conrail System using a Hook Bolt and a Washer Nut

The original Conrail hook bolt configuration, when the deck was installed, consisted of a 14-inch hook bolt with a washer nut. Figure 3 shows the hole in the washer nut for a nail to be driven in to prevent the washer nut from turning. The lower portion of the hook bolt neck is fluted – intended to engage into the tie to prevent turning. This system withstood about 275 MGT of HAL traffic before the hook bolts had to be straightened and the nuts tightened. At the time of the first tightening, there was one broken hook bolt and 22 spun hook bolts out of a total of 56 on the bridge (Figure 4). Due to the relatively-deep girder flanges, the fluting of the hook bolts was only minimally engaged in the ties. In many cases, the hook bolts turned loose over time. In the process, they rounded the holes in the deck ties so that the fluting could no longer engage the ties. Also, in some cases, the nail worked out of the washer nut, allowing rotation.

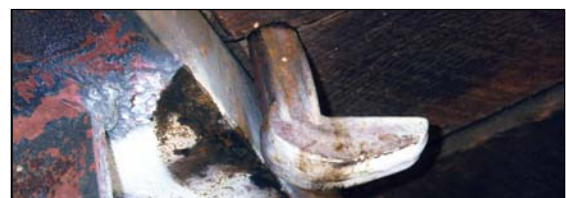
Figure 4. Turned Hook Bolt

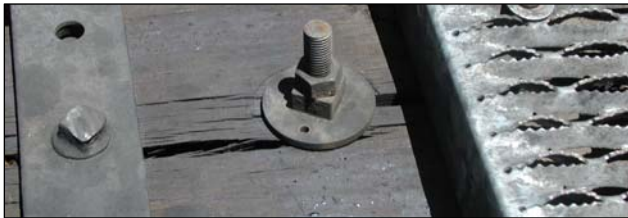
Figure 5. Double Nut and Washer Nut with Nail Hole

After establishing the performance of the original system with both new and worn ties, a common field retrofit was applied. The hook bolts were again aligned and tightened, with double nuts and a threaded fastener adhesive (Loctite) applied to keep the nuts from loosening (Figure 5). This system lasted in service for 511 MGT on a portion of the bridge until maintenance was required due to loose or spun hook bolts.
