## Premium Rail Performance Under 39-Ton Axle Loads at FAST

Joseph LoPresti and F. C. Robles Hernandez

### Summary

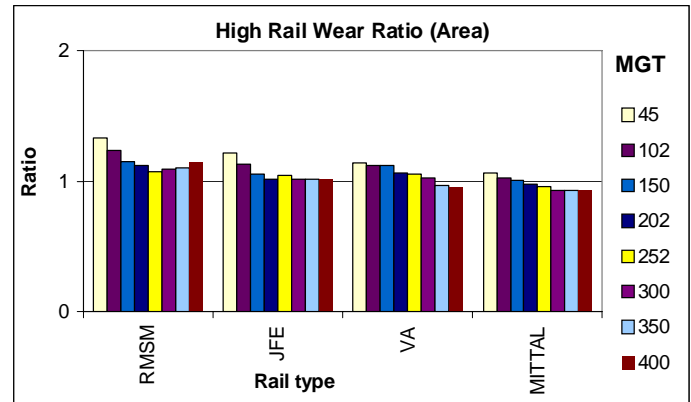
Figure 2. High Rail Wear Ratios

Figure 2 shows a comparison of the wear on the high rails. Area loss is measured, and the ratio between the control rail and each of the noncontrol rails is calculated. The control rail was wearing less than the other rails early in the test. The early advantage may be attributable to a better initial profile match between the control rails and the FAST wheels, and less decarburization on the rail surface. Neither was quantified.

Relative wear performance has continued to change during the test. Two of the rails have worn less than the control rail after 400 MGT; one is nearly the same, and one is wearing

more than the control rail. The change in wear can be attributed to variations in the metallurgy of the rails that affect the way the steel work hardens. The rail with most wear is wearing about 15 percent more than the control rail; the rail with least wear is wearing about 7 percent less than the control rail. Area loss after 400 MGT averages just over 0.4 square inch, which is about 8 percent of the head area.

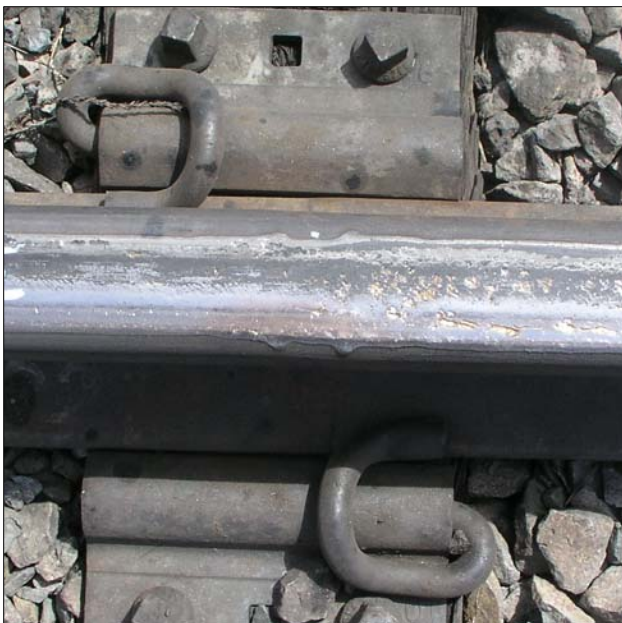
Figure 4. Difference in RCF

There are differences among the rail types in the amount and severity of RCF. Figure 4 shows two rail types with an electric flash weld between them. Note that the rail on the right has more RCF than the rail on the left.

The rails were inspected, and the degree of RCF was characterized for each rail at each tie. The conditions were grouped as (0) little or none, (1) mild to moderate, or (2) heavy RCF. The rail on the right in Figure 4 would be classified as having heavy RCF; the rail on the left would be little or none. The low rail was characterized at 270 MGT, prior to grinding. Both low and high rails were characterized at 400 MGT (see Figure 5). The best and worst rails had RCF on 20 and 75 percent of their respective low rail lengths at 270 MGT. Performance was different after 400 MGT. The low rail that had the most widespread, but not most severe RCF after 270 MGT was best after 400 MGT.

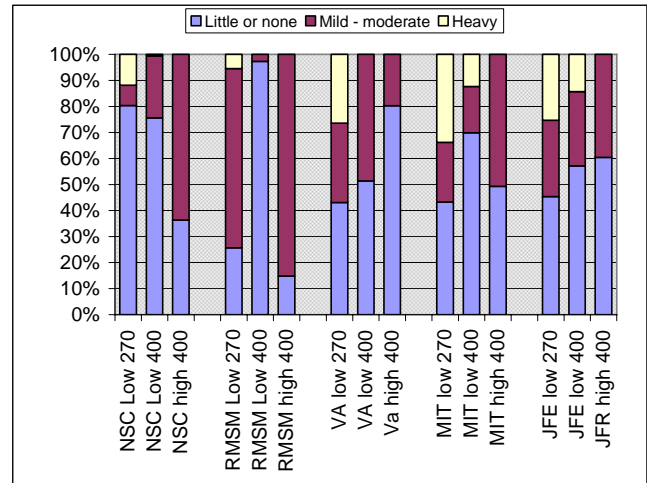
Figure 5. RCF Characterization

This can be attributed to the depth of the RCF. Almost all of the shallow RCF was removed by rail grinding, while some of the deeper damage remained. Since crack initiation is a major portion of crack development and growth life, rails with cracks that remained after grinding developed RCF more quickly than rails without cracks. Also worth noting is that the high rail conditions do not match the low rail

condition. The rail with least RCF on the low rail has the most RCF on the high rail. The nonlubricated high rail at FAST wears rapidly, but the low rail wears very little. The difference in wear rates in combination with the different characteristics of the rails produces the difference in RCF conditions.

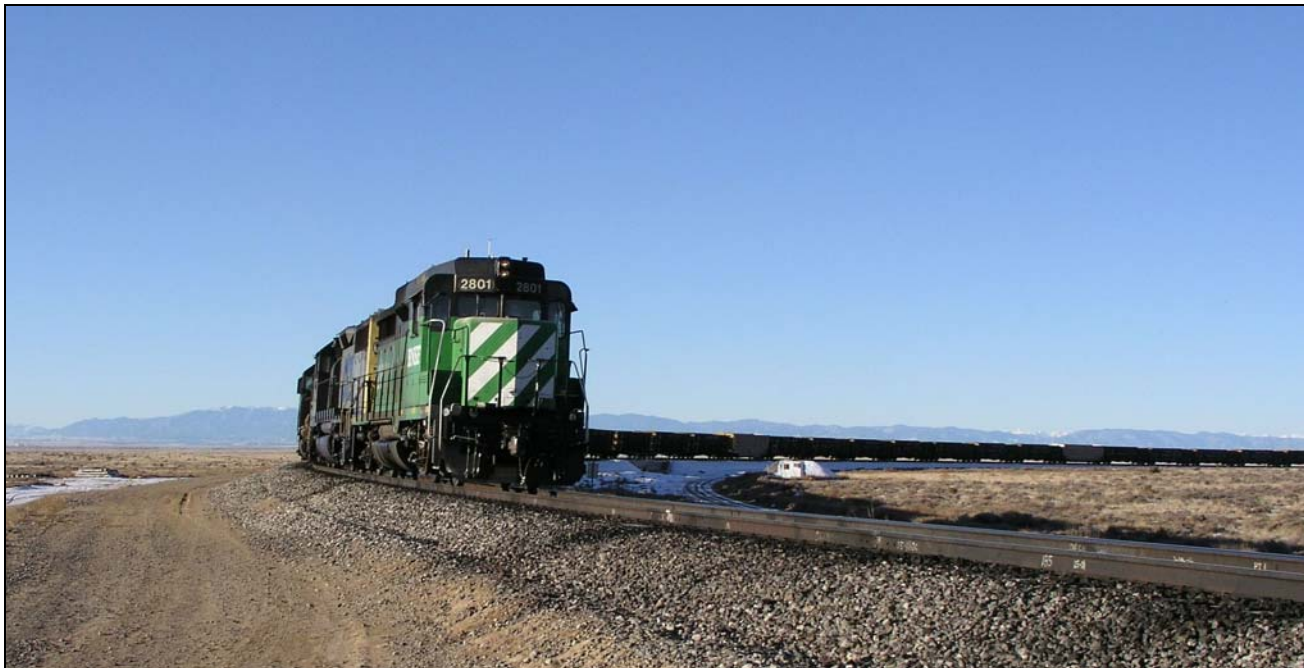
Figure 7. Test Train at FAST

The 141RE rails are installed in a 5-degree curve with 4 inches of superelevation and no direct high-rail lubrication. The test train at FAST (Figure 7), typically consisting of 75-80, 315,000-pound gross rail load coal cars, is operated at 40 mph, resulting in approximately 1.7 inches of superelevation deficiency. Traffic is bidirectional with approximately 50 percent of traffic in each direction.
