The work described in this document was performed by Transportation Technology Center, Inc.,  
a wholly owned subsidiary of the Association of American Railroads.

## In Track Tie Plate Performance: Plate Stress and Hold-Down Forces

Richard Reiff and Kari Gonzales

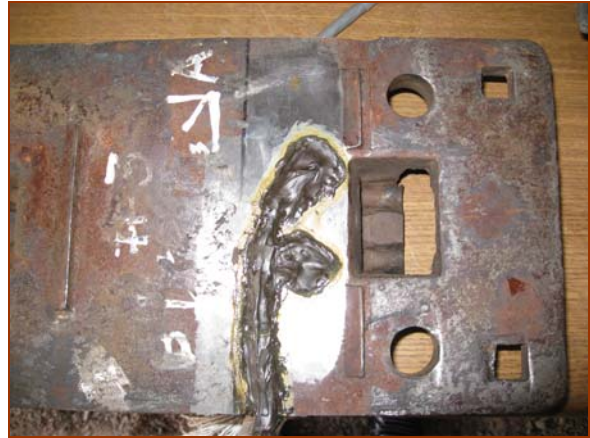
Figure 1: Bottom View of NorFast Plate, Showing Strain Gages

The approach follows previous evaluations of plate strains in standard tie plates on wood and plastic ties.<sup>2</sup> In the previous test, four rosette strain gages were mounted to the bottom of a conventional tie plate (along the field side of the plate where many fractures had occurred) to measure strains experienced by tie plates installed on wood and plastic ties. Results from the test conducted at FAST showed that the stress in the stiffer (wood) ties were significantly less than when installed on resilient (plastic) ties. In the current test, a pair of strain gage arrays was placed on the bottom of three different tie plate designs at or near where the largest strains were expected to occur. The plate designs included:

Figure 1 shows the strain gage array. Figure 2 shows load washers installed on the Pandrol Rolled plate.

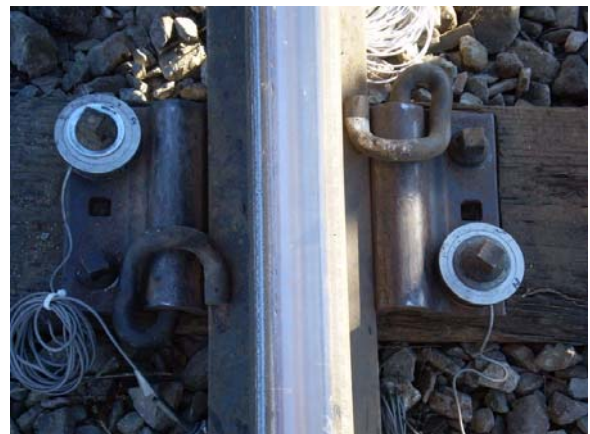
Figure 2: Top View of Pandrol Plate, Showing Measuring Load Washers

In addition, load measuring washers were placed between screw spikes and tie plates of the NorFast plate to determine the effect of varying hold-down conditions, from loose to high torque under static conditions with no train operations. The NorFast plate was selected as its configuration allowed load measuring washers on all four corners without modification to the plate or washer.

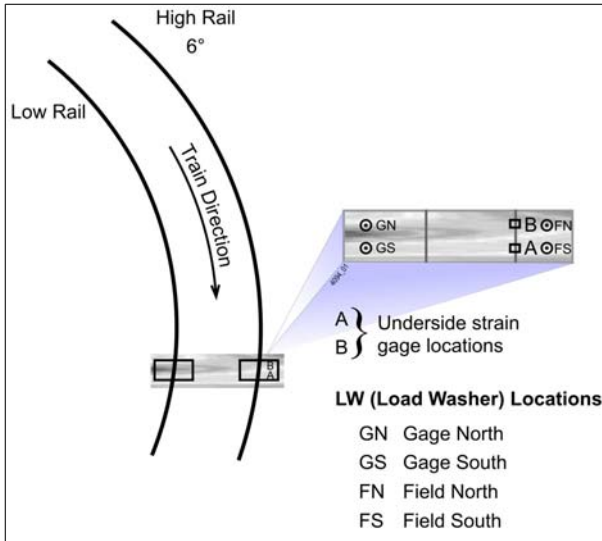
Figure 3: Tie Plate Orientation as Installed In Track

After installation of strain gages, the plates were calibrated statically in the laboratory with a vertical load. Each plate was installed in Section 25 at FAST, 6-degree curve on timber ties, with the orientation shown in Figure 3. The test train at FAST contains 80 cars each loaded to GRL of approximately 315,000 pounds.

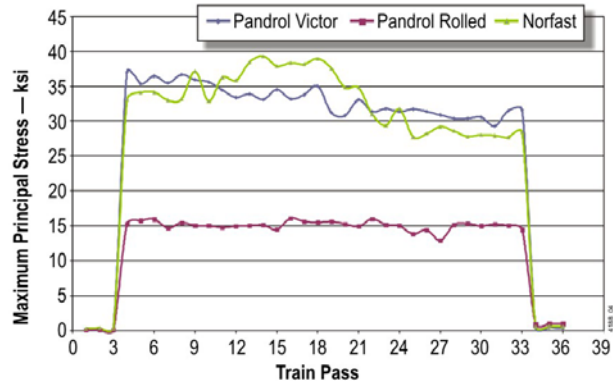
Figure 4: Maximum Principal Stress under Tie Plate, Gage B

Figure 4 shows maximum principal stress measured under the passage of a train, averaged for three laps. As Figure 3 shows, in the direction of train travel, the strain gage at location B is encountered prior to strain gage at location A. Figure 4 suggests the NorFast plate experienced higher strains than the other plates, and the Pandrol Rolled plate experienced the lowest strain values. Similar trends were observed at strain gage location A. This may have been due to the cleats of the NorFast plate not fully seating into the tie and increasing overall plate bending.

Data also shows the effect on the overall plate stress when various screw spikes were intentionally loosened, intended to simulate the effect on tie plate stress from missing or broken hold-down spikes. Results suggest that the Pandrol Victor and Pandrol Rolled plates experienced no significant change in bottom of plate stresses generated by loose or tight hold-down screws, whereas the NorFast plate did experience an increase in strain when the gage side hold-down screws were loose (train passes 13-18). This data represents stresses generated

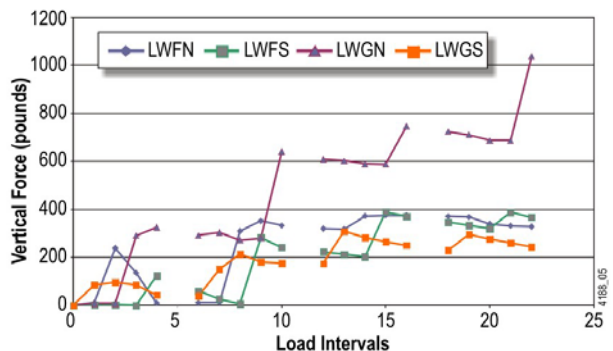
Figure 5: Hold-Down Load with Various Screw Spike Torque Values

Figure 5 displays the effect of tightening sequence of screw spikes on the NorFast plate stresses for different load washer locations: field north (LWFN), field south (LWFS), gage north (LWGN), and gage south (LWGS). This data represents static hold-down forces that might be introduced only during installation or maintenance; no train operation was conducted during these measurements. Data is presented in four groups. Each group represents the final hold-down force generated after each of the four spike locations reached a specific torque. For this comparison, the torque was increased as follows:

- Group 1 – 180 lb-ft (interval 0-4)
- Group 2 – 200 lb-ft (interval 6-10)
- Group 3 – 220 lb-ft (interval 12-16)
- Group 4 – 240 lb-ft (interval 18-22)

Note that for each torque group, the spikes were tightened in a rotating pattern. For the first two groups (up to 200 lb-ft), some screw spike positions produced no measurable hold-down force. Only when the torque was equal to and above 220 lb-ft did all the screws contribute to holding the plate down. This suggests that when hold-down spikes are at lower torque values, some spikes take more of the uplift load than others, possibly contributing to fatigue failures.

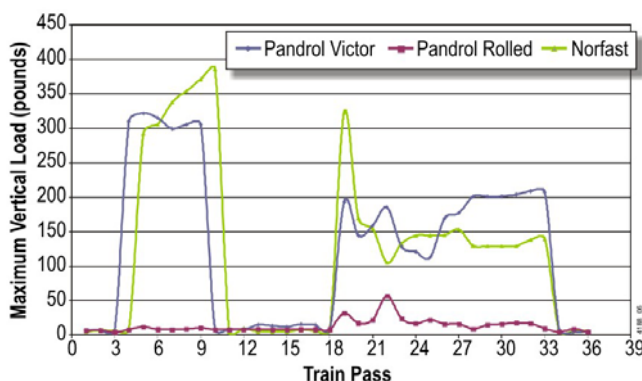
**Figure 6: Maximum Dynamic Vertical Load Applied to Load Washers with Various Screw Spikes Loose and Retightened**

As an example, Figure 6 shows data for the hold-down screw located on the north, field-side of the tie plate. The three lines represent the hold-down forces measured for each plate under the various loose-spike conditions shown.

Data in Figure 6 is similar for all four positions evaluated. Note that the first all-tight condition generated higher hold-down forces than the final all-tight spike condition for two plates, which is similar in performance for other spikes. This suggests that field tightening (without the use of a torque wrench) did not replicate the original hold-down force, and/or repeated tightening and loosening of screw spikes (without the use of any type of plugging agent) gradually reduces total available hold-down force.

some conditions, may be subjected to higher stresses. However, data shown in Figure 6 does not support this suggestion. During these evaluations, the Pandrol Rolled plate exhibited the lowest stresses of all plates, at least along the line where fractures had previously occurred.
