## Drag Brake and Durability Tests of High Performance Wheels

### Summary

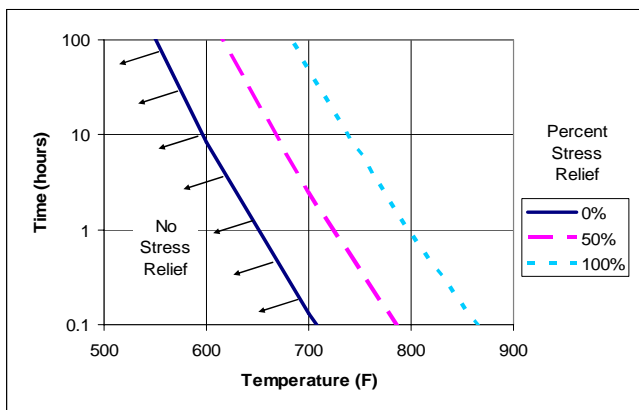
Elevated temperatures from tread braking affect the fatigue life of a wheel by reducing the yield strength and relieving beneficial residual stresses.<sup>1</sup> Figure 1 shows the estimated residual stress relief in an AAR Class C wheel as a function of time and tread temperature.

**Figure 1. Estimated Residual Stress Relief in AAR Class C Wheels<sup>1</sup>**

Freight car brake systems do not distribute the heat load evenly to all wheels in the car. Thus, each wheel involved in the brake test was exposed to a different temperature history. While not ideal, this is an unavoidable outcome of a drag brake test. According to the curves in Figure 1, some of the wheels were heated sufficiently during the drag brake test to relieve beneficial residual stresses. Other than heat discoloration, no damage was visually observed on any of the wheelsets involved in the drag brake test. Select wheels were

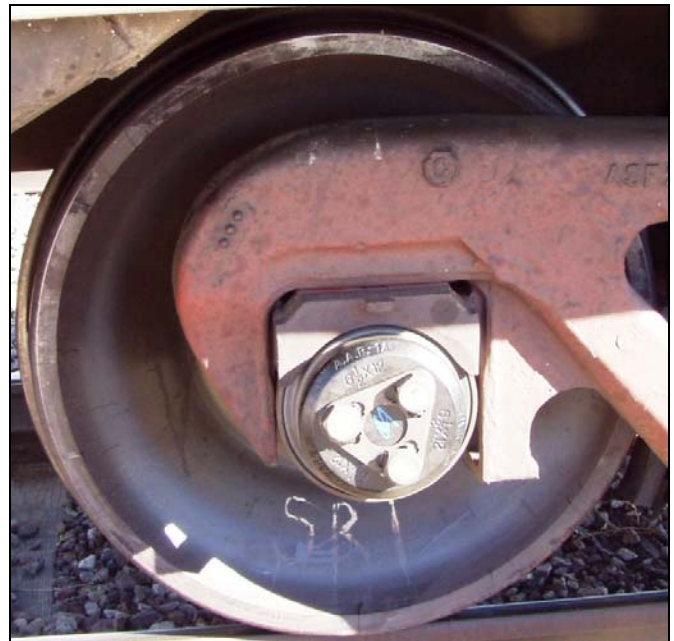
A drag brake test was conducted on one wheelset of each high performance wheel type and three control wheelsets with AAR Class C wheels. These wheelsets were installed in cars loaded to 286,000 pounds gross rail load (GRL). The cars were pulled at 25 mph around TTC’s 9.1-mile-long Transit Test Track (TTT) with the brakes applied. Each lap was completed in approximately 20 minutes. Three laps were completed in continuous succession during each test session. Table 1 shows the operating conditions of a typical test day. The drag brake test consisted of 5 test days total per wheelset and more than 250 miles traveled with the brakes applied. Figure 2 shows wheel plate bluing, which is indicative of exposure to heat from tread braking.

**Figure 2. High Temperatures have Blued this Wheel Plate during the Drag Brake Test**

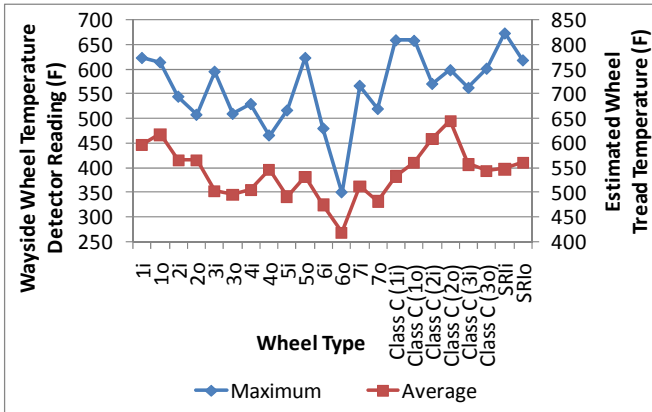
During the drag brake test, wheel temperatures were measured once per lap using a wayside wheel temperature detector. Previous studies show that when wheels are heated with tread brakes, the wheel tread temperature can be estimated at 150°F hotter than the value reported by the wayside detector.<sup>2</sup> Figure 3 shows temperature statistics for each wheel in the drag brake test. The high performance wheels donated by the manufacturers are generically labeled 1 through 7. The presence of an “i” or “o” in the wheel name is used to identify wheels in the inner and outer rails of the TTT, respectively. Figure 4 shows the number of laps for each wheel at elevated temperatures. Some wheels did not reach the elevated temperature (>650°F).

Figure 3. Wheel Temperature Statistics

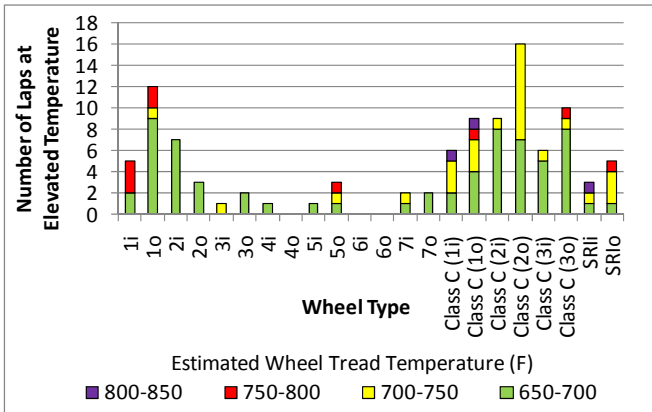
Figure 4. Number of Laps at Elevated Temperature

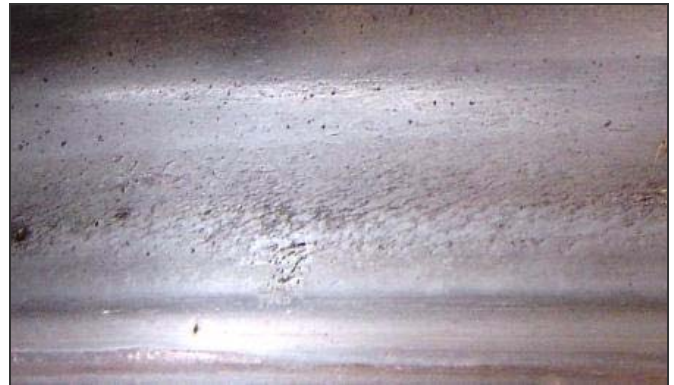
A visual inspection of the wheels involved in the durability test was conducted after the wheels had reached approximately 10,000 miles. Wheel profiles were recorded on all wheels. This allowed the wear rates of the wheels in the 315,000-pound cars to be calculated. Initial wheel profiles were not recorded on the wheels in the 286,000-pound cars, so the wear rate was not able to be calculated. Cars are occasionally cut out of the test train for servicing, and so the mileage of the wheels in the durability test is not identical. Delays in the manufacturing of the SRI wheels necessitated a later start date for these wheels, and therefore they have accumulated fewer miles than the other wheels. The Class C wheels were not new at the start of these tests, so the mileage is unknown. Figure 5 shows an example of RCF cracks observed on many of the wheels. Figure 6 shows minor shelling present on two wheels. Table 2 lists the results of the inspection.

RCF cracks are a potential precursor to wheel shelling. These cracks may either wear off or grow, connect, and turn in to shells. Fifteen out of 48 wheels have RCF cracks and 2 more have minor shelling. Each of the six cars involved in the durability test has at least one wheel with RCF cracks. At least one wheel from each type of high performance wheel has RCF cracks or shelling. The presence or absence of RCF cracks on the wheels in the 286,000-pound cars is not well correlated with the wheel temperatures from the drag brake test.

Figure 5. RCF Cracks were observed on 15 of 48 Wheels

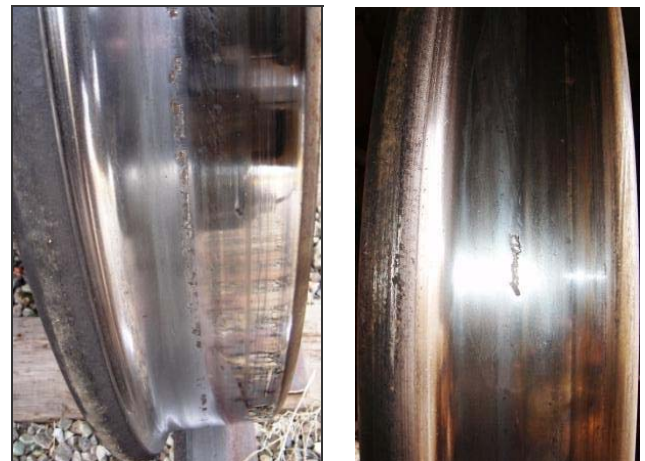
Figure 6. Minor Wheel Shelling was observed on Two Wheels

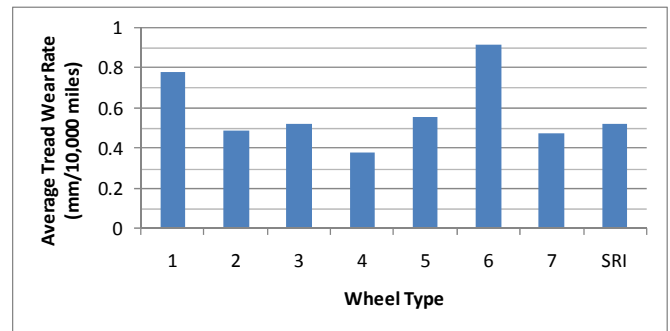
Figure 7 shows the average tread wear rate for each type of wheel in units of millimeters of wear per 10,000 miles of service. While this is the best assessment of wear rate with the currently available data, several sources of error should be considered. Wheel wear rates tend to be highest when wheels are new and slow down as the wheel profiles wear to a more conformal fit with the rail profile. The average wear rates are calculated from small sample sizes (either 2 or 4 wheels of each type) using wheels that are loaded in excess of their expected service loads and operated in an environment with an extremely high density of curved track. Wheel profile comparisons have some inherent subjectivity and are more prone to error when small amounts of wear are involved, as is the current case.

Figure 7. Tread Wear Rate
