Revenue Service Test of Rail Anchors on Concrete Tie Track at Western Mega Site

Summary

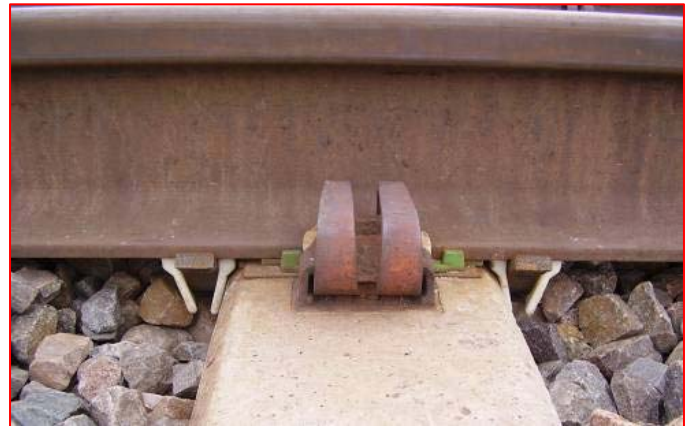
Figure 2. Box Anchors of Rail at Test Site

Three locations at the western mega site were selected for the test. Each location included bonded IJs. Two locations, milepost (MP) 61.3 and MP 65.7, had IJs that appeared to be in poor condition (old), and one location (MP 69.1) had IJs that were just installed (new). At each test location, the rail on one side of the track was box-anchored for 120 consecutive ties in either direction from the joint (Figure 2) whereas the

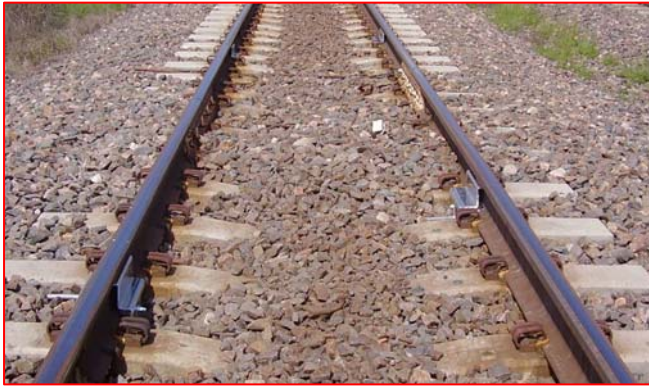
Figure 3. RNT Sensors Installed at Test Site

RNT sensors were installed at two locations to monitor changes in RNT over time. Figure 3 shows the actual layout of four RNT sensors installed at one test location. As shown, two sensors were installed on the anchored rail and the other two were installed on the unanchored rail. Each sensor was approximately 6 feet from the joint bars.

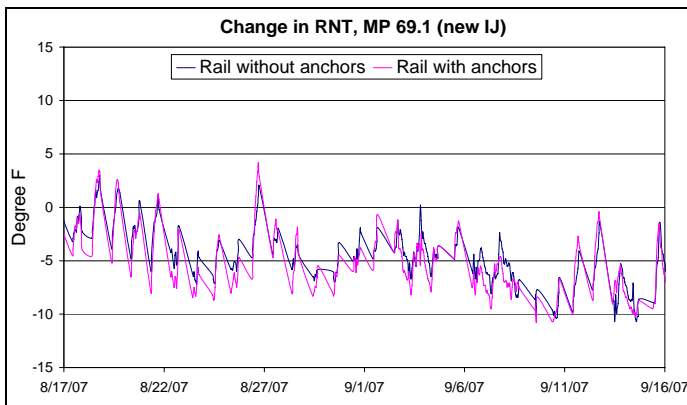
Figure 4. Change of RNT at New IJ Location

Monitoring the change in RNT over time at these locations indicated no apparent difference between the anchored and unanchored rails. Figure 4 shows the results from two sensors installed at the location with the new IJs. For illustration purposes, the data shows one month (summer) of operation. As expected, RNT fluctuated on a daily basis and drifted lower over time. Comparison between the anchored and unanchored rails indicates no obvious difference in the short- and long-term changes in RNT; i.e., no additional longitudinal resistance from the anchors was present under normal operating and weather conditions.

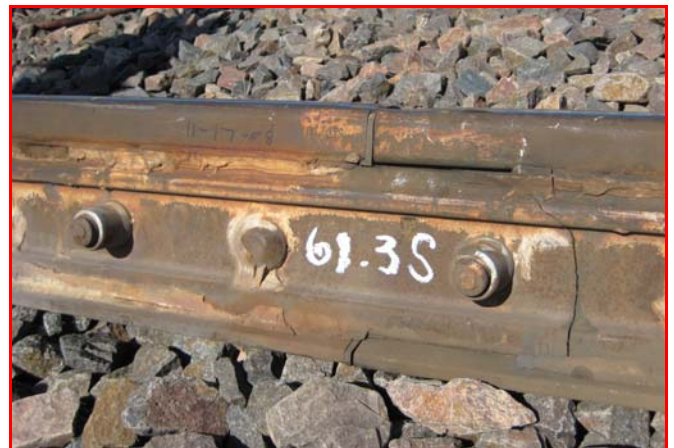
Figure 6. Cracked and Replaced Joint

On November 8, 2008, at one of the test locations with the old IJs (MP 61.3), the joint bars on the rail with anchors cracked. Figure 6 shows the actual rail section that was replaced due to cracked bars. As shown, the joint bar on the field side of the rail broke. The joint bar on the gage side of the rail also cracked, although the crack did not extend across the entire bar (not shown in Figure 6).

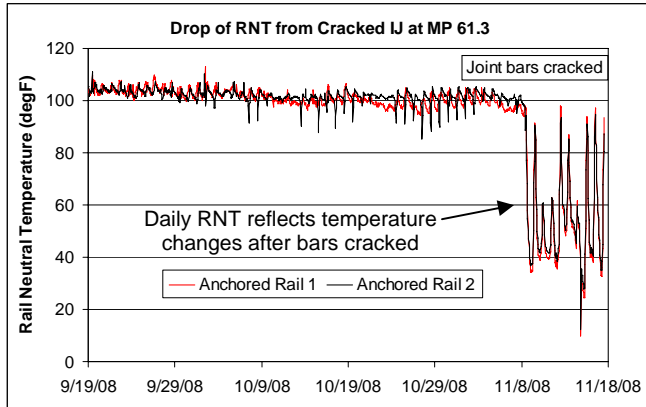
Figure 7. Drop of RNT from Cracked Bars

Figure 7 shows the drop in RNT due to cracking of the joint bars. Daily RNT reflects temperature changes after the joint bars cracked. In this figure, data is shown from the two RNT sensors installed on the anchored rail. As illustrated, there was a large drop in RNT (by approximately 60 degrees F) due to cracking of the joint bars. In other words, the anchors did not provide any significant longitudinal resistance that would have reduced the amount of drop in RNT.

Note that the failed joint section was replaced on November 17, 2008. Between November 8 and November 17, 2008, the change in RNT essentially reflected the change in rail temperature, which generally can vary over a much wider range than RNT.

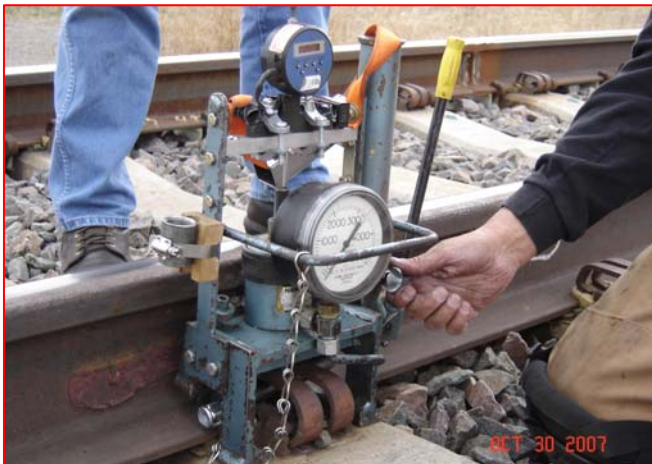
Figure 8. Toe Load Measuring Device

Toe load is the hold-down force provided by a spring clip on the base of rail. In theory, it is equal to the force required to just lift a clip from the base of the rail. As part of this test, TTCI used the device shown in Figure 8 to measure toe load. The device is used to lift the spring clip from the rail base via a hydraulic cylinder, while recording the force required to lift the clip at different displacement levels.

At each test location, measurements were taken every tenth tie, on both rails for the clips on both the gage and field sides of the rails. Measurements were taken at different times (MGT) in order to monitor potential degradation in toe load over time.
