Durability Test of High Performance Wheels: 20,000-Mile Interim Results

Summary

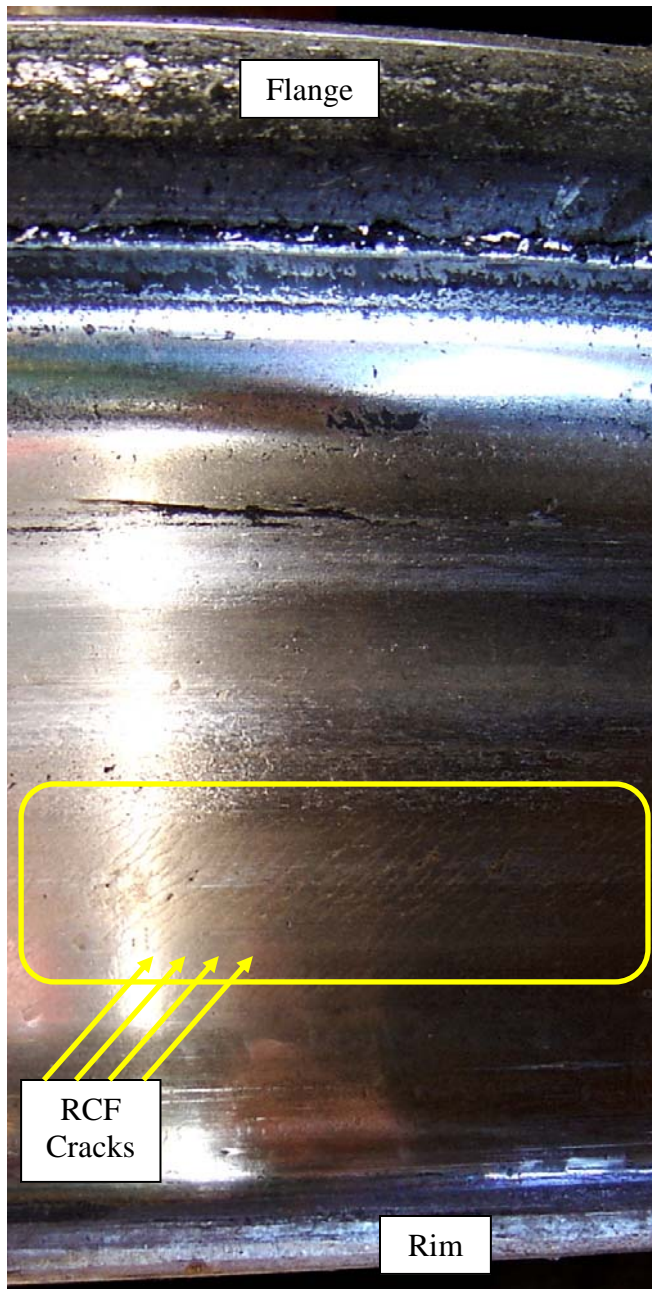
Figure 1. Example of RCF Cracks that were Too Shallow to Produce a Visible Result with Dye Penetrant Applied

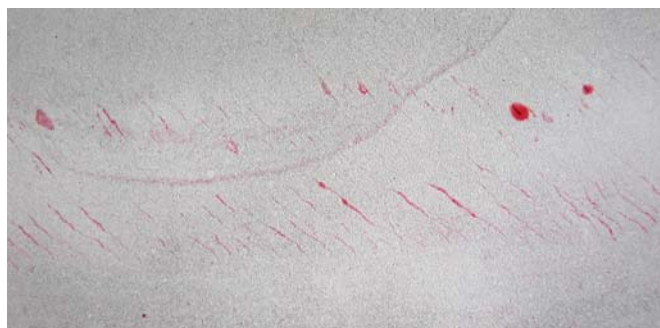
RCF cracks are a *potential* precursor to wheel shelling. RCF cracks are commonly referred to as "heat checks" and are not a condemnable condition according to AAR interchange rules.² Twenty-one out of 40 high performance wheels had RCF cracks, and five high performance wheels had very small shells. Two out of eight AAR Class C wheels in the test also had RCF cracks, and three AAR Class C wheels had small shells. Each of the six cars involved in the durability test had at least two wheels with RCF cracks or shelling. At least one wheel from each type of high performance wheel had RCF cracks or shelling. Although RCF cracks were observed on more wheels at the 20,000-mile inspection than at the 10,000-mile inspection, the cracks do not appear to be increasing in severity, possibly indicating that the rate of crack growth and wear are nearly equal. Dye penetrant was applied to the wheels that had RCF cracks visible on the tread surface. On the majority of wheels, the cracks were too shallow to hold a sufficient quantity of dye to produce a visible result upon application of the developer. Figure 1 shows an example of a wheel with RCF cracks that were visible upon inspection, but too shallow to show any result when dye penetrant was applied. Figure 2 shows an example of some of the deeper RCF cracks where the dye penetrant inspection method produced visible results.

Figure 2. Example of RCF Cracks that Produced a Visible Result with Dye Penetrant Applied

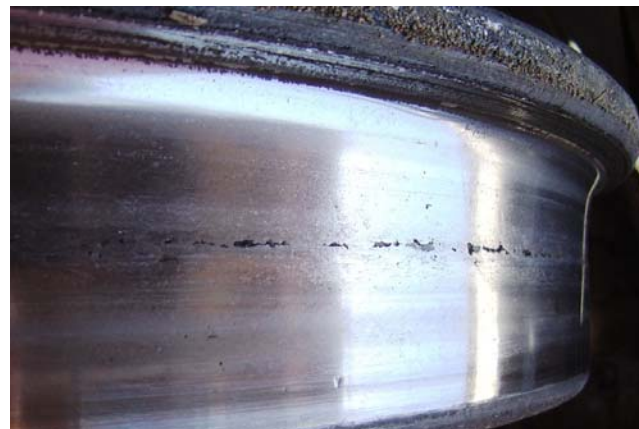
Figure 3 is a photo of small wheel shells. These shells are the most severe shelling present on the test wheels. Small shells were observed on more wheels at the 20,000-mile inspection than at the 10,000-mile inspection, but the shells that were observed during the 10,000-mile inspection do not appear to be growing.

Figure 3. Small Wheel Shells Near the Tapeline Ridge

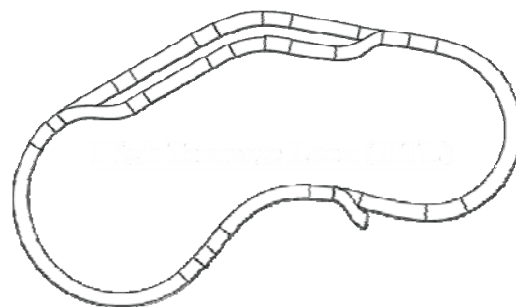
Figure 4 shows the HTL, and Figure 5 shows a typical worn wheel profile at FAST. The reverse curve of the HTL ensures that the rail contacts this ridge at least twice per lap (2.7 miles). The geometry of this ridge produces higher contact stresses compared to typical revenue service wheel/rail profiles. All of the shelling observed to date on the wheels in the durability test has occurred near the area of this ridge, implying that the durability test is accelerating fatigue damage not only with heavier axle loads or thermally abused wheels, but also through increased contact stresses due to the wheel wear profiles.

Figure 4. Outline of the HTL – Durability Test Site

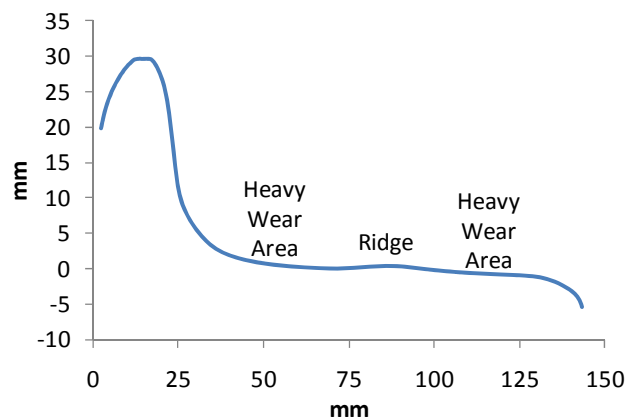
Because the HTL is largely comprised of curves, wheels in the train at FAST tend to concentrate wear near the flange root and between the tapeline and the rim, leaving a small ridge of material near the tapeline.

Figure 5. Typical Worn Wheel Profile at FAST Stretched along the Wheel Radial Dimension to Accentuate the Wear Ridge

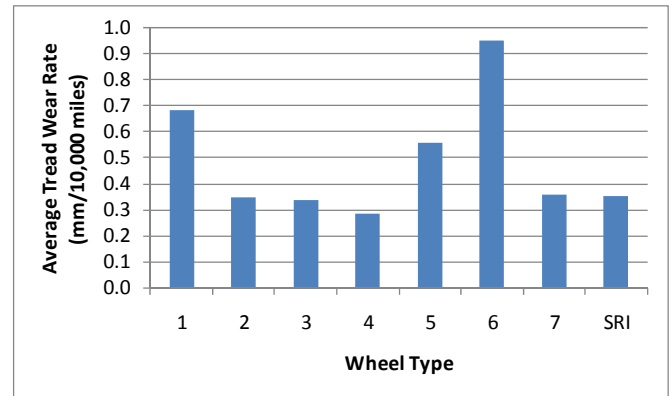
Figure 6 shows the average tread wear rate for each type of wheel in units of millimeters of wear per 10,000 miles of service. It should be noted that wheel wear rates tend to be highest when wheels are new, the sample sizes for the data in Figure 6 are small, the wheels are operated in an environment with an extremely high density of curved track, and wheel profile comparisons have some inherent subjectivity.

Figure 6. Tread Wear Rate

The bainitic wheel (wheel 6) shows a higher tread wear rate than the other wheels in the test, all of which have a pearlitic microstructure. This result is not surprising, because previous test results of rail wear rates have also shown that steel with a bainitic microstructure wears more quickly than steel with a pearlitic microstructure in the wheel/rail contact environment.³
