Influence of Lug Contact Misalignment on Knuckle and Coupler Stress

Summary

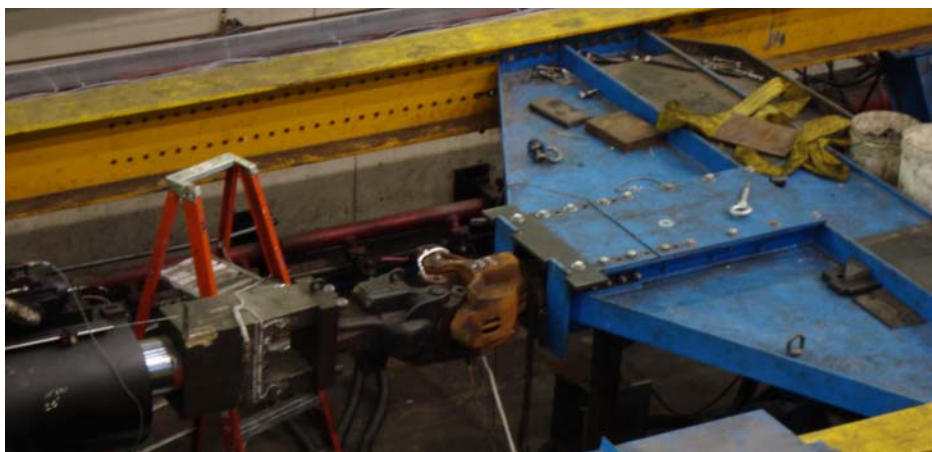
Testing was completed using the Simuloader load frame, as shown below, located in the Rail Dynamics Laboratory at the Transportation Technology Center.

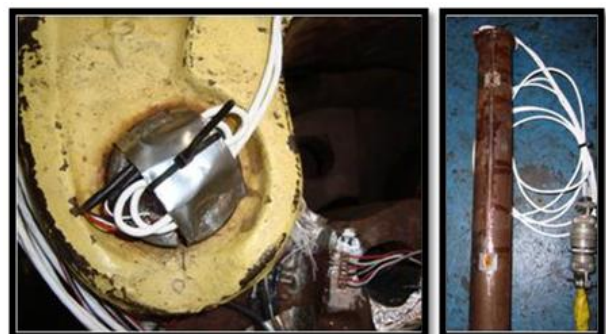
Figure 2. Instrumented Pin

A second set of tests was performed using an instrumented pin to determine the stress levels experienced at the top and bottom of the pin under various knuckle/coupler interface conditions. The pin was instrumented using a layout similar to that described by Tanzer (R-745).³ Figure 2 displays the initial pin orientation (left) and the strain gages (right) used for the instrumented pin testing sequence.

A test to determine the pin angle, which results in the maximum stress on the pin, was completed before any shims were added to the lug interface. To define this angle, a series of draft loads were applied from 0 to 100,000 pounds in the initial position shown in Figure 2. After the strains were recorded in the initial position, the pin was rotated through 180 degrees in 5-degree intervals to determine the angle of maximum stress. Once this angle was determined, the pin was placed in this position for the remainder of the lug misalignment testing. Before the test matrix listed above was completed, a stepped pull was performed at loads of 100,000, 200,000, 300,000, and 400,000 pounds to ensure that no residual stress was in the pin.

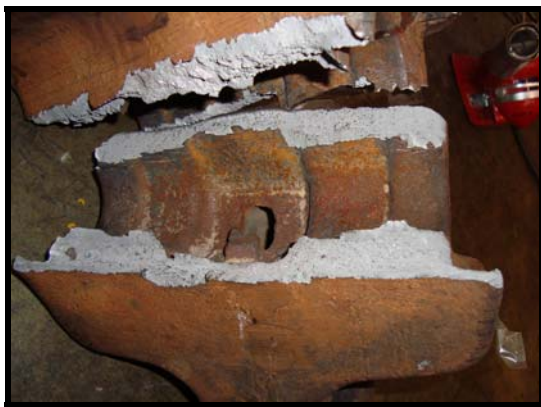
Figure 3. Knuckle Fracture Surface

The second fracture occurred during testing of the instrumented F-type knuckle. The break occurred at 400,000 pounds and once again was observed to be a 100-percent brittle fracture. One small inclusion was present, but no fatigue associated with the inclusion was observed. Figure 3 shows the broken knuckle fracture surface.

Two of the five knuckles tested experienced brittle fracture during testing. During calibration of the load frame, one F-type knuckle fractured at the pin hole. The estimated maximum load applied at the time of fracture was 450,000 pounds. The fracture face did not show any indications of metallurgical flaws. The break was a 100-percent brittle fracture.

Table 1 shows that both fractures occurred well below the specified limits for Grade E material listed in the AAR M-211 standard.²

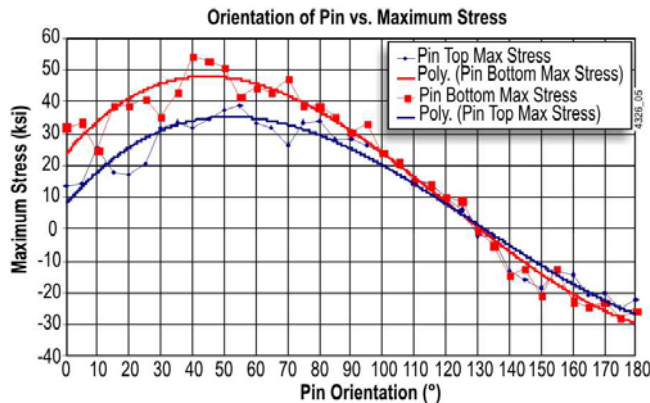
Figure 5. Pin Orientation Stresses

Figure 5 displays the stress data for the upper and lower strain gages mounted on the pin during static testing. The stress in the upper portion of the pin is shown in blue and the stress in the bottom of the pin is shown in red. The data in Figure 7 shows that with a 100,000-pound applied load, at an angle of 50 degrees from the starting point results in the highest

stresses in the upper and lower portion of the pin. The maximum observed stress in the pin at 100,000 pounds was 55 ksi for the upper strain gage and 39 ksi for the lower strain gage.

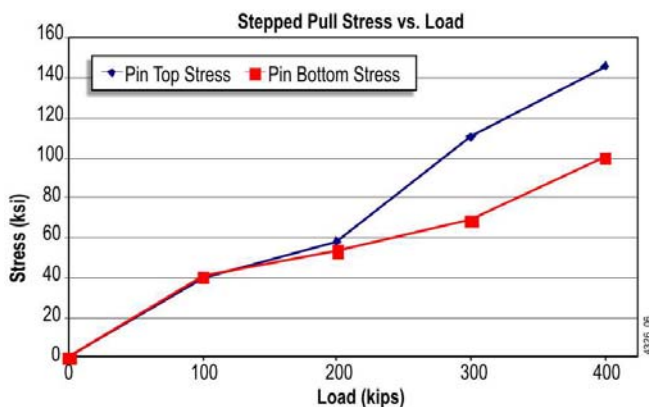
Figure 6. Stepped Pull Stresses

Figure 6 shows the results of the stepped load testing. Comparing the top (blue) and bottom (red) pin stresses shows a 1.26 ksi difference at 100,000 pounds of applied load and a 62.16 ksi difference at 400,000 pounds of applied load. The data shown in Figure 6 indicates that as the draft force was increased the top of the pin received more of the load than the bottom of the pin. This trend may be component specific and additional testing must be completed before concrete conclusions can be drawn.

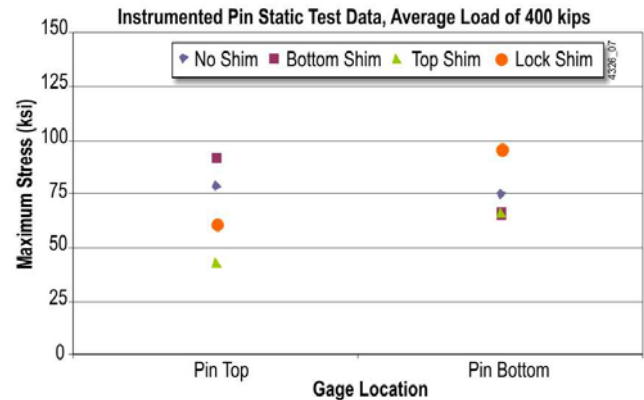
Figure 7. Pin Stress Data

Figure 7 shows the stress results from the shim testing with the instrumented pin.

Pin stress levels ranged from 75 ksi to 79 ksi at the bottom and top of the pin, respectively, with no shims at the lug interface. After shims were placed at either the lug or lock interfaces, pin stress ranges from a minimum of 43 ksi at the top of the pin when shims were located at the top lugs to a maximum of 92 ksi at the top of the pin when shims were placed at the bottom lug interface. The data collected during this testing suggests that small misalignments between the knuckle and coupler contact surfaces can have a significant influence on pin stress and may reduce the life of the pin.

The last set of testing with the instrumented pin was completed using the matrix used in the knuckle and coupler testing to determine the influence of lug contact misalignments on pin stress. At the conclusion of testing, the instrumented pin was removed and a bend was observed. Because it is unknown when the bend in the pin occurred, more testing will be required to validate the stress results observed.
