# New Rail Profile Designs for Switch Points

Huimin Wu, Benjamin Madrill, and David D. Davis

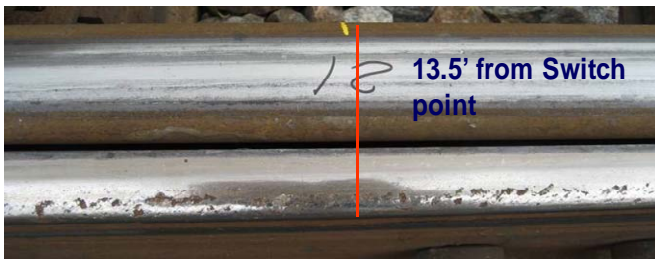
RCF has been commonly observed on the running surface of switch points. Figure 1 shows an example of defects found on switch points that occurred after less than 100 million gross tons (MGT) of traffic.

**Figure 1. Surface Defects on the Switch Rail of a No. 20 Switch, Straight Route, 13.5 feet from the Switch Point**

Field observations and the results from contact and wear pattern analysis indicate that the current design of the switch point profile may contribute considerably to the formation and development of RCF on the switch point running surface. The surface defects shown in Figures 1, 3, 4, and 5 are likely the accumulated result of wheel/rail interaction forces since the switch point was new.

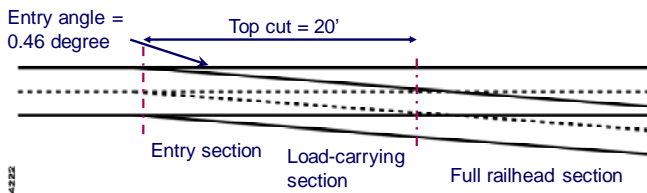
The switch point can be divided into three sections based on different wheel/rail contact features, as Figure 2 shows: (1) the entry zone where the stock rail and gage side of the switch point carry the load, (2) the load-carrying zone where the switch point carries the load, and (3) the full railhead zone where the switch rail is back to full section.

**Figure 2. No. 20 Switch Point Layout with a Top Cut Distance of 20 feet**

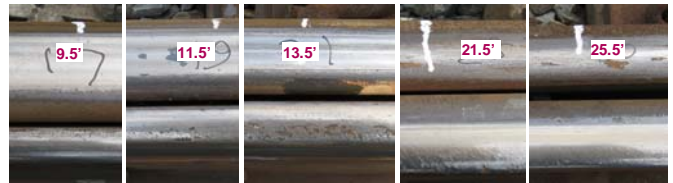
- Severe RCF usually started about 9 to 10 feet from the switch point tip and reduced in severity after 21 feet. In this zone, the switch rail carries most of vertical load and the contact regions move from occurring primarily on the top of the stock and switch rail gage side to the top of the switch rail or to the gage corner of the switch rail.
- The surface condition in the full railhead zone was considerably better than that in the load-carrying zone (Figures 3 and 4).
- The stock rails showed fewer surface defects than the matching switch point (Figure 5).
- In general, the switch point surface conditions for the straight and diverging routes were worse than conditions on open tangent track or in 1.5-degree curves.

**Figure 3. Rail Surface Conditions versus Distance from the Switch Point Tip (Straight Route)**

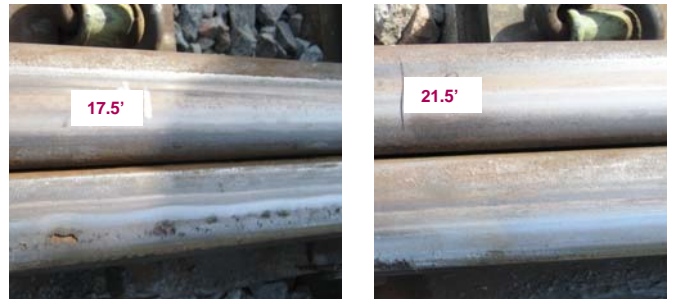
**Figure 4. Rail Surface Conditions versus Distance from the Switch Point Tip (Diverging Route)**

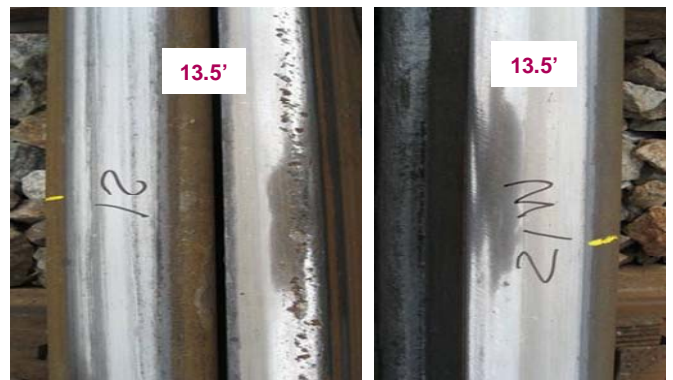
**Figure 5. Surface Condition of the Switch Rail and the Matching Stock Rail at the Same Distance from the Switch Point Tip**

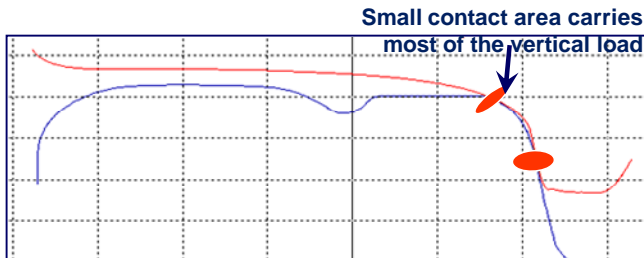
Figure 6 shows the typical contact pattern of a common worn wheel contacting a new switch point profile of the current design. Very high contact stress and shear stress can be induced at the switch point gage corner due to the small contact area. This condition can only be improved when the sharp corner is worn into the shape shown in Figure 7.

**Figure 6. Contact Pattern of a Worn Wheel in Contact with the Current Switch Point Design**

pattern shown in Figure 6. While this design was acceptable in the past when softer rail steels would quickly deform or wear into conformal shapes with passing wheels, with today’s head hardened rails, nonconformal switch points are prone to develop RCF before they deform or wear into conformal shapes with passing wheels.

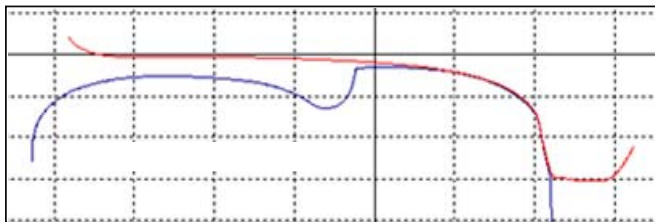
**Figure 7. Contact Pattern of a Worn Wheel in Contact with a Worn Switch Point**

Figure 9 shows the switch point profile Design 1 that contains three tangential arcs with a straight gage side cut of 78 degrees. Figure 10 shows a comparison of the current design and the new Design 1. The new Design 1 switch point profile provides a large wheel/rail contact area to carry the vertical load and tangential force and will more quickly wear into the conformal shape shown in Figure 7.

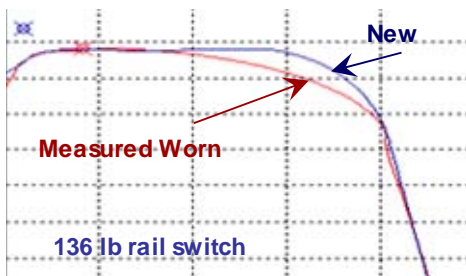
Figure 8, which compares a typical worn switch rail profile with a new switch rail shape for the current design, shows the concentrated wear that occurs at the switch rail gage corner.

**Figure 8. Comparison of the Current Switch Point Design and the Worn Switch Point after less than 100 MGT of Service**

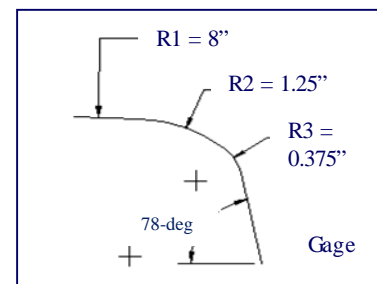
**Figure 9. New Switch Point Profile Design 1**

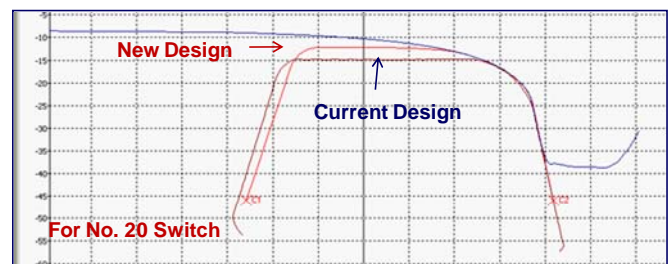
**Figure 10. Comparison of the Current Switch Point Design and the New Switch Point Profile Design 1**

As Figure 10 shows, to increase the size of the wheel/rail contact area, the switch point top of the new design is slightly higher than the current design in the load-carrying zone from 9 to 19 feet from the switch point tip. The top cut slopes for the first and second cuts, and the length of the second cut have been adjusted to keep the switch point tip elevation the same as in the current design.

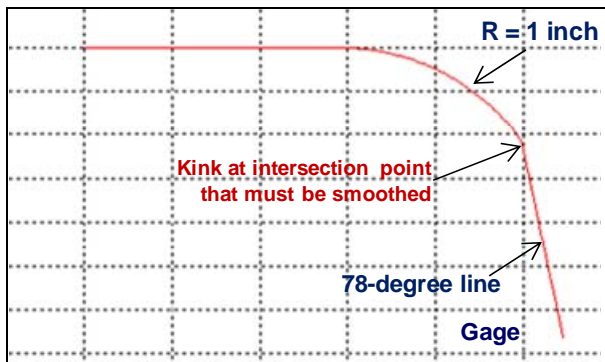
In order to simplify the machining process and use an existing cutting tool, an alternative switch point profile design (Design 2) has been developed. This switch point profile has a 1-inch radius at the switch point gage corner. It maintains the 78-degree gage side cut and has a flat top (or 1:20 slope) cut that is tangential to the 1-inch radius arc, as Figure 11 shows.

Figure 11. New Switch Point Profile Design 2

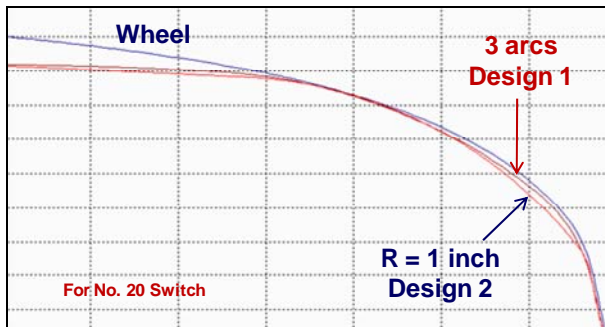
Design 2 maintains the desired contact features (Figure 12) produced using Design 1. Because the 1-inch radius arc is not tangential to the 78-degree line, it creates a small kink at the intersection point of the two segments that must be smoothed during production. This switch point should quickly wear into a conformal shape with the commonly worn wheel profile shapes.

Figure 12. Comparison of the Contact Patterns for Switch Point Profile Designs 1 and 2

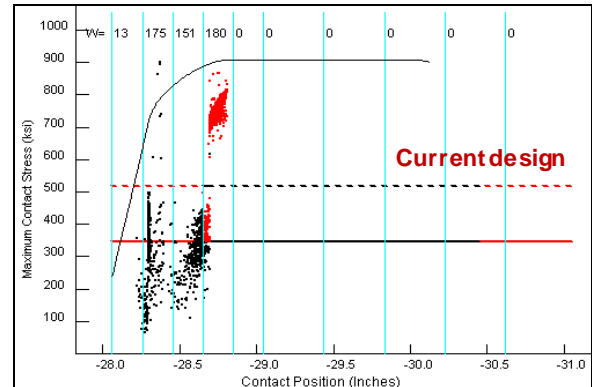
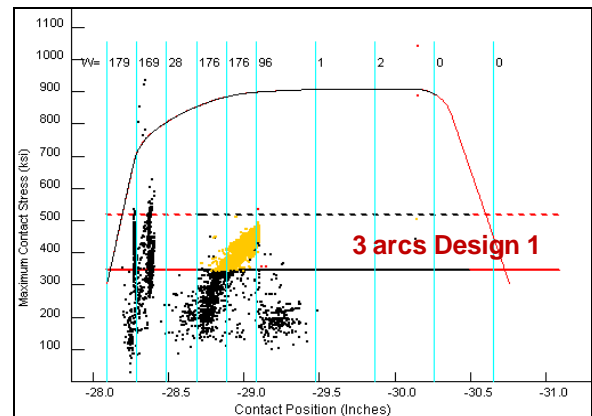
The new switch point profile designs were analyzed for contact stresses using typical worn wheel profiles. Figure 13 shows the contact stress distribution for 180 measured worn wheel profiles contacting the current and the new Design 1 switch point profiles. The analysis suggests that the maximum contact stresses produced by the new Design 1 may be 30 to 40 percent lower than those produced using the current design. Also, the analysis suggests that the contact positions are spread over a wider range for the new Design 1 compared to the current design, which concentrates contact in a narrow range. These improvements in contact stress and contact patterns should result in a lower rate of wear and a lower risk of RCF.

Figure 13. Contact Stress Level Comparison
