# Revenue Service Test of High Performance Wheels: 23,000-Mile Interim Results

## Summary

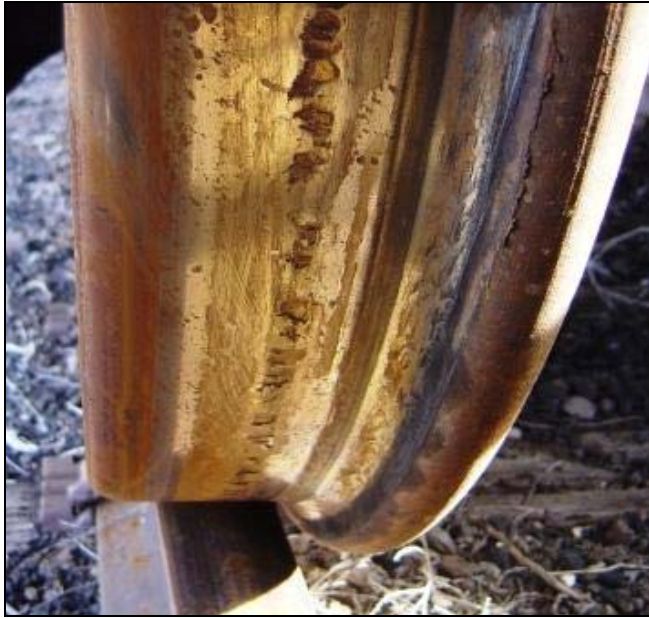
Figure 1. Wheel with Spalls

A wheel slide event that results in a spall is not reflective of the performance of the wheel. Thus, wheels with spalling damage were excluded from further analysis. Figure 1 shows an example of a spalled wheel seen during the inspection.

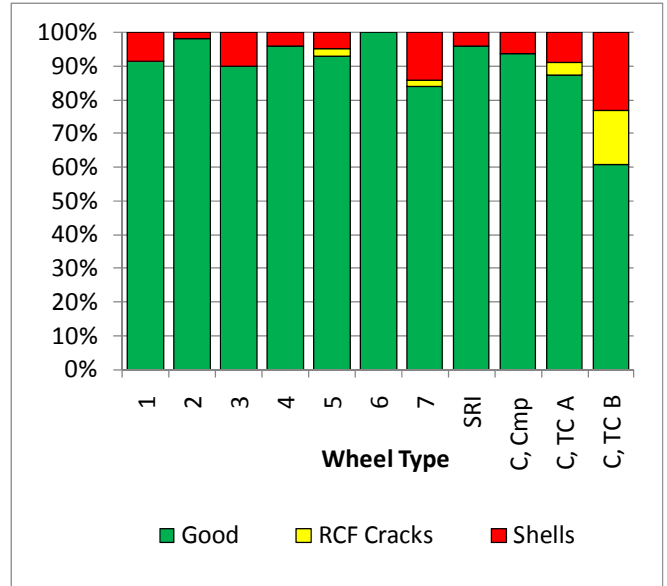
Figure 2. Tread Condition

Wheels without spalls were placed into one of three possible categories: RCF cracks, shells, or good. Wheels in the RCF crack category did not have shells. Wheels in the shells category may or may not have also had RCF cracks. Wheels in the good category had no visible indications of RCF cracks or shells. Table 1 is a categorized summary of the wheel tread conditions. Figure 2 shows the categorized percentages of unspalled wheels per wheel type. None of the wheels inspected had damage that would be deemed condemnable under AAR rules.

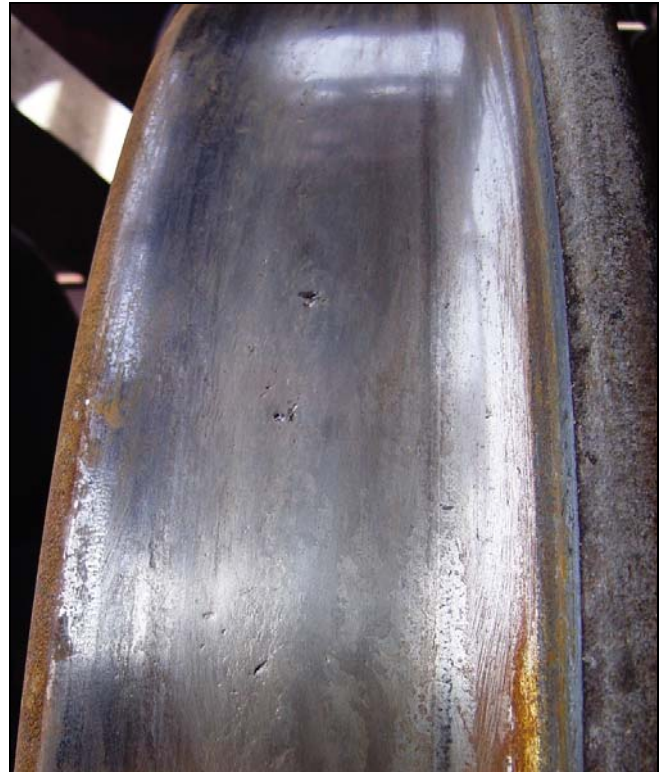
Figure 3. Wheel with Small Shells

Figure 3 shows an example of a wheel with shells seen during the inspection.

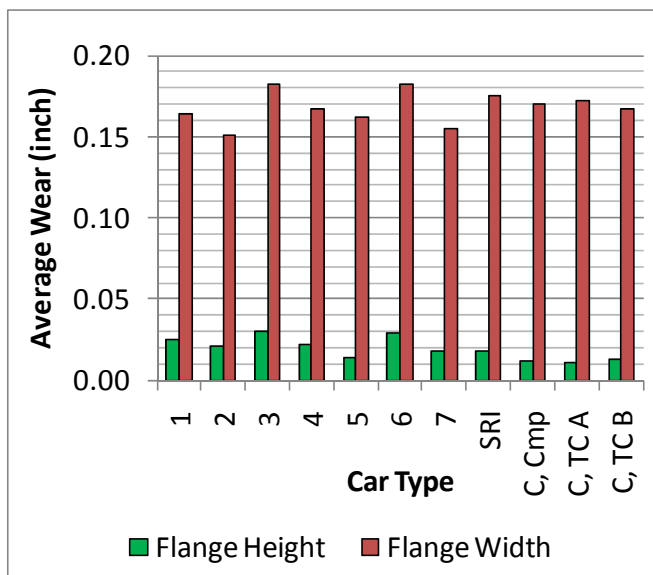
Figure 4. Wheel Wear

Wheel profiles measured during the inspection were compared to the wheel profiles from the same wheels measured before initiation of the revenue service test in August 2009. In this manner, a wear value of the flange width and flange height was established for each wheel

measured during the inspection. Figure 4 shows the average wear of the flange width and flange height for the sample of wheels measured during the inspection, categorized by wheel type. As shown, the flange width is wearing more quickly than the tread (as indicated by the flange height) for the wheels in the revenue service test. This result is consistent with other studies that have found high initial flange width wear rates for wheels with AAR-1B profiles in revenue service due to poor conformity with typical worn rail profiles.<sup>7</sup> At this early stage of the test, all wheel types are showing similar wear rates.
