The work described in this document was performed by Transportation Technology Center, Inc.,  
a wholly owned subsidiary of the Association of American Railroads.

## Update of Mega Site Experiments in Revenue Service

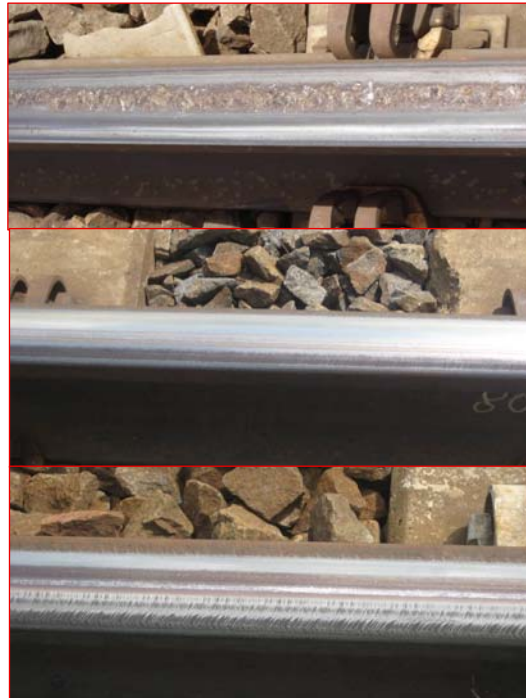
**Figure 1. Rail Surface Conditions at 250 MGT (top – without TOR friction control or preventive grinding, middle – with TOR friction control, bottom – with preventive grinding)**

To date, more than 350 MGT have accumulated. Preliminary results have shown that both maintenance strategies are effective to prevent or delay RCF from initiating. Figure 1 shows a comparison of rail surface conditions at 250 MGT. At 250 MGT following a corrective grinding with neither method implemented, severe RCF was observed, but with one method implemented no RCF was observed.

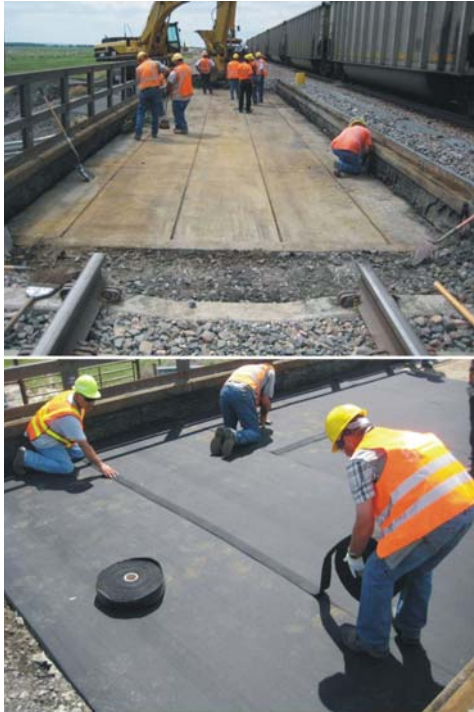
Figure 2. Ballast Mats for a Bridge at Western Mega Site

ballast mats to reduce track stiffness and increase track damping on the bridge. In June 2009, the installation of ballast mats on this revenue service bridge was completed.

To date, the performance of this bridge and its approaches has been excellent. Figure 2 shows the installation of ballast mats on this bridge.

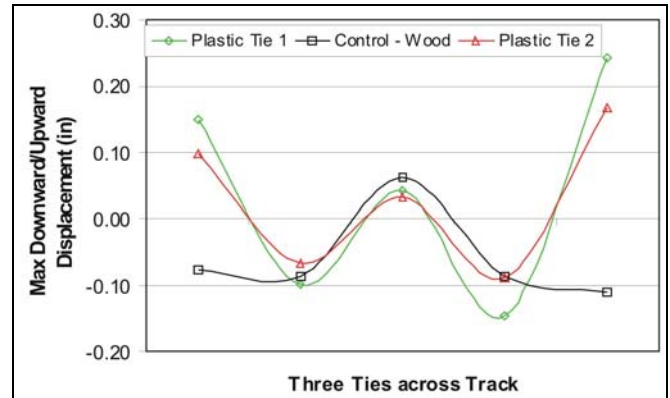
Figure 3. Deformation Behaviors of Plastic and Wood Ties

Two types of plastic ties are being monitored at the eastern mega site (in a 6.8-degree curve) for over 280 MGT. These plastic ties have continued to perform well. In October 2009, measurements were taken to compare the bending behavior of plastic ties with the control; i.e., wood ties under dynamic train loads. Figure 3 shows the measured maximum downward and upward displacement results.

A significant difference between the plastic ties and the wood ties is that the ends of the plastic ties tend to bend upward much more than the wood ties, which is characteristic of lower bending stiffness of plastic ties as compared to wood ties. In the long run, these test results may point to potential issues of pumping ballast around the ends of ties and large bending stress in the tie plates, which have indeed been observed for some plastic ties evaluated under the FAST program (Gonzales et al. 2008).<sup>8</sup>

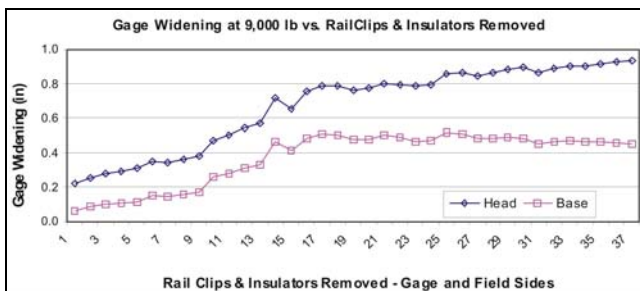
Figure 4. Gage Widening as a Function of Missing Rail Clips and Insulators

Figure 4 shows the test results obtained in a tangent track section at the western mega site when the clips and insulators were removed one-by-one on both the gage and field sides of the rail. When all nine ties had their fastenings (clips and insulators) removed, the maximum gage spreading was measured at 0.97 inch.

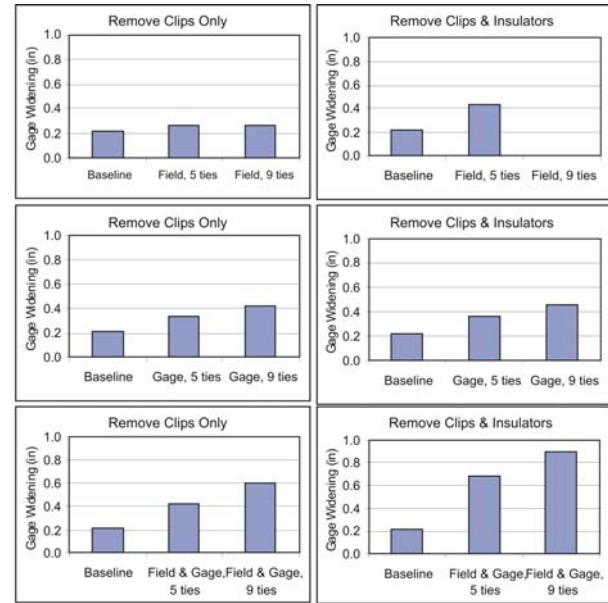
Figure 5. Effects of Missing Clips and Insulators on Gage Strength when there is No Vertical Load Applied

In reality, it rarely happens that all fastening components (clip and insulator) on both the gage and field side of the rail would fail at the same time. To find out how clips and insulators would affect gage strength, Figure 5 shows a summary of the test results concerning gage widening as a function of (1) missing clips on the field side, the gage side, or both the field and gage sides of the rail (three charts on the left); and (2) missing clips and insulators on the field side, the gage side, or both the field and gage side of the rail (three charts on the right). Results are given as the baseline (i.e., no failed component), missing fastenings for five consecutive ties, and missing fastenings for nine consecutive ties.

From the results shown, the following preliminary conclusions can be drawn: (1) Missing field-side rail clips have less effect on gage strength than missing gage side clips. For example, removing all field-side rail clips on nine ties (leaving gage-side clips in place) had no significant influence on gage strength. (2) Missing field-side insulators have a greater effect on gage strength than missing gage-side insulators. (3) Unless all clips and insulators on both the field and gage side of the rail are missing, it would take a large number of missing clips or insulators for eight to nine consecutive ties to reduce gage strength below the level of 0.56 inch of gage spreading at 9,000 pounds. Note that similar results were observed in the tests conducted at FAST and at the western mega site, as well as between the tests performed on tangent track and in a 2-degree curve.
