Testing of a Prototype Hybrid Composite Beam Span at FAST

Duane Otter and Lucy Tunna

Summary

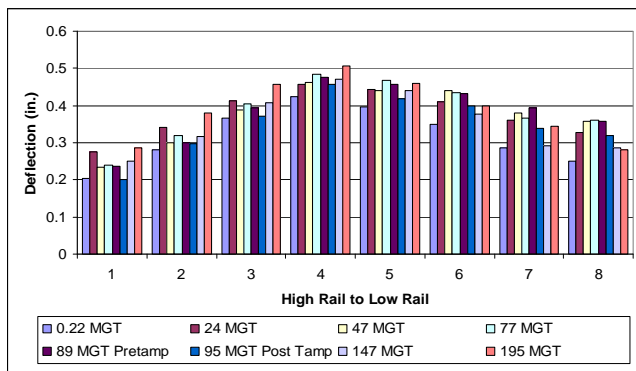
Measurements show that the HCB span deflects about twice as much as a comparable prestressed concrete span. Figure 1 shows the vertical deflections measured after various amounts of accumulated tonnage. Deflections were measured under each of the eight beam units that make up the HCB span. (Figure 8 shows the ends of four beam units.)

Figure 1. Vertical Deflections in the 8 HCB units at Various Tonnage Accumulations

Note that the deflections generally increased with accumulated tonnage, as track geometry became rougher. After tamping between 89 and 95 MGT, deflections decreased.

With additional tonnage, the deflections again generally increased. The final deflection measurements were taken at 195 MGT. Variations in actual track superelevation and actual train speed also likely contributed to some of the variation in deflection measurements.

The maximum deflection measured was about 0.51 inch. The average deflection for all eight beams is less than 0.4 inch. The maximum recommended deflection for a 30-foot prestressed concrete span is 0.56 inch according to AREMA Chapter 8.³ The same limit is recommended for steel spans in AREMA Chapter 15.³ Theoretical average deflection was calculated to be about 0.3 inch,¹ not including any impact effects. The measured deflections for a 30-foot prestressed concrete span originally at this location, were less than 0.2 inch under the train at FAST. Field testing of timber trestles typically showed deflections of about 0.4 inch on spans of 14 to 15 feet, half the length of this HCB span.

The beams toward the center of the span show higher deflections. This is likely due to a stiffening effect from the ballast curbs on the outsides. While the ballast curbs have gaps to reduce the amount of stress in the curb, they still add considerable stiffness. Perhaps a stiffer deck or transverse structural connections between beam elements would make the deflections more uniform and reduce the maximum deflection. The design of HCB spans for railroad applications is likely to be governed by deflections. For this reason, HCB spans will tend to be deeper than prestressed concrete spans of the same lengths.

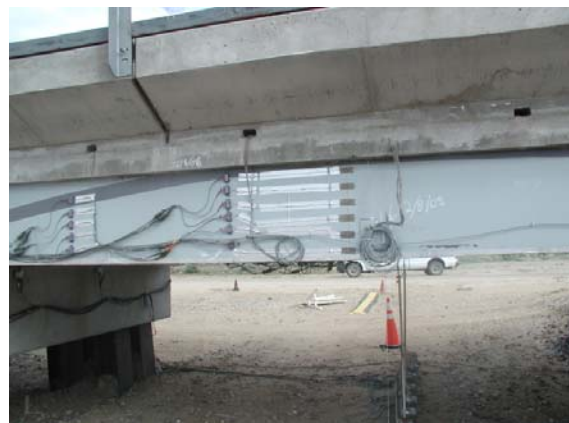
In addition to deflection measurements, strain measurements were also taken. Strain gages were attached at mid span to the bottoms of the eight HCB sections. Strain gages were also applied near mid span to the side faces at various depths on the outside beams, as Figure 2 shows. The results from these strain gage measurements were presented previously.² (Inside beam faces were not accessible for installing strain gages.) Measurements after additional tonnage accumulation showed little change. They confirmed that the magnitudes of the strains continue to indicate low stresses in the various components of the HCB, as predicted.¹ Because deflection is the governing factor in the design of this particular HCB, there is plenty of reserve load-carrying capacity.

Figure 2. Gages for Measurement of Web Strains

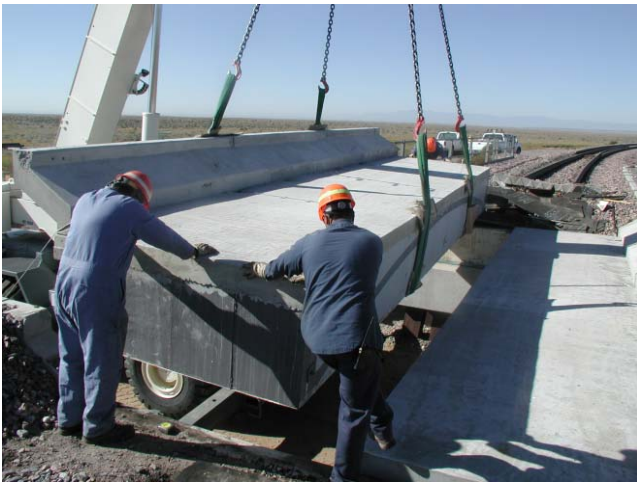
The span at FAST was comprised of eight HCB sections covered with a 6-inch deep reinforced-concrete deck. Each section was 28 inches deep by 20 inches wide. The eight sections were bolted together in two groups of four beams. The concrete deck was cast in two halves. The deck had both top and bottom bar reinforcement, in both the longitudinal and transverse directions. The span was installed in a similar fashion as is typically done with prestressed concrete spans, as Figure 3 shows. Note however, the use of slings as the original lifting loops were removed with the deck rehabilitation. Care was taken to avoid lifting too close to the center of the span.

Figure 3. Installation of HCB Span with New Deck at FAST

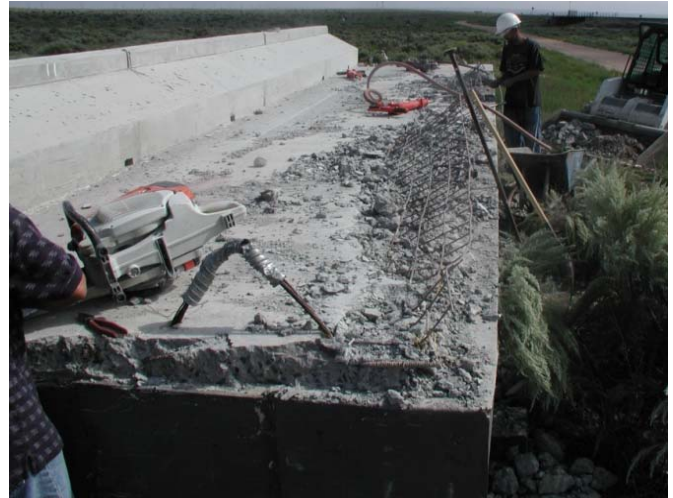
In order to conduct endurance testing on the HCB span, the original deck was removed, except for the portion over the outermost beam, in order to retain the ballast curb. Figure 4 shows the removal of the 4-inch deck.

Figure 4. Removal of 4-inch Concrete Deck

The initial 30-foot HCB prototype installed at FAST had a concrete deck only 4 inches thick, with minimal steel reinforcement (one layer of welded wire fabric). After a series of controlled tests and tonnage accumulation, the track was removed for deck inspection. The inspection revealed cracks in the concrete deck at both ends of the span.¹ The HCB sections themselves showed no signs of deterioration or damage.

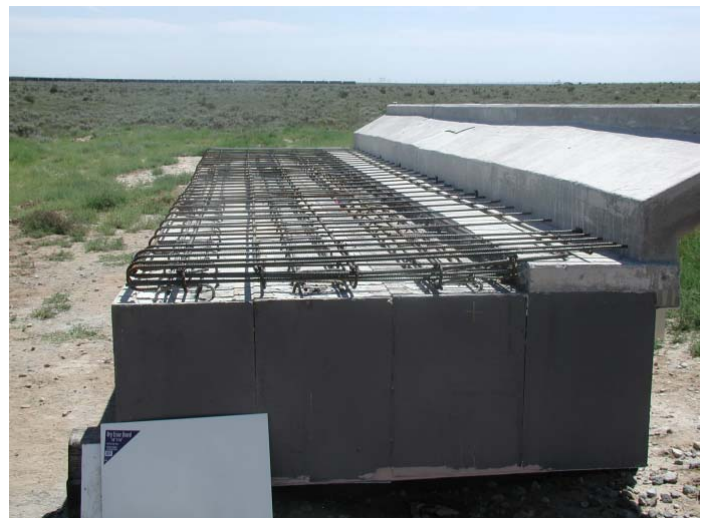
A new 6-inch concrete deck was cast. Figure 5 shows the ballast curb and the remaining portion of the original deck, including the new reinforcement. The new reinforcement pattern followed the BNSF-Union Pacific joint common standard design for prestressed concrete double-cell box girders of the same length, with top and bottom layers of reinforcing bars longitudinally and transversely. Top bars were continued over the portion of the original deck to help provide continuity in the deck. Figure 6 shows the 6-inch concrete pour.

Figure 5. Reinforcement for New 6-inch Deck

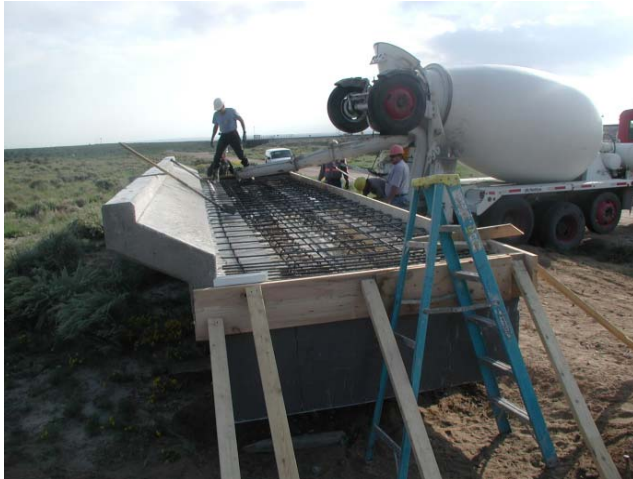
Figure 6. Concrete Pour for New Thicker Deck

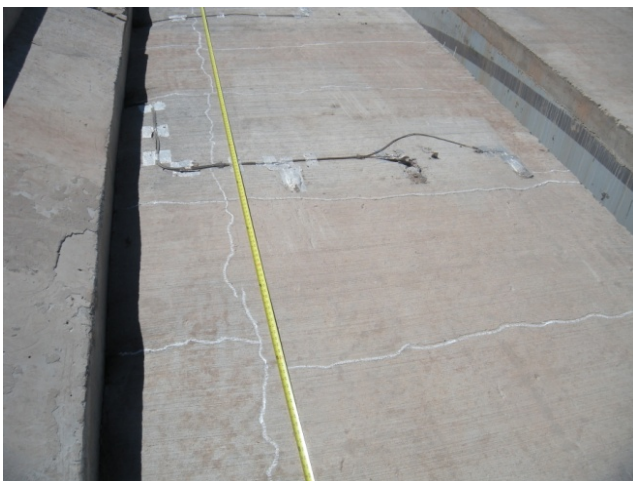
The HCB span was removed from FAST after 237 MGT of accumulated tonnage. No significant damage to the beams was visible externally; however, the deck showed some cracks running parallel and perpendicular to the ballast curbs. Figure 7 shows a crack running longitudinally for about the middle 15 feet of the 30-foot span on the span piece, which was on the high-rail side (outside) of the curve. This crack coincides with the joint between the old and new deck concrete. Some transverse cracks are also highlighted. The cross section view in Figure 8 shows how the longitudinal crack coincides with the deck joint on the outside span piece. These cracks appeared to be narrow and controlled, consistent with reinforced concrete. There were no areas where the cracking was as significant as that noted with the original deck.¹

Figure 7. Post-Test Cracks in High-Rail Span Piece

The low-rail (inside) span piece had fewer visible cracks and none as long or as wide as those in the outside span piece. The load on the high-rail side is higher under typical FAST train operations at 40 mph, which is faster than the balanced speed with an unbalance of almost 3 inches. The difference in loads between low and high rail is likely responsible for the differences in deck performance noted between the two pieces.

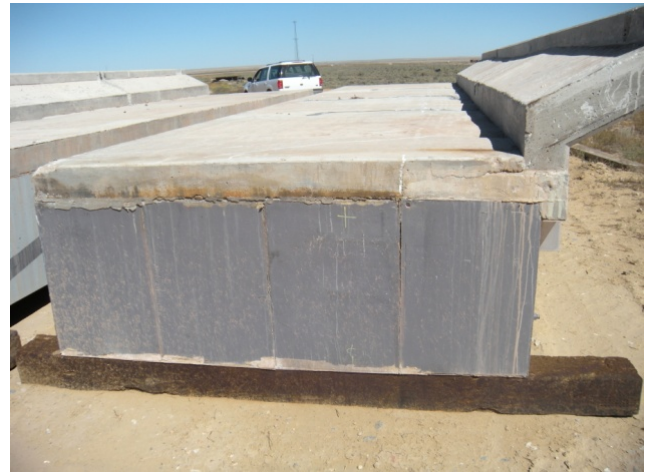
Figure 8. Cross Section Cracks in High Rail Span Piece
