In-Service Evaluation of Track-to-Wire Connections for Signals

Richard P. Reiff, Ted Hawken, and David D. Davis

Note: TTCI is reissuing TD-11-026 (August 2011) as TD-11-026 (Reissued Dec. 2011) because the track wire connections referred to in the originally distributed TD are being reclassified to better reflect the important variables in the test. This reclassification will assist railroad practitioners in determining which design features affect track wire performance. The new Table 1 more clearly describes the track wire connection design features tested.

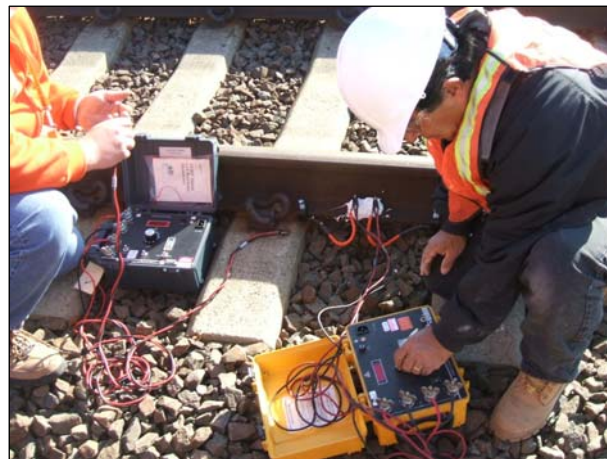
Samples of new and improved track wire connection technologies were installed in the track at FAST, Pueblo, Colorado, and were subjected to repeated loading of 39-ton axle load traffic. After one year of testing at FAST, examples of many of these technologies were installed at two revenue service sites. Each test installation included a pair of track wires connected to a central block to allow resistance measurements. Where feasible, at least two replications were installed for each type of technology. Resistance between the two studs was measured monthly to determine total electrical resistance (micro ohms) of each specific pair.

Figure 1. Resistance Measurement at the Amtrak Test Site

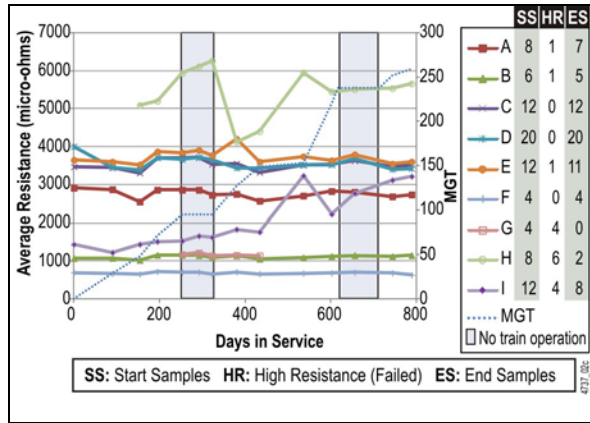
In 2008, approximately 20 different technologies were installed in track at FAST for testing. Suppliers donated materials and provided technical assistance for installation. Not all technologies were installed at the same time. Figure 2 summarizes resistance data collected after 750 days of in-track monitoring. Performance for each group, as shown here, is an average resistance through a pair of rail/wire connections. This was measured with two connections in series. Most technologies performed similarly during the test at FAST; base clamp and epoxy connections exhibited the most failures, and epoxy connections exhibited a continued increase in average

Figure 2. Summary of Average Resistance for Each Group of Connections Installed at FAST

In some cases, group averages show an increase and then a drop in average resistance, which indicates one or more connections either started to increase resistance or failed (failure is defined as resistance >20,000 ohms and/or mechanically separated from the rail). After the failed or failing connections were removed, the remaining samples produced lower average resistances.

Performance for each group is shown using the following code SS/HR/ES:

The code 8/1/7 for Group A, Wedge Pin Direct to Wire connections indicate eight samples installed, one failed by either falling off or developing a resistance >20,000 ohms, and seven remained in service at the end of test.

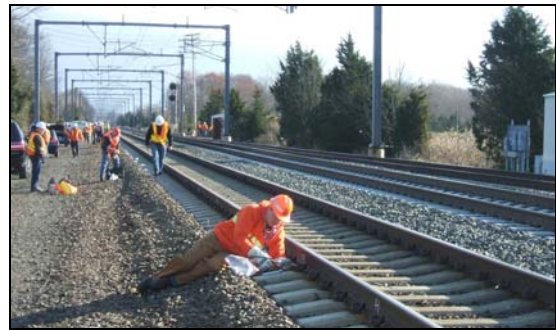
Figure 3. Amtrak Field Site near Guilford during Installation of Test Connections

Components under test at FAST are subjected to a heavy axle load train operating at 40 mph, but other issues may affect performance. Therefore, two revenue service sites were selected to install some of the same track wire connection technologies being tested at FAST. Sites on the Northeast Corridor (Figure 3) at Guilford, Connecticut, and Kingston, Rhode Island, were subjected to high-speed Amtrak trains operating up to 150 mph and salty ocean air. A second site on CSX, at Folkston, Georgia, was subjected to freight trains operating up to 60 mph and Amtrak traffic operating at 70 mph. Data collection identical to that at FAST was conducted monthly by the host railroads.

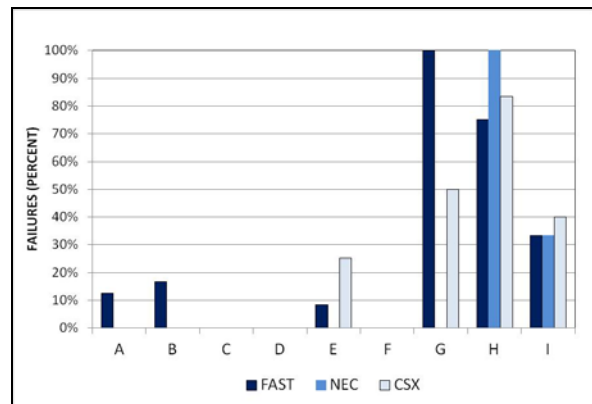
Figure 4 shows the percentage of failures to date of the original installations for the major technology categories at three test locations. Observations indicate epoxy technologies (Table 1 Group H), base clamps (I), and base brazed (G) exhibited the highest failure rates. It should be noted that the epoxy technologies are considered experimental. Base clamps were provided by a wide range of suppliers, with drive on, some screw on, and epoxy assisted experiencing failures.

Figure 4. Percent of Original Installation Failed during Testing To Date, By Location

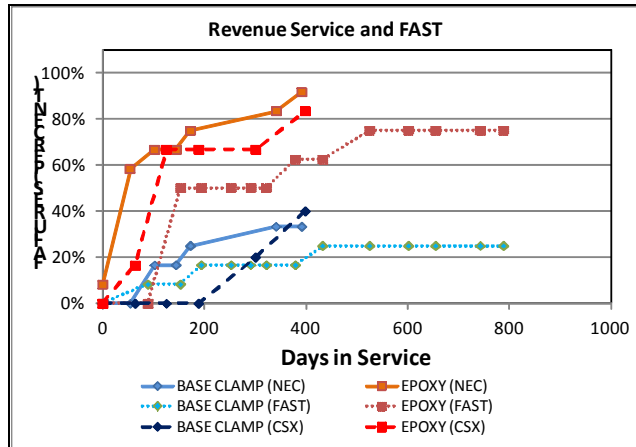
The effect of the service environment can be assessed qualitatively by comparing the performance of the same groups of products across the three test situations (FAST— heavy axle loads, dry climate; Northeast Corridor (NEC) — high-speed passenger, wet, corrosive climate; CSX—shared corridor, wet climate). Figure 6 shows the performance of base clamps and epoxies.

Figure 6. Base Clamp and Epoxy Failures versus Days in Service at Three Service Environments

From this comparison, it appears that the combination of higher frequency vibration from high-speed passenger trains and the salt spray environment is more severe than the heavy axle load environment at FAST.

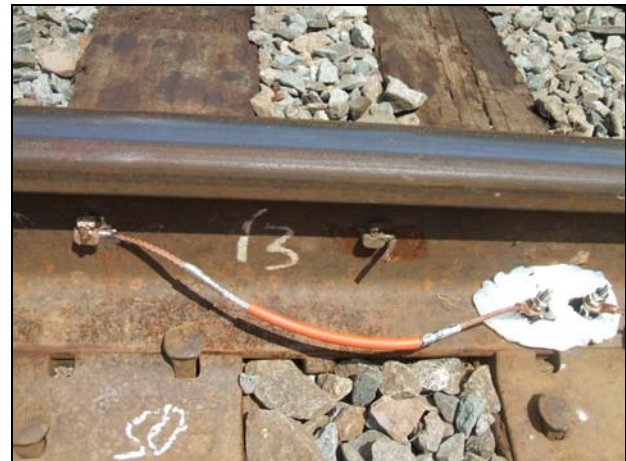
At one revenue service site, a tie maintenance crew went through the zone soon after installation, damaging or destroying most of the connections. Most of the surviving connections had damage to the wires, and several still had the rail attachment connected to the rail web; however, the wire was broken or pulled apart (Figure 7).

Figure 6. Replacement Wire Connection (Left) and Original Damaged Rail Attachment (Middle) after Passage of a Ballast Regulator

Although this required reinstallation and restart of the test, the post-maintenance condition pointed to the need for future development of damage resistant track wire connections. Damage from maintenance cannot always be avoided, and the need to move connection points (especially those associated with welding or elevated rail temperature) suggests a possible improvement by making connections with a “fused, repairable link.” By providing a breakaway location whereby the connection to the rail is not damaged, but sufficient wire remains to allow reattachment, could save considerable time during repair processes. To address this issue, TTCI conducted a number of pull tests in the laboratory to determine minimum wire breakaway strength. Results were reported in another *Technology Digest*.³
