# Characterization of a Vintage Riveted Steel Deck Plate Girder Bridge Span at FAST

Lucy Tunna, MaryClara Jones, and Duane Otter

## Summary

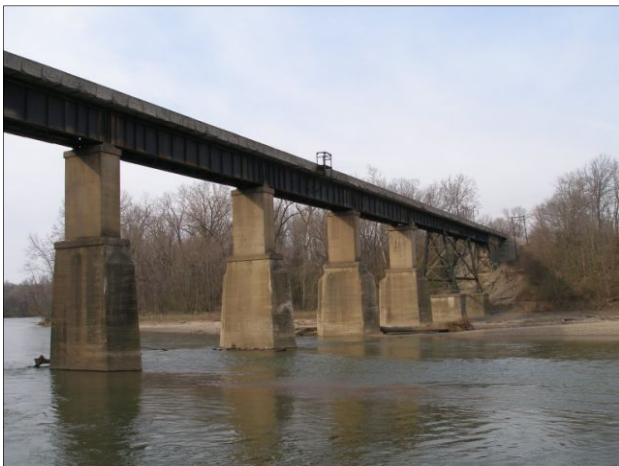
The 55-foot 5-inch span is a typical example of a riveted steel deck plate girder span, similar to many of the steel bridges still in revenue service today. Figure 1 shows the steel span in revenue service.

Figure 1. Vintage Riveted Steel Span in Revenue Service on NS

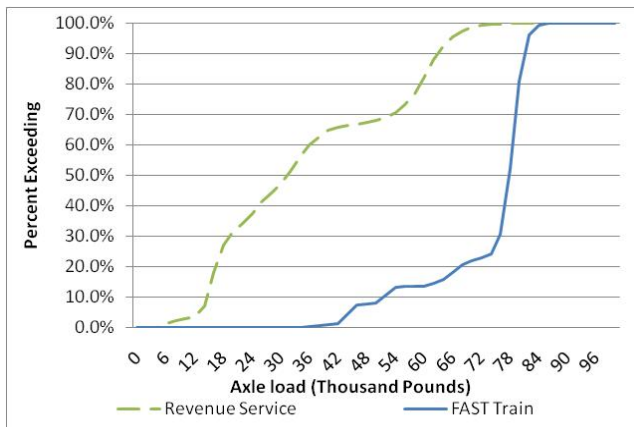
Prior to installation at FAST, the vintage riveted span carried very little HAL traffic when compared to HAL traffic at FAST. Approximately 75 percent of the traffic at FAST is heavier than any traffic measured on the vintage riveted span while it was in revenue service. Figure 2 displays the axle loads at FAST compared to revenue service. Figure 2 also shows the axle loads the 55-foot 6-inch welded steel span was carrying before it was removed.

Figure 2. Comparison of Cumulative Distribution of Axle Loads

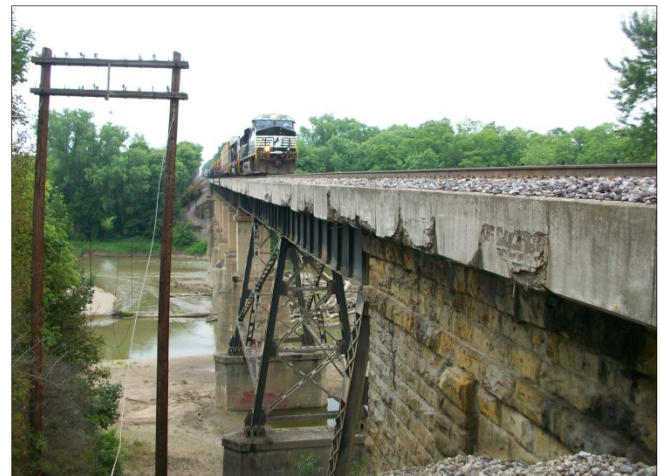
When installed in revenue service, the vintage riveted span had concrete floor pans and a ballasted deck, as Figure 3 shows. The live load with this deck was rated at Cooper’s E-42, following AREMA Chapter 15 recommended practice.<sup>1</sup> When the span was installed at FAST, it was installed as an open-deck span, with ties directly supported by the steel girders, as Figure 5 shows. With the open deck, the live load rating increased almost 50 percent to Cooper’s E-61, including a 10 percent reduction for corrosion. For comparison, the previous welded steel span at FAST rates at Cooper’s E-89. The loading of the HAL train is equivalent to Cooper’s E-62. Figure 4 compares the ratings with the HAL train loading. Currently, the HAL train at FAST is running near the limit of calculated span capacity.

Figure 3. 1912 Vintage Riveted Span with Ballasted Deck on NS

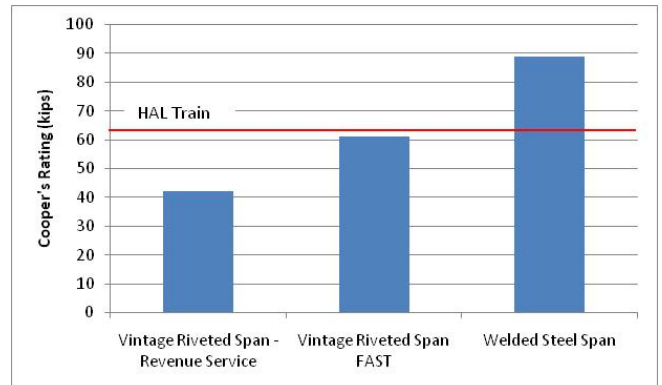
Figure 4: Ratings for Vintage Riveted Span and Welded Steel Span Compared to Cooper Equivalent Loading for HAL Train

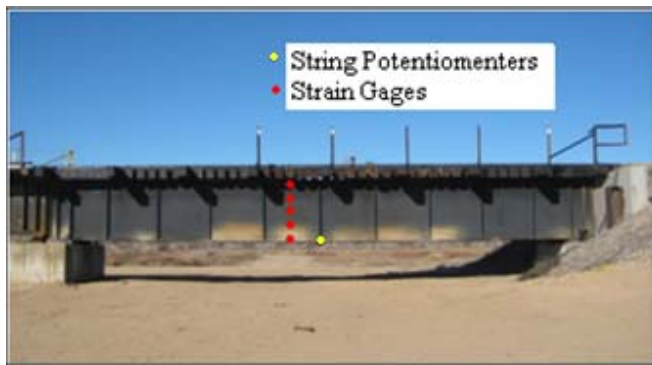
Mid-span deflections were measured using string potentiometers attached to the bottom of the span. Strain gages were attached near mid-span at the top and at the bottom of both girders to determine peak stresses. Also, strain gages were placed near 1/4-, 1/2-, and 3/4-heights on the web of the span to determine the effects the conversion from ballasted deck to open deck had on bending stress distribution.

Figure 5 displays the vintage riveted span installed at FAST and the location of the instrumentation.

Figure 5. Vintage Riveted Span at FAST

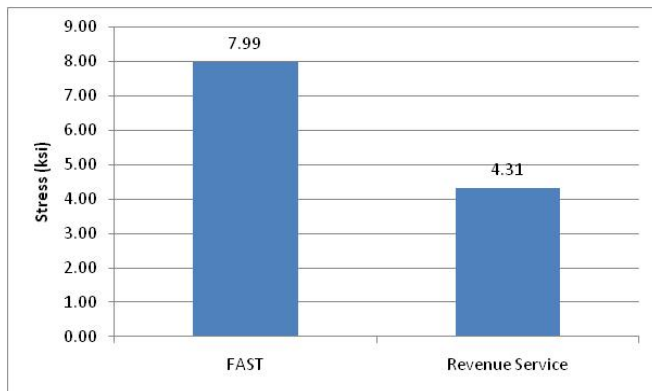
Figure 6 compares the average peak stresses in the vintage riveted span measured at FAST and in revenue service. As expected, because of the higher axle loads at FAST, the corresponding stress is higher. The typical peak live load stresses experienced at FAST are about 80 to 90 percent greater than those in revenue service.

Figure 6. Comparison of Average Peak Live Load Stresses for Vintage Riveted Span

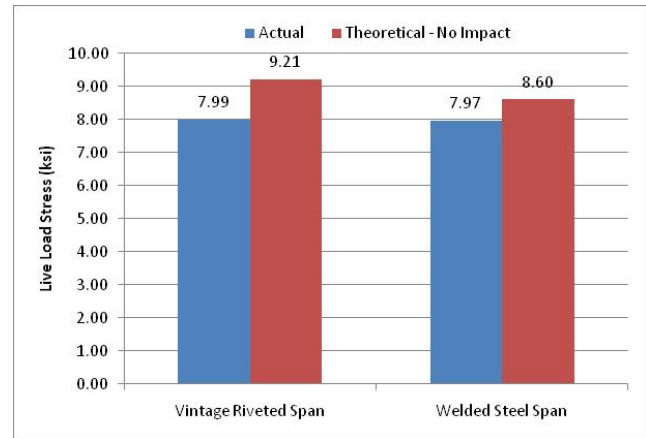
Theoretical stress values were calculated using conventional bending beam models. Because the test train at FAST has no flat wheels, no rail joints on the span, and the bridge approaches were smooth, no impact was included in the theoretical calculations. Figure 7 compares the measured stresses in the vintage riveted span and the previous welded steel span to theoretical values. Note that stresses were measured over a limited time period, and over the life span of the bridge, higher impacts and stresses can be expected.

Figure 7. Comparison of Typical Peak Stresses of Vintage Riveted Span and Welded Steel Span at FAST

The measured stress values are about 7 to 15 percent less than the theoretical calculated stress values for both the vintage riveted span and the previous welded steel span. Similar results have been reported by Sweeney et al.<sup>2</sup> Some possible contributing factors include partial fixity of the bridge bearings and distribution of wheel loads by the rails.

Information provided by NS and Conrail indicates that the yield strength of the steel in the vintage span is 30 ksi and in the welded span is 36 ksi. So while the live load stresses in each span at FAST are similar, they are 20 percent higher in the vintage riveted span as a fraction of the yield strength.

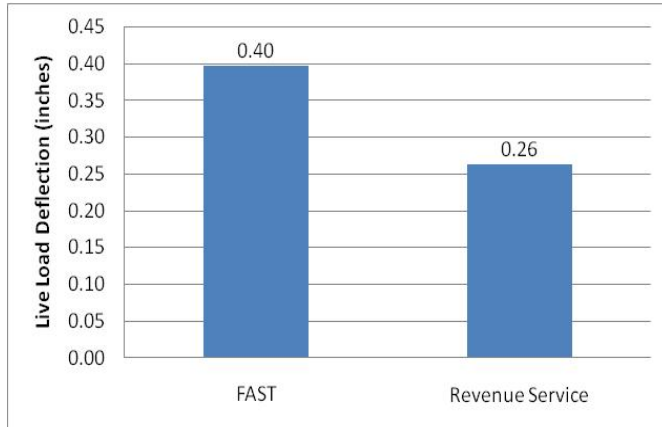
Comparison of the mid-span live load deflections at FAST to revenue service indicates the span had smaller deflections in revenue service than at FAST, as expected. This is due primarily to the heavier axle loads operated at FAST. It might also be due in part to additional span stiffness from the concrete floor pans supporting the ballasted deck. In revenue service, the span experienced many lighter weight and empty train cars. Figure 8 displays the typical measured peak deflection and calculated deflection for the vintage riveted span. The mid-span deflection of the vintage span at FAST is approximately 50 percent greater than the deflection of the span in revenue service.

Figure 8. Comparison of Mid-Span Live Load Deflections for Vintage Riveted Span

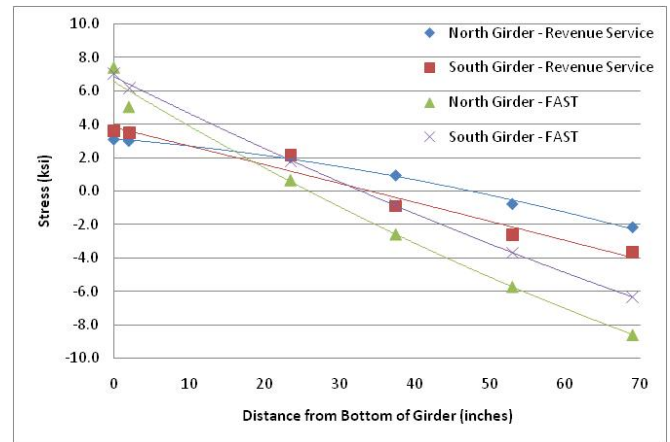
When the vintage span was in service on the NS, five strain gages were attached to each girder near mid span. These gages were placed on the bottom angle, near 1/4 height, near 1/2 height, near 3/4 height, and on the top angle. Figure 10 shows the results from these strain gages from the bottom of the girder to the top. Note that the neutral axis (location of zero bending stress) is lower in the span at FAST than it was in revenue service. This is most likely due to composite action of the concrete floor pans while the span was in revenue service. With the concrete floor pans removed for service at FAST, the resulting neutral axis shifted lower. Because more of the steel

is in compression without the floor pans, bracing becomes more important to provide stability to the span. The presence of the concrete floor pans in revenue service provided redundancy in the case of corroded or missing bracing.

Figure 10. Stresses at Mid-Span of Vintage Riveted Span
