Development of Automated Inspection of Structural Components Algorithm

Jim Robeda, Kari Gonzales, and Mary Clara Jones

Summary

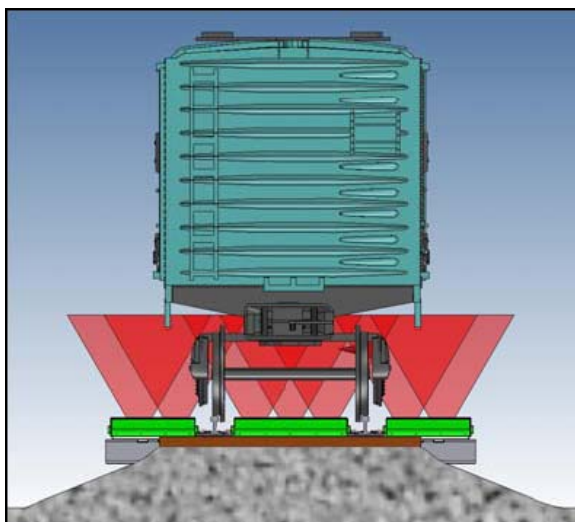
Figure 1. AISC Camera Schematic

Figure 1 shows a graphical representation of the AISC camera placement. Figure 2 shows the AISC installation at Gallup, New Mexico. Algorithm development to fully automate the system is currently under way.

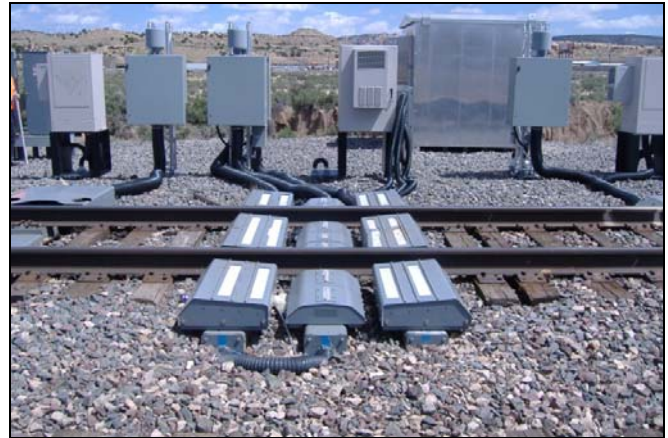
Figure 2. AISC located at Gallup, NM

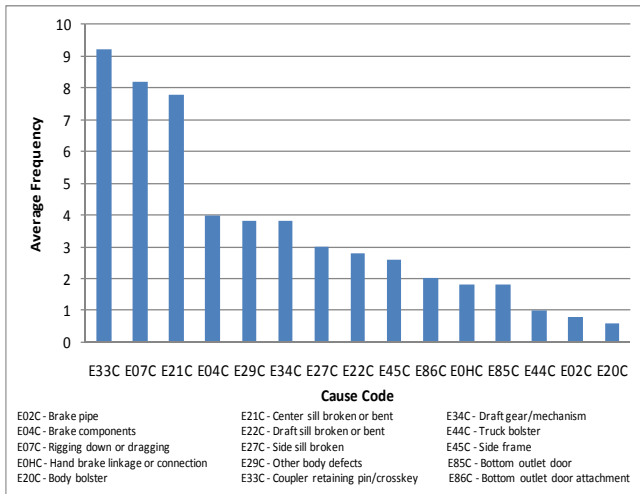
Data from FRA accident statistics was used to generate a comprehensive list of accidents for approximately the past 5 years.¹ Figure 3 is a plot of the average number of accidents per year between 2006 and November of 2010 in rank order.

Figure 3. Average FRA Accidents per Year between 2006 and 2010

A risk assessment model was completed using the combination of data shown in Figures 3 and 4. Data from each of the figures was given a rank based on the number of accidents per year for each cause code and the average cost per accident. Next, the product of the two ranks was calculated to determine a score or severity index. This orders the cause codes by risk. The lower the score, the more risk.

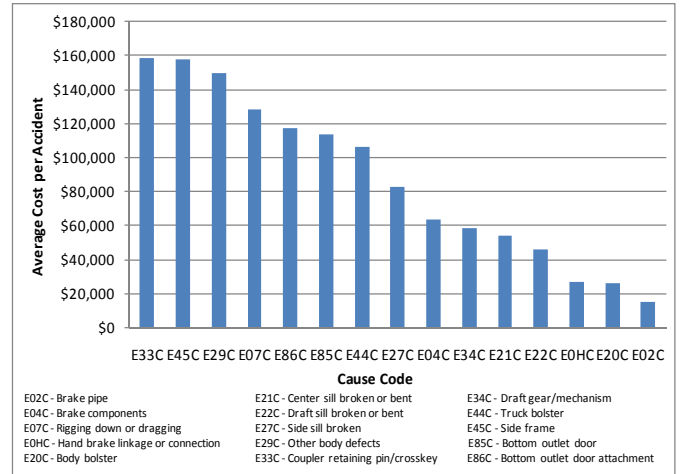
The FRA accident data was queried for cost for those cause codes identified.¹ Each accident listed in the FRA accident data gives an accident damage cost. The total accident cost per year for each accident cause code and the average count per year were used to calculate an average cost per accident.

Figure 4 displays the average cost per accident since 2006 in rank order.

Figure 4. Average Cost per Accident

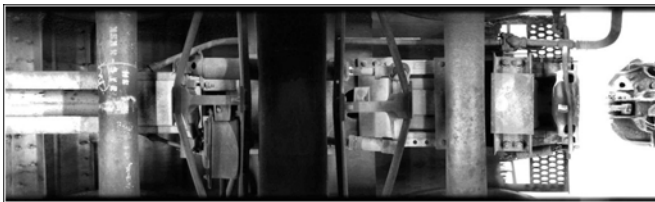
Figure 5 shows an AISC generated image of a railcar undercarriage. The image is enhanced by the algorithm using a well-established technique called histogram equalization.

Figure 5. Enhanced AISC0-Generated Image

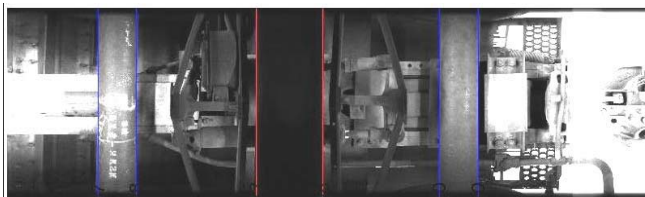
Figures 6 and 7 show the initial steps for algorithm detection of the axles, truck bolster and brake beams. These parts are well defined by edges and geometric features that can be exploited for successful detections.

Figure 6. Edge Detection of Axles and Truck Bolster

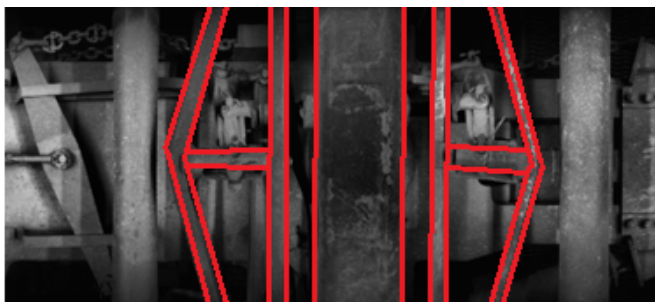
Figure 7. Classification of the Bolster and Brake Beams
