High Performance Wheel Test: 158,000-mile Interim Results

Summary

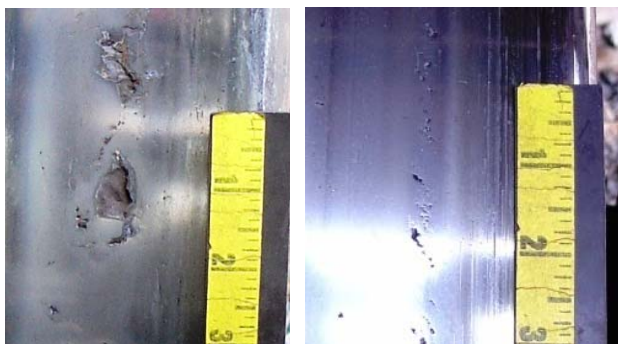
- “Medium Shells” — at least one shell with a minor axis (smallest dimension) larger than 1/8 inch
- “Small Shells” — visible shells, but none with a minor axis of 1/8 inch or larger
- “Large RCF Cracks” — visible RCF cracks at least 3/4 inch in length
- “Small RCF Cracks” — visible RCF cracks shorter than 3/4 inch in length
- “Excellent Condition” — no visible shells or RCF cracks

Figure 1 shows representative photographs of medium and small shells. Table 1 is a categorized summary of the wheel tread conditions. Figure 2 shows the categorized percentages of unspalled wheels per wheel type. None of the wheels inspected had shells large enough to be deemed condemnable under AAR rules. Recent data from a wayside wheel profile detector was not available for analysis. In future inspections, TTCI personnel will take wear measurements during the inspection to facilitate wear evaluations between the different wheel types.

Figure 1. Medium Shells (left) and Small Shells (right) with an Inch Ruler for Size Reference

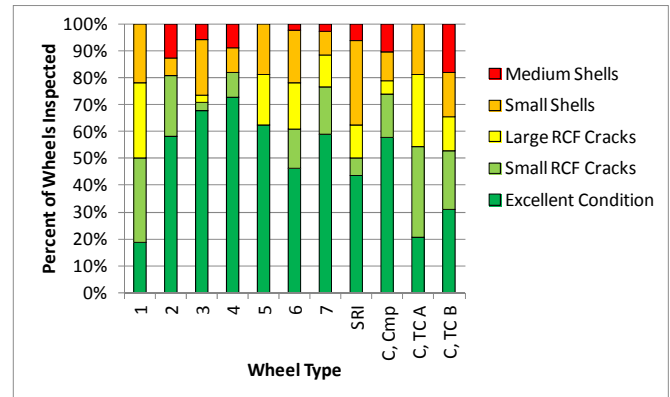
Figure 2. Tread Condition of Wheels in Revenue Service Test

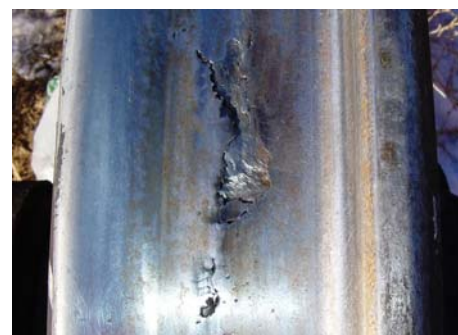
TTCI personnel inspected the entire circumference of all 48 wheels in the durability test after 73,000 miles (the SRI wheels have approximately 8,000 fewer miles than the other wheel types). No spalling or evidence of wheel slides was found. One Type 5 wheelset was removed at 68,200 miles due to a large shell approximately 2.5 inches long by 0.75 inch wide that was producing impact loads of 87,000 pounds. The mate wheel was in excellent condition. Figure 3 shows a photograph of the wheel tread surface.

Figure 3. Shell on Type 5 Wheel

- Type 1 and Type 6 wheels both show higher tread wear rates, and half of the Type 1 and Type 6 wheels have developed medium sized shells.
- One Type 5 wheelset was removed due to large impact loads from a shell at 68,200 miles.

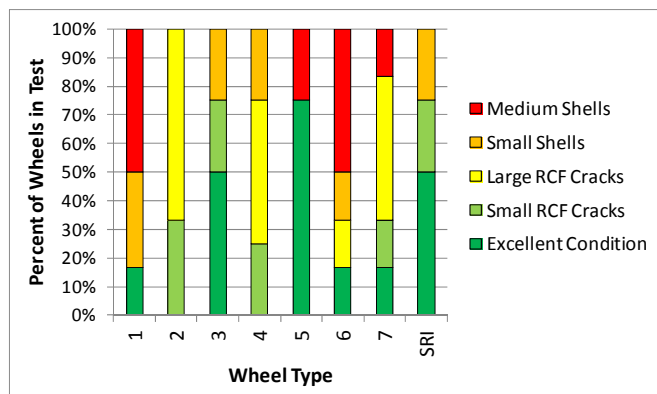
Table 3 is a categorized summary of the wheel tread conditions of all of the wheels in the durability test. Figure 4 shows the categorized percentages per wheel type. Fourteen of the 40 high performance wheels in the durability test have developed small or medium sized shells. Each car in the durability test contains at least one wheel with small or medium sized shells. The two cars loaded to 286,000 pounds GRL have seven wheels with small or medium sized shells. The two cars loaded to 315,000 pounds GRL also have seven wheels with small or medium sized shells.

Figure 4. Tread Condition of Wheels in Durability Test

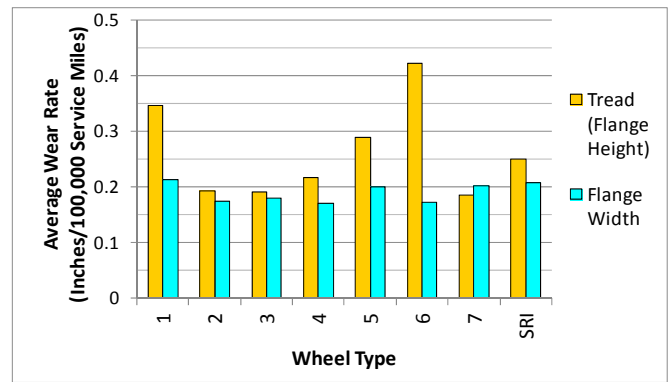
Figure 5 shows the wear rates of the wheels in the durability test based on hand measured wheel profiles. Type 6 wheels (bainitic) show the highest average tread wear rate. The Type 1, Type 5, and SRI wheels show somewhat higher average tread wear rates. Type 2, Type 3, and Type 7 wheels have the lowest average tread wear rates. All wheels show comparable average flange wear rates. Results from the durability test should not be considered as significant as the results from the revenue service test, because of the small sample size and unique operating characteristics at FAST.

Figure 5. Wear Rate of Wheels in Durability Test
