# Evaluation of Alternative Open Deck Bridge Ties at FAST

Duane Otter and Lucy Tunna

## Summary

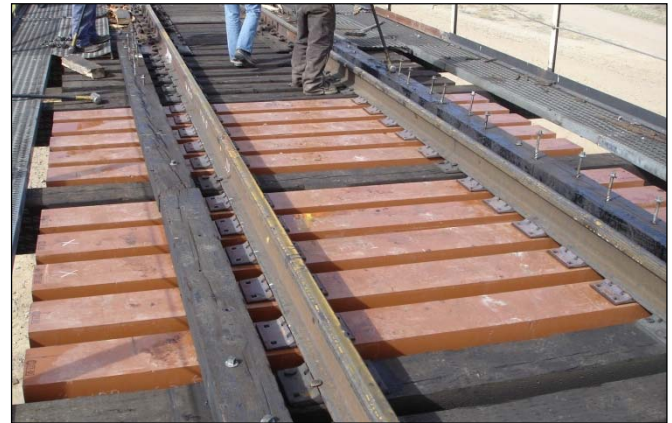
Figure 1 shows the tie layout for the FFU ties. Note that there is one 18-foot long Douglas fir walkway support tie separating two adjacent 5-tie panels.

Figure 1. Bridge Deck Tie Tests on Vintage Span

The Douglas fir glulam ties are installed in two similar panels at the east end of the span.

TTCI fastened the ties to the steel girder using hook bolts every fourth tie. Rail and tie plates were fastened using cut spikes. All ties were fastened to an outside spacer timber with lag screws. Note that this installation is typical of North American bridge installation practice; in this case closely following plans used by Norfolk Southern, the donor of the vintage span.

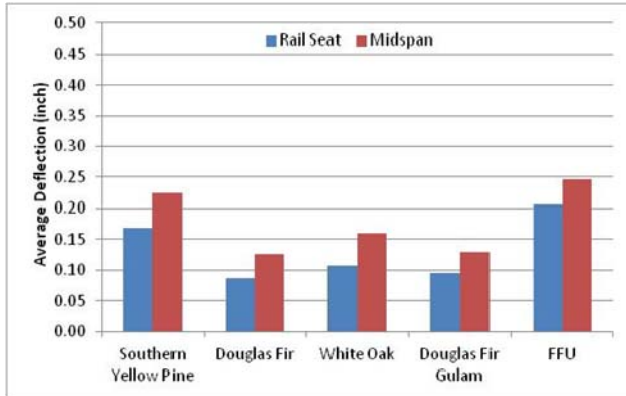
Figure 3 shows the average deflection values at center of tie and beneath the rail seats for two different ties of five various types: southern yellow pine, Douglas fir (solid sawn), white oak, Douglas fir glulam, and FFU. These deflections are all within the recommended range of values for alternative bridge ties.<sup>3</sup> The Douglas fir glulam ties are slightly stiffer than the white oak ties. The FFU ties are slightly less stiff than the southern yellow pine ties. The Douglas fir glulam ties have essentially the same deflections as the Douglas fir solid sawn ties. As expected, the tie center deflections are greater than those under the rail seats for all tie types. The deflection values measured at FAST for the various tie types reflect the same relative deflection trends as measured in laboratory tests.<sup>4</sup> This trend provides additional support for the recently recommended laboratory guidelines.<sup>2</sup>

Figure 3. Average Deflection of Various Solid Sawn Timber and Alternative Ties under FAST Train

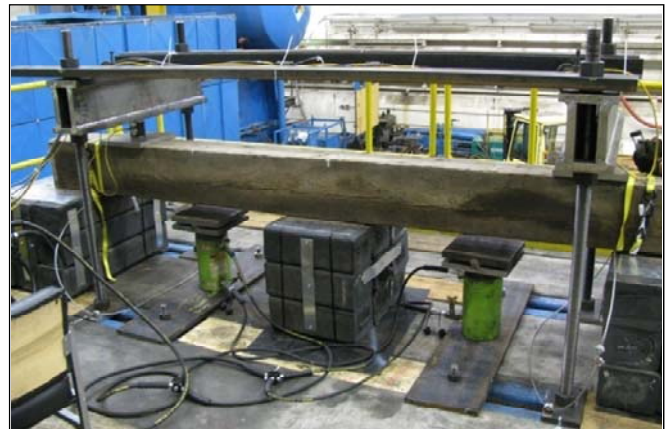
A test rig, based on one designed by Sweeney and Madsen,<sup>6</sup> was set up in the laboratory (Figure 6). The test rig simulates the girder spacing of the span and load points of the rail. Spacing of the reaction points was set up to replicate center-to-center girder spacing (8 feet). Spacing of the load points was 60.0 inches for standard gage track.

Figure 6. TTCL Laboratory Test Rig

For both the Douglas fir glulam ties and the FFU ties, two randomly chosen ties were tested in the laboratory. These ties were checked for defects before testing. A deflection test and a design load test were performed in the laboratory. Each test was performed twice, once with the load applied in approximately 2 to 5 minutes and once with the load applied more slowly, over 20 minutes.

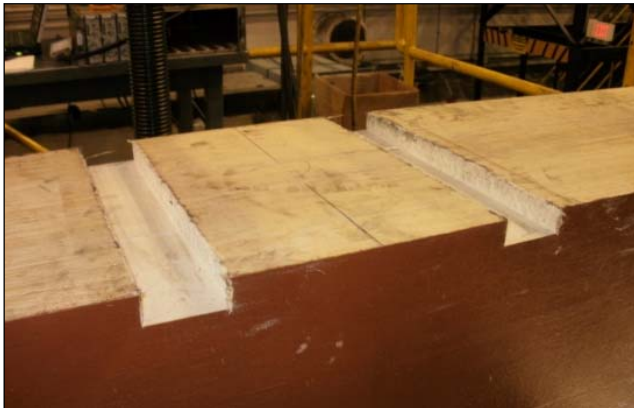
After these tests, the bottoms of the FFU ties were milled so they would fit over the protruding rivet heads on the top surface of the vintage girder on the bridge at FAST, where they were installed for in-service testing. Figure 7 shows the milling for one girder flange on the bottom side of an FFU tie. There are two lines of rivets on each of the top flanges. The milling pattern allows for the ties to move longitudinally along

the top flange. During installation at FAST, the milling facilitated quick and accurate lateral location of the ties on the girders. The milling of the FFU ties to clear the rivets was done based on the vendor's recommendation. None of the timber ties installed on the span were milled. The timber ties were set directly on top of the rivets and allowed to seat under train traffic.

Figure 7. FFU Tie Milled to Clear Rivet Heads on Top Flange

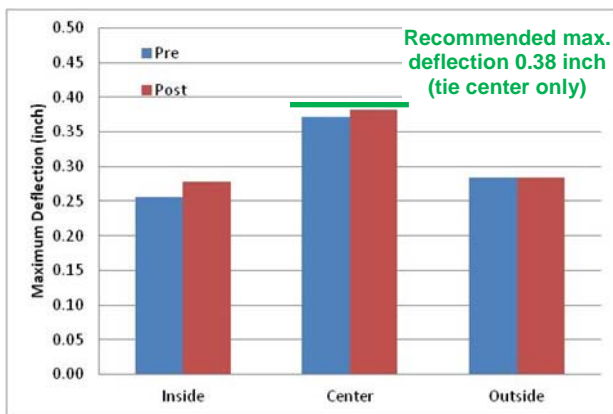
After milling, the ties were tested again in the laboratory before being installed at FAST. Figure 8 shows the deflection differences for one FFU tie before and after milling. Testing of a second FFU tie yielded similar results. Under the live load of 27,000 pounds, both ties stayed below the recommended maximum deflection of 0.38 inch for tie center deflection for an 8-foot girder spacing. Both FFU ties provided tie center deflections greater than the 0.11-inch recommended minimum for an 8-foot girder spacing. Both ties also performed well under the 53,000-pound load. No damage was observed.

Figure 8. FFU Tie 1 Deflections under 27,000 Pounds, 2-5 Minute Loading, Before (Pre) and After (Post) Milling

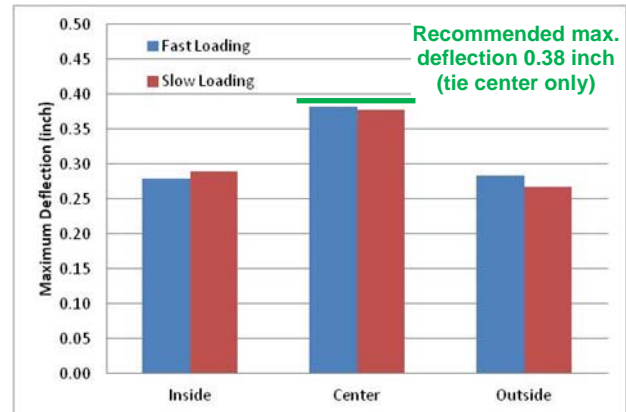
Figure 9 shows the difference in deflection when the ties were loaded slowly (20 minutes) and when the ties were loaded more quickly (2-5 minutes). There is no significant difference in the performance of the ties at the two loading rates.

Figure 9. FFU Tie 1 Deflections under 27,000 Pounds, Post Milling, at Two Loading Rates
