# Investigation of ‘Fail-to-Couple’ Events in Hump Yards

Devin Sammon and Kari Gonzales, TTCI  
Jake Hunter, CSX

## Summary

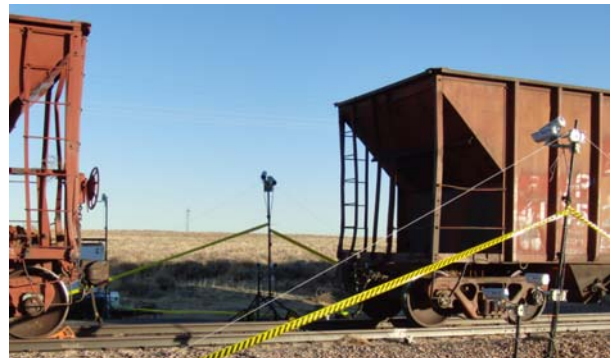
Figure 1. Eight Stationary Wayside Cameras

Nine stationary cameras were used to capture each impact, including one below the couplers at the impact site. In conjunction with these nine cameras, three additional cameras

were attached to the impact car using magnets. Figures 1 and 2 show the location of the stationary and car-mounted cameras, respectively.

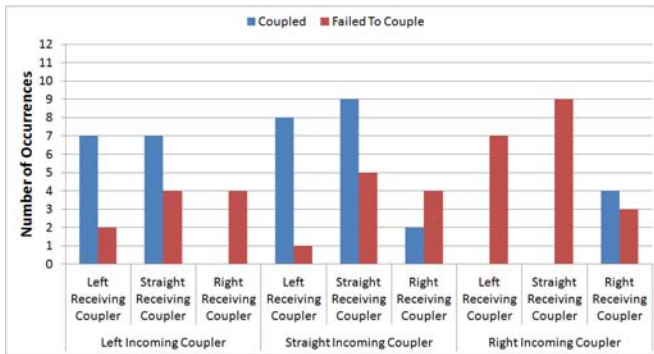
Results from the testing indicate that one of the major contributors to FTC events is the incoming coupler position. Figure 3 is a summary of the results based on coupler position. The y-axis shows the number of occurrences of coupled (blue) and FTC (red) events. The x-axis indicates the test condition. The plot shows that when the incoming coupler is shifted to the right, there is a lower percentage of successful couplings. The only exception to this observation is when both incoming and receiving couplers are shifted to the right.

Figure 3. Test Results Based on Coupler Position

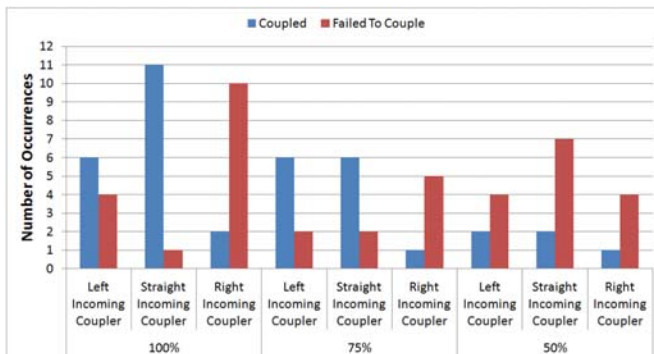
Knuckle position also proved to be a critical variable in FTC events. Figure 4 shows the test results based on the radial position of the knuckle. Results indicate that as the incoming knuckle is more open, the potential for coupling increases significantly. The plot also reinforces the observation that when the incoming coupler is shifted to the right, it is unlikely that the cars will couple correctly.

Figure 4. Testing Results Based on Incoming Knuckle and Coupler Position

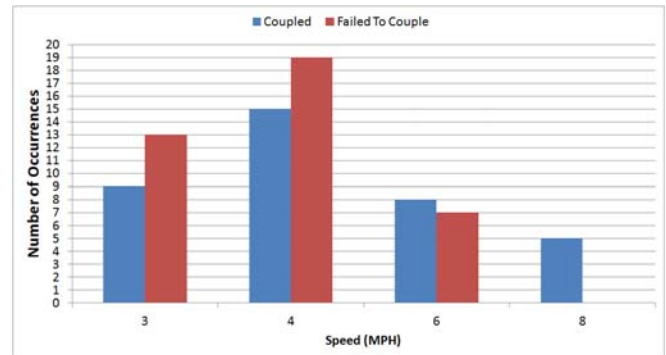
Figure 5 shows the test results with respect to incoming car speed. The plot shows a large number of FTC events at lower speeds. These results are directly influenced by the type of testing conducted at the lower speeds. The majority of the slower speed tests was done with position variations of the

coupler and knuckle that created increased FTC conditions (e.g., incoming coupler to the right and knuckle closed). In contrast, the higher speeds show a higher instance of coupling. Again, these results may be skewed, because most of the tests conducted at higher speeds were done with variations that were successful at lower speeds. A critical observation from the testing at various speeds is that coupling at higher speeds causes more damage to the components and vehicle. Additional testing planned for 2012 will isolate speed from coupling system positions to better determine the influence of speed on FTC events.

Figure 5. Testing Results based on Incoming Car Speed

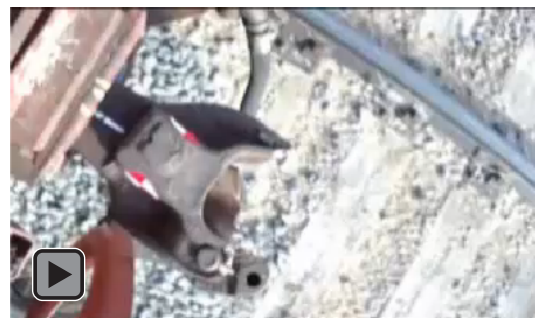
A total of five components broke during tests at speeds greater than 4 mph. The damage included cracked striker plates, broken brake hose castings, broken uncoupling levers, and a cracked coupler. Two major delays were encountered during testing. First, a draft gear was broken after repeated runs at higher speeds. The second delay was encountered during a 6 mph run with the incoming coupler shifted to the left and the receiving coupler shifted to the right. The couplers slipped past the knuckle, and both couplers made contact with the opposite car's brake hose, severing both brake hoses. Video 1 shows the test run.

Video 1. Test Run Resulting in Broken Brake Hose Castings

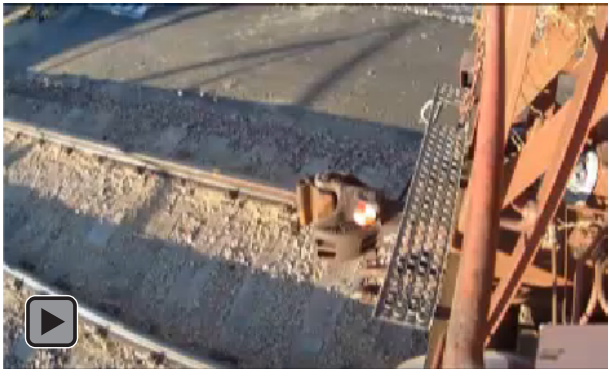
A coupler bypass also occurred. For this test, the incoming coupler was shifted to the right, the receiving coupler was shifted to the left, and the knuckle was 100 percent open.

At a speed of only 3mph, these two couplers made contact between the heel and front face of the knuckles. Contacting in these regions caused the two couplers to bypass and contact the opposing striker. As a result, the two cars were slightly lifted from the track, and the couplers were stuck together.

Video 2 shows the result of the test. Several attempts were made to pull the cars apart with two locomotives, but the couplers remained stuck. After the failed attempts to remove the bypass with motive power, one of the coupler heads was torch-cut from the shank to alleviate the bypass. Although statistics on bypassed couplers are unknown at this time, it is obvious that this type of event can be extremely costly in terms of train delays, component costs, and overall safety.

**Video 2. Coupler Bypass Event**

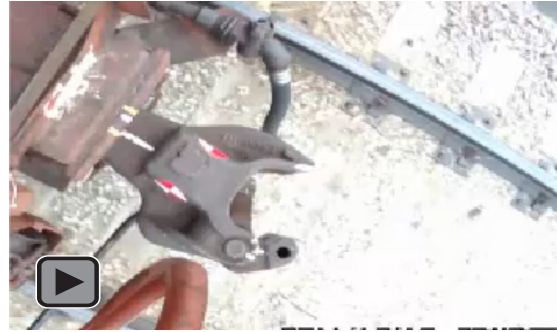
A final observation made from the tests performed at TTC is that there is a small window that determines whether or not a particular system will couple. Videos 3 and 4 show the influence of small changes on the coupling result. The figures compare two test runs using the following conditions:

- Incoming knuckle 75 percent open
- Incoming coupler shifted to the left
- Receiving knuckle closed
- Receiving coupler straight
- 4 mph test speed

The cars shown in Video 3 successfully coupled while the cars in Video 4 did not. This scenario emphasizes that small variations in alignment can have a large influence on the ability for two cars to couple.

**Video 3. Coupling Event**

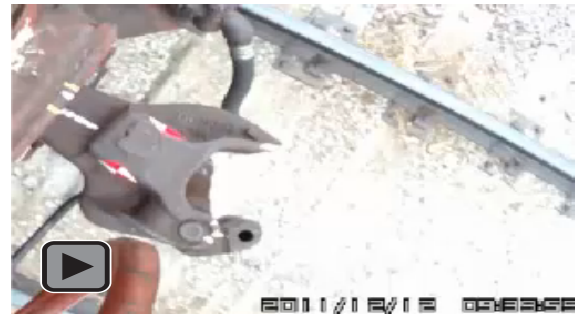
**Video 4. Fail-To-Couple Event**
