Evaluation of Ultrasonic Impact Treatment for Steel Bridge Weld Details

Lucy Tunna, Richard Joy, and Duane Otter

Summary

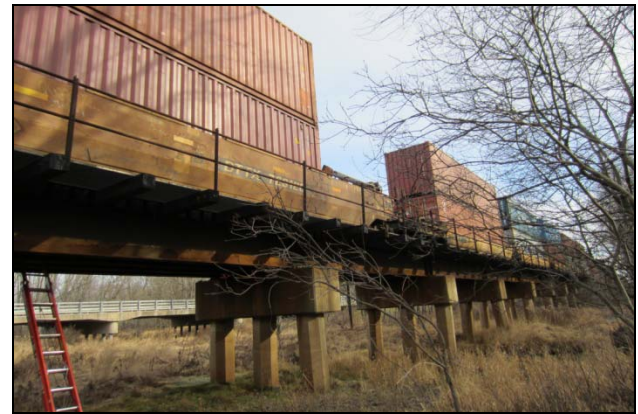
Figure 1. CN Test Bridge near Stevens Point

To test UIT effectiveness in preventing fatigue cracks, a 16-span steel bridge on CN near Stevens Point, Wisconsin, was selected (Figure 1). This bridge has approximately 200 weld details. Some of these details had existing cracks prior to the beginning of the test.

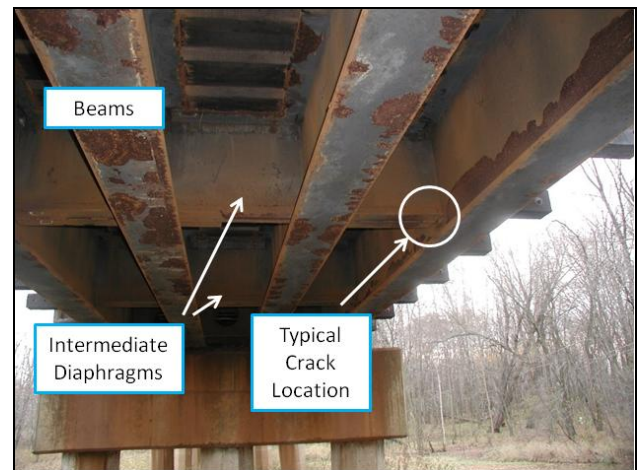
Figure 2. Underside of Test Bridge Showing Location of Weld Details

Figure 2 shows the typical crack locations, where the diaphragms are welded to the main beams. This bridge is an ideal candidate for this testing, because it had already accumulated a significant number of fatigue cycles, as evidenced by the existing cracks. The numerous existing fatigue cracks at the stiffener toe details indicated a high probability for additional crack initiation.

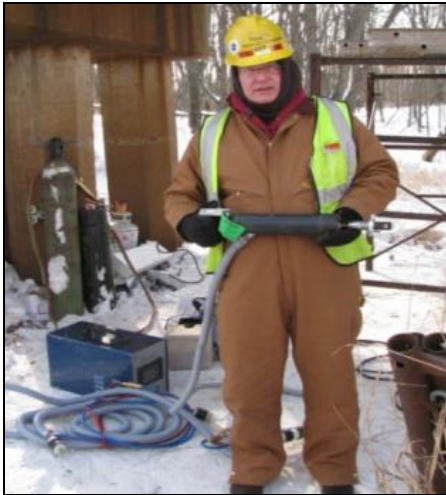
Figure 3. Handheld UIT Tool and Related Equipment

UIT is applied using a handheld tool. The equipment is portable and can be carried by hand. Figure 3 shows the tool and related equipment. Figure 4 shows UIT application. Figure 5 shows a treated weld detail. For this bridge, all work was performed on the underside of the bridge and between train passages, removing the need for work windows or temporary track outages.

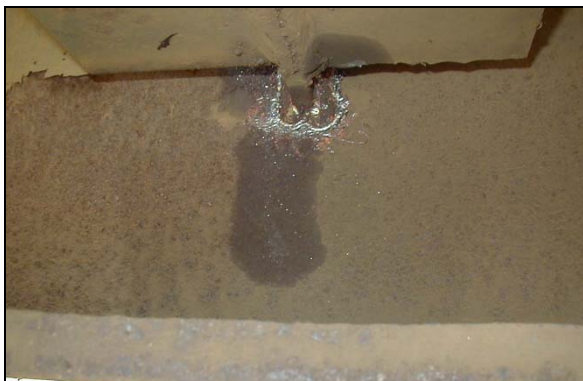
Figure 5. Treated Weld Detail

The interior beams of each span contain stiffener toes on either side of the beam. For these stiffeners, both sides of the web were treated for beams located on the west side of the bridge, and only the outside stiffener toe of the beams located on the east side of the bridge were treated. This difference in treatment process was carried out to test the effectiveness of one-sided versus two-sided treatment.

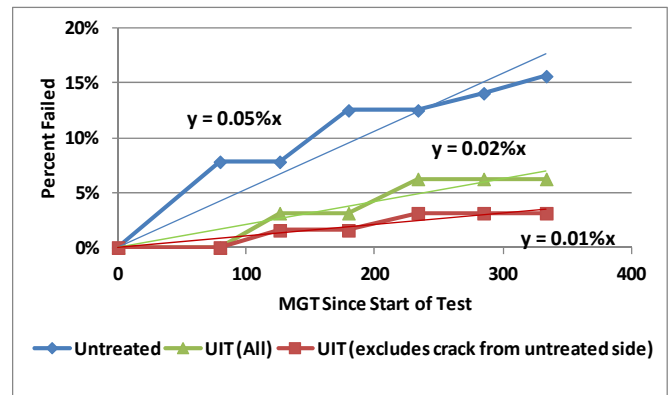
Figure 6. Failures — UIT for Crack Initiation Prevention (0 to 350 MGT)

Figure 6 shows a summary of failure rates from 2005 to 2011. A total of 10 cracks were found in untreated details and 4 cracks were found in UIT details. One of the cracks in a UIT detail was in a location that was only treated on one side of the web. The crack initiated on the untreated side and propagated through the web. Results indicate that the failure rate for treated details is up to 80 percent better than for untreated details.

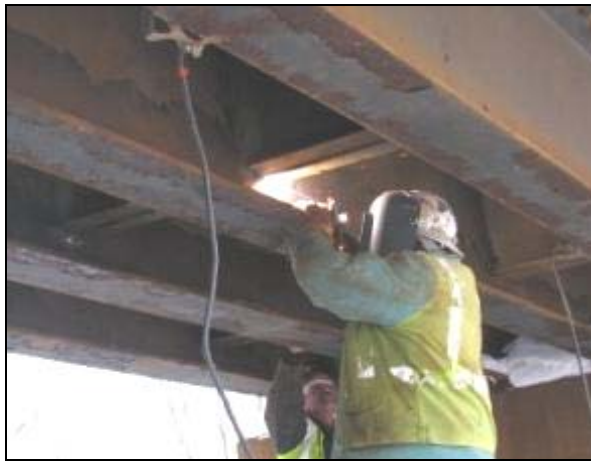
Figure 7. Welder Repairing Cracked Detail

As of the December 2011 inspection, one of the untreated weld repairs had cracked, while none of the UIT repairs had cracked. These results are encouraging, although the accumulated tonnage is still relatively low compared to that expected during the life of the bridge. Inspections are expected to continue annually until definitive conclusions can be drawn. Figure 7 shows a welder making repairs. Figure 8 shows a weld repaired detail after UIT.

Based on the success of the UIT application after 4 years of service, bridge engineers asked if UIT could be used in conjunction with repair welds to extend the life of a steel span. To address this issue, CN and TTCI engineers developed a weld repair plan and test plan, using four spans of this bridge containing several cracks. Weld repairs were made to 24 cracked weld details. Half of these repairs were then treated with UIT. The other half were left untreated to serve as a control. All work was done from the underside of the bridge with no train delay or bridge outage required.

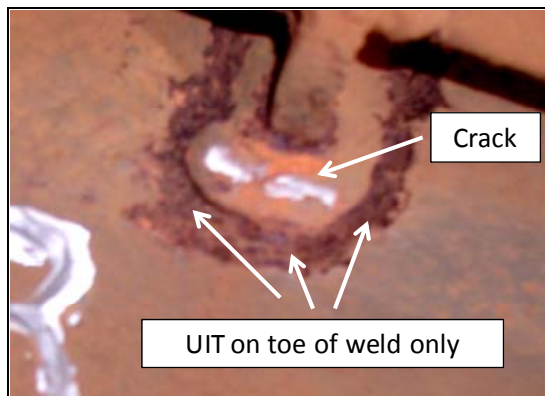
Figure 9. UIT Application on Toe of the Weld Only

In the 4 years since the original UIT was applied, the provider has made improvements in the procedure, resulting in a more extensive and thorough UIT application. The original application was at the toe of the weld only. Figure 9 shows an example, with a crack originating in the untreated portion of the weld. The vendor now recommends more thorough treatment including the entire weld and surrounding parent metal such as applied to the weld repair shown in Figure 8.
