# Evaluation of Prototype Switch Point Running Surface Profiles for Heavy Axle Loads

Huimin Wu and David Davis

## Summary

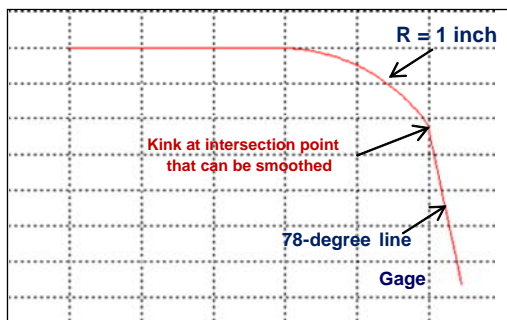
The new three circular arc design was shown in TD-10-011.<sup>1</sup> In order to simplify the machining process and use an existing cutting tool, a simplified design was also provided, as Figure 1 shows. This profile has a 1-inch radius at the switch point gage corner. It maintains the 78-degree gage side cut and has a flat top (or 1:20 slope) cut that is tangential to the 1-inch radius arc. Because the 1-inch radius arc is not tangential to the 78-degree line, it creates a visible intersection of the curved and flat surfaces that can be smoothed during production. This switch point should quickly wear into a conformal shape with the commonly worn wheel profiles. The new profile is intended to approximate the gage corner of a canted rail. This running surface profile is similar to what the wheel encounters on the rest of the track outside of turnouts. Figure 2 shows a comparison of the current design and the new design.

Figure 1. New Switch Point Profile Design 2

The tested switch points were manufactured by two switch suppliers. The concept drawing as shown in Figure 1 was interpreted differently by each supplier. Thus, the prototype points were made with somewhat different shapes and show some differences in performance.

Figure 3 compares the manufactured switch point profiles with the recommended shape (Figure 1). The prototype switch points (Prototype 1, Figure 3a) at Marceline, were produced simply using a cutter with 1-inch radius to tangentially connect the two straight sections at the rail top and the gage side, respectively. Compared to the intended profile, too much metal was removed at the rail gage corner, resulting in strong two-point contact. The prototype switch point profile (Prototype 2, Figure 3b) installed at Bonner Springs, although not in complete agreement with the recommended shape, was reasonably close to the intended profile.

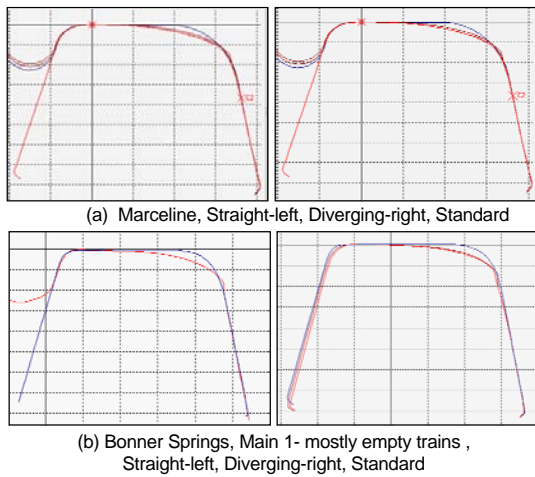
**Standard Switch Points** The standard switch points from two switch suppliers at the two test sites produced similar wear patterns as in the previous survey.<sup>1</sup> Figure 4 shows the switch point profiles at the two test sites, measured at 14 feet from the point of switch after about 7 months and after 18 months since the switch points were installed, overlaid with the new profiles (blue lines in plots). The actual Marceline points were measured before installation, whereas representative new profiles were used for the Bonner Springs turnouts. Two main observations are: (1) High rates of wear occurred in the first 7 months, and (2) The wear was concentrated at the rail gage corner.

**Figure 4. Standard Switch Point Wear Pattern**

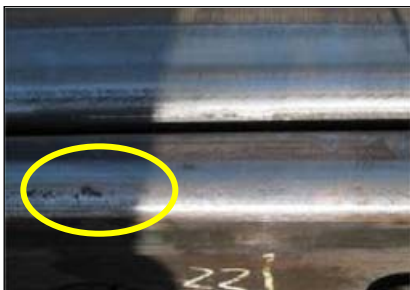
Figure 5 is a photo of the standard switch point taken 7 months after the installation at Marceline, which shows the surface damage at the rail gage corner. Rail grinding (using a hand grinder) had been conducted a few days before to remove the plastic flow at the gage corner.

**Figure 5. Standard, Straight, about 14 feet (measurement position 22) from Point of Switch – April 2011, Marceline**

Figure 7 is a photo of the prototype switch point taken at 7 months after the installation at Marceline. Compared to Figure 5, the rail surface condition was much better and the contact band was located on the top of the rail, which agreed with the measured profiles. Local forces that maintain the switches also noted less RCF occurred and less grinding was needed on the prototypes.

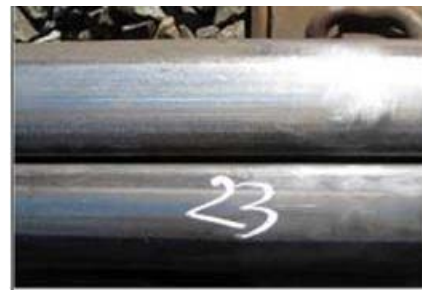
**Figure 7. Prototype, Straight, 15 feet (measurement position 23) from the Point of the Switch – April 2011, Marceline**

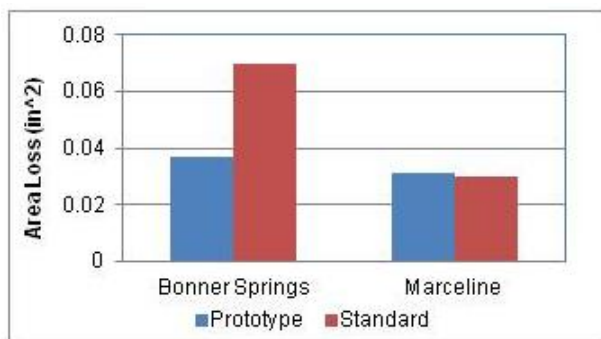
Figure 9 compares the wear in terms of rail cross section area loss for the prototype and standard diverging switch point profiles at 13 feet from the switch point after 18 months of wear. Compared to the standard switch, the prototype at Bonner Springs showed about 50 percent less area loss, but at Marceline the prototype had slightly more area loss.

Figure 9. Wear Comparison of Prototypes, Diverging Route, 13 feet from the Point of Switch

As discussed above, the prototype switch point profiles at Bonner Springs were made closer to the recommended design. However, the profiles at Marceline were made quite different from the recommended shape and caused strong two-point contact, which has a negative effect on curving (diverging route). Figure 8 clearly shows the wear at the rail gage face.
