2012 Results at Facility for Accelerated Service Testing

Joseph LoPresti and Semih Kalay

Summary

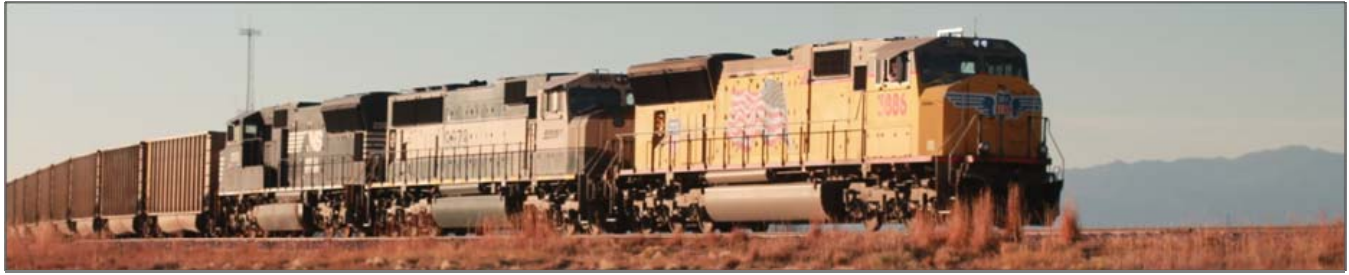
Figure 1. HAL Train at FAST

Tonnage was accumulated at FAST at an accelerated rate in 2012. One hundred sixty five 165 MGT were accumulated on the track components and structures being evaluated under the 39-ton axle load train (Figure 1). This tonnage is the highest tonnage recorded in a single year at FAST and exceeds the 10-year average of 132 MGT by 24 percent. Tonnage in-and-of itself of course is of little value to the railroad industry. It is the effects of the tonnage accumulation on the components being tested and what can be learned from those effects that is of interest.

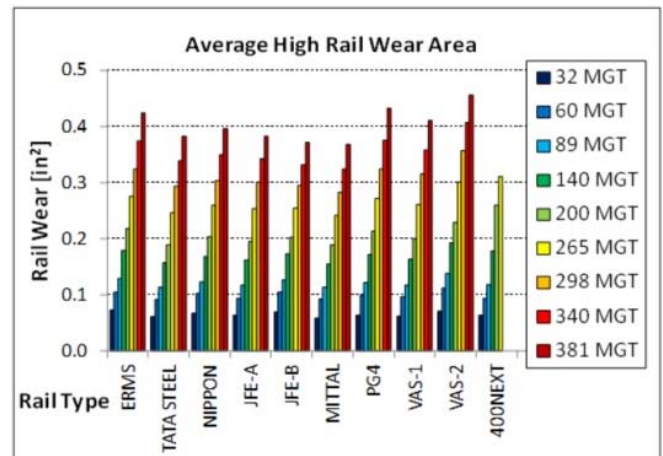
Figure 2. Premium Rail Wear Results at 381 MGT

Figure 2 shows rail wear (area loss) for the rails on the high rail of the curve through 381 MGT. There are at least two segments of each type rail in the 1,000-foot curve; the plot shows the average of at least eight profile measurements for each type of rail (there are more segments and more measurements for the rail being used as an experimental control). Note that the experimental 400NEXT rail was installed later than the other test rails and, thus, has accumulated less tonnage.

The rail with the best wear performance has worn about 24 percent less than the rail with the most wear. Detailed statistical analysis is underway and will be included in the final report. Although there have been some minor changes in the relative wear rankings of the rails, general trends have remained fairly consistent since the 200 MGT measurements. All rail types were showing some RCF after 140 MGT, and the rail had to be ground after 381 MGT to remove RCF that was severe enough to interfere with ultrasonic rail-flaw detection. Studying the effects of vehicle curving and rail metallurgy on the development of RCF has become a major focus of the experiment.

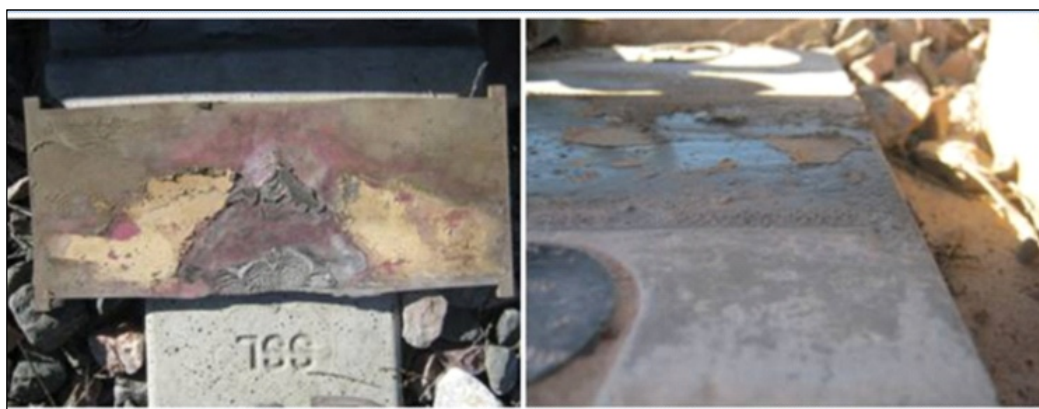
Figure 3. Tie and Pad Deterioration on Half-Frame Tie

Each test zone was ranked after 435 MGT using the following metrics: single-tie lateral-push resistance, rail-bending strains, loaded rail deflection, rail, tie, and subgrade accelerations, ballast degradation, and track-surface roughness. The half-frame ties were ranked number one overall. The rank was determined by summing the relative rank in each category (see Table 3). At this time, evidence of rail seat deterioration and rail pad degradation was discovered on the half-frame ties (Figure 3). The pads on the half-frame ties are different from pads typically used in North America (i.e., single-pad design, thicker and softer). These issues will be investigated in 2013.

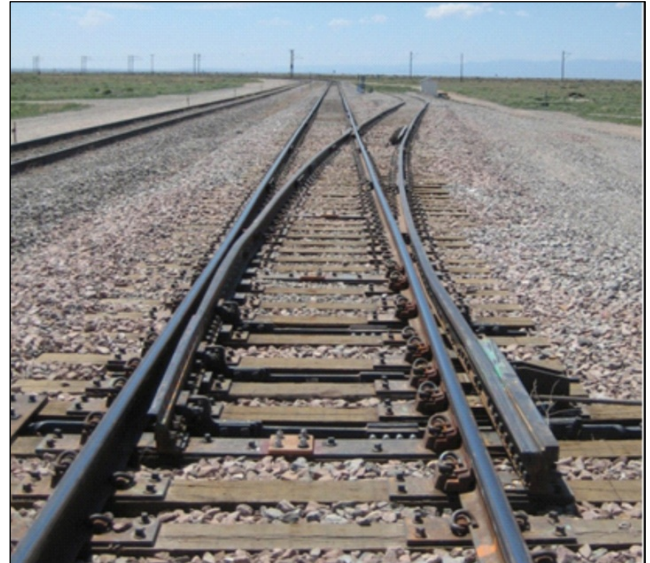
Figure 4. Vertical-Lift Continuous Running Surface Turnout

In 2012, TTCI tested a continuous mainline running surface turnout at FAST. The intended application is to install this type of turnout at locations where there is very low tonnage diverging traffic at low speed; e.g., an industrial spur or setout track. The turnout (Figure 4) incorporates a lift frog to eliminate the typical flangeway gap at the frog and vertical lift switch points to eliminate the transition between switch point and stock rail.

One switch point was relocated from the gage side of the stock rail to the field side. Testing with instrumented wheelsets showed that for the mainline, lateral and vertical wheel and rail interaction forces are much lower than in conventional turnouts and are similar to open track. Lateral and vertical forces during diverging moves were as expected and were acceptable for the intended speeds. The supplier, the owner (railroad) of the turnout, and TTCI engineers identified several issues and made improvements during testing at FAST.
