Summary of Stress-State Reduction in Concrete Bridges

Curt Mademann and Duane Otter

Summary

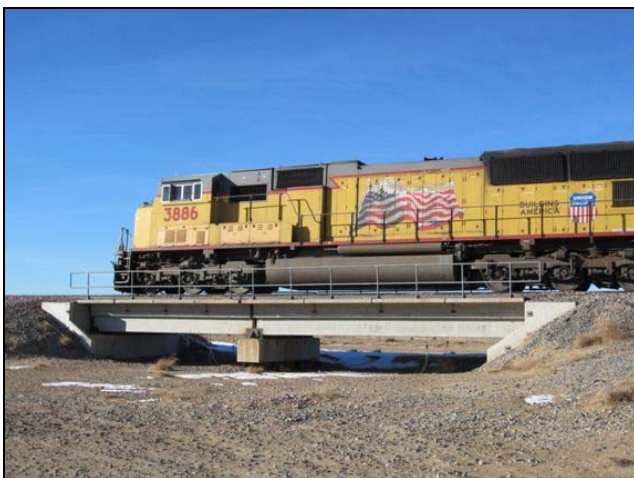
Figure 1. Conventional Concrete Bridge at FAST

The conventional concrete bridge has 24- and 32-foot double-cell-box girder spans. The intermediate span of the SOA bridge is a 42-foot double-cell box girder and is made of high-performance concrete. The flanking spans are a 30-foot double-cell box girder and a 15-foot slab span.

The conventional concrete bridge has a ballast depth of 12 inches below the high rail and 8 inches below the low rail. The 30- and 42-foot spans of the SOA concrete bridge have a ballast depth 19 inches below the high rail and 15 inches below the low rail, and the 15-foot slab span has respective

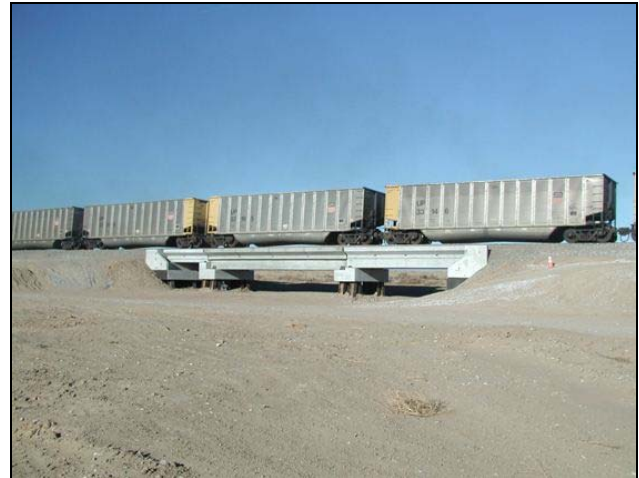
Figure 2. SOA Concrete Bridge at FAST

ballast depths of 18 inches below the high rail and 14 inches below the low rail.

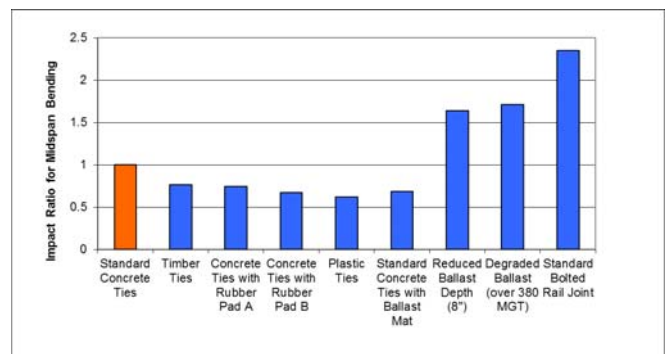
TTCI has evaluated the impact-reducing capabilities of plastic ties, wood ties, concrete ties with rubber pads, and a ballast mat. Figure 3 shows that the use of these materials resulted in a reduction in impacts and track maintenance on the bridges compared to the standard concrete ties previously used. Maximum midspan impacts were greatly increased when ballast depth was reduced from 12 inches to 8 inches. Also, maximum impacts increased over 380 MGT of accumulation on the SOA bridge. This increase was likely caused by ballast degradation. The largest impact value on the concrete bridges occurred when a bolted rail joint was installed over the SOA bridge. The bolted rail joint is typical of what might be found if a plug rail is installed. There was no railhead height mismatch and minimal gap.

Figure 3. Maximum Relative Impact for Midspan Bending

The effect of ballast degradation on the concrete bridges has been studied. A sieve analysis of the ballast on the 42-foot SOA bridge span was performed at installation of the ballast mat and after 457 MGT of accumulated traffic. Figure 6 shows an increase in ballast degradation on the SOA bridge, which likely contributed to an increase in wheel impacts. Impacts were immediately measured following installation of the ballast mat, and then again after approximately 380 MGT of accumulated tonnage. Figure 3 shows an increase in impacts.

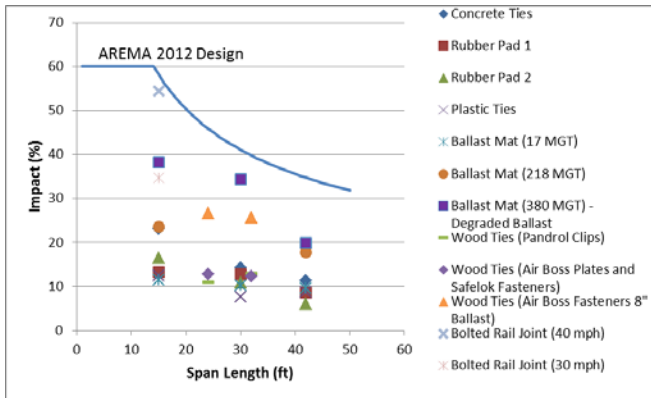
Figure 4 shows that the averages of the measured impacts were all within the recommended American Railway Engineering and Maintenance-of-Way (AREMA) 2012 design values.⁷ This was expected, because the train at FAST typically does not have any flat wheels. The largest impact value came from a bolted rail joint with a train traveling at 40 mph. Reducing train speed to 30 mph reduced the impact from ~55 percent to ~35 percent for the 15-foot span.

Figure 4. Average Impact as a Function of Span Length

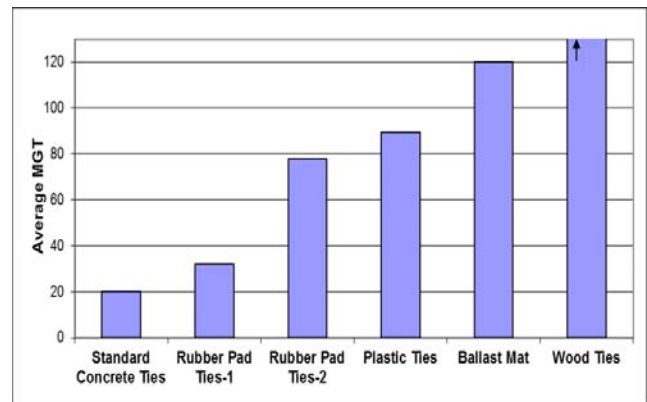
A major advantage of using plastic ties, wood ties, concrete ties with rubber pads, and the ballast mat was a reduction in track surfacing requirements. As Figure 5 shows, average ballast tamping cycles were reduced after these materials were installed on the concrete bridges. Reduced tamping is likely the result of reduced impact loads, which cause ballast degradation.

Figure 5. Ballast Tamping Cycles

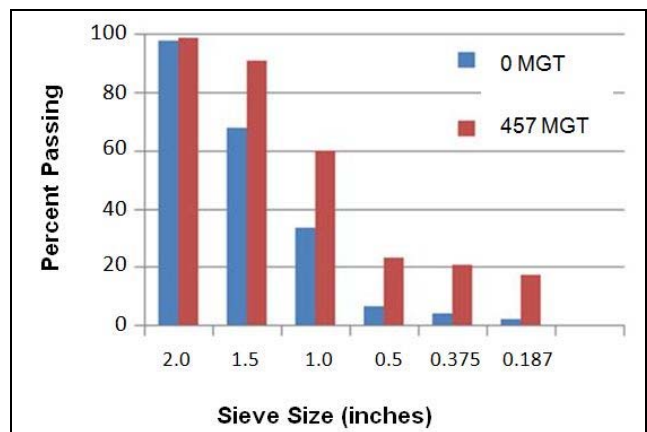
Figure 6. Ballast Sieve Analysis on SOA Bridge

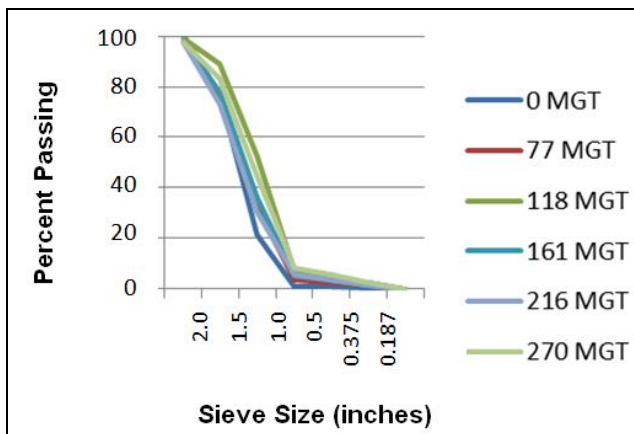
Sieve analysis was also carried out on ballast samples collected periodically from the conventional concrete bridge. Figure 7 shows the ballast distribution at different collection intervals. Figure 8 shows a more detailed view of the percent of the sample passing the 0.5-inch sieve opening. Track structure on this bridge during this period was timber ties with elastic fasteners, 8 inches of ballast beneath ties at the low rail, and no ballast mat.

Figure 7. Ballast Sieve Analysis on Conventional Concrete Bridge

Both figures indicate ballast degradation with increased MGT accumulation, which is also reinforced from visual inspection. Ballast degradation testing on the conventional concrete bridge is ongoing.

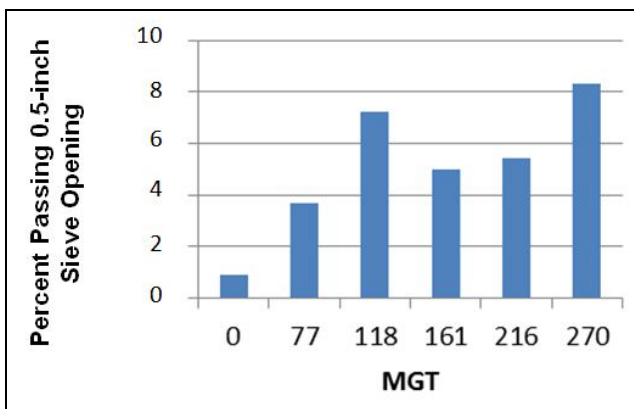
Figure 8. Ballast Passing 0.5-inch Sieve Opening
