Heavy Axle Load Testing of Prototype Rail Joint Bars

Muhammad Akhtar and David Davis

Summary

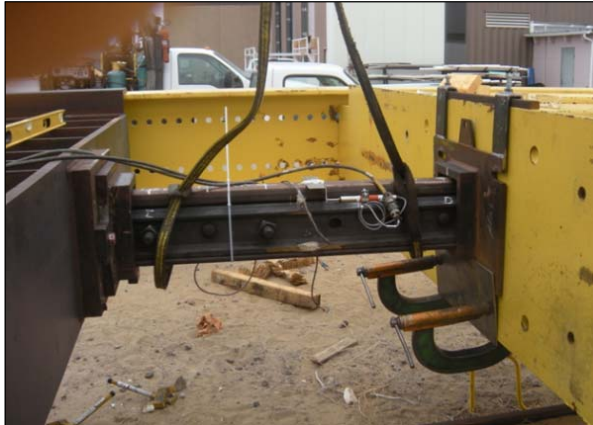
Figure 1. Rail Joint Test Setup

Two joints were assembled using standard and new joint bars. The load was applied to create shear between rail and

joint bars. Linear Variable Differential Transformers (LVDTs) were installed to measure relative movement of the joint bars with respect to the rail. Figure 1 shows the test setup. Load was measured using load cells on the squeeze frame. During the application of load, a sudden increase in relative joint bar movement and simultaneous reduction in load showed a joint bar slip. Each joint bar was tested at three levels of bolt torque.

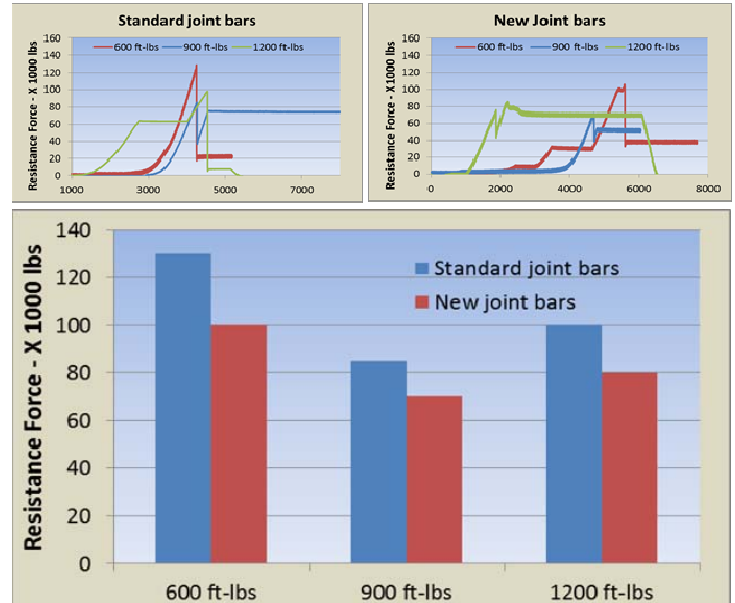
Figure 2. Resistance Force of Rail Joints

The applied shear force time history is shown in Figure 2 (top). Slippage of joint bars was characterized by a sudden reduction in force, referred to as resistance; i.e., the force a joint can resist without slippage while performing as a friction-type joint bar.

Figure 2 (bottom) compares the resistance force of each joint at various torques. In the tests, a rail joint with new joint bars showed lower resistance force than with standard joint bars. This is contrary to expected performance. It seems like the machining marks and sharp corners at compound curves did not allow the joint bar surfaces to make more contact with the rail. This was confirmed by the inspection after

disassembling the joint that contact was minimal with the rail. The results may have been better if rolled joint bars were used.

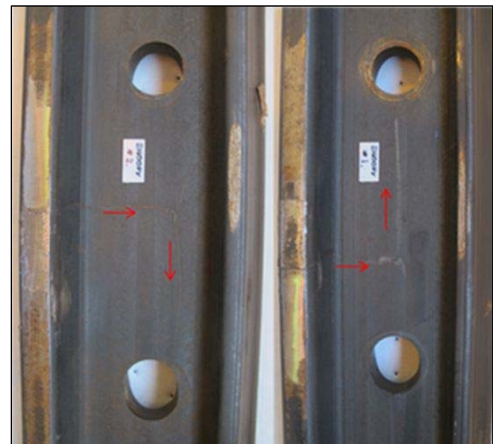
Figure 3. Cracked Joint Bars

Bending stress data was collected from new and current joint bars under the test train at FAST. Bending strains were measured in the bottom of the joint bars. The strains in both joint bars were nearly similar, suggesting that the slight reduction in bottom section modulus did not reduce joint bending strength significantly. The rail ends gap and daily ambient temperature were logged to understand the thermal force and joint gap relationship. However, both joint bars broke after 25 MGT, effectively ending the test. The gap and temperature data collected was not enough to understand the effect of the larger contact feature of the joint bars. In both joint bars, cracks started from the middle bottom center of the joint bars and propagated horizontally. The horizontal crack followed the machining indentation along the joint bars. Figure 3 shows the cracks.

The joint bar prototypes tested did not improve the longitudinal strength of the joint, despite the larger rail contact area. This is attributed to poor fit with the rail due to the prototypes being machined. Fatigue cracking occurred very early in the test (at 25 MGT). The poor fit created stress raisers, which caused the bars to fail before the new design features could be evaluated.

Additional prototype bars should be made with improved fit to the rail so that a better design evaluation can be made. A finish that approximates rolled bars is needed so that a fair comparison of the cross section design and material properties can be made.

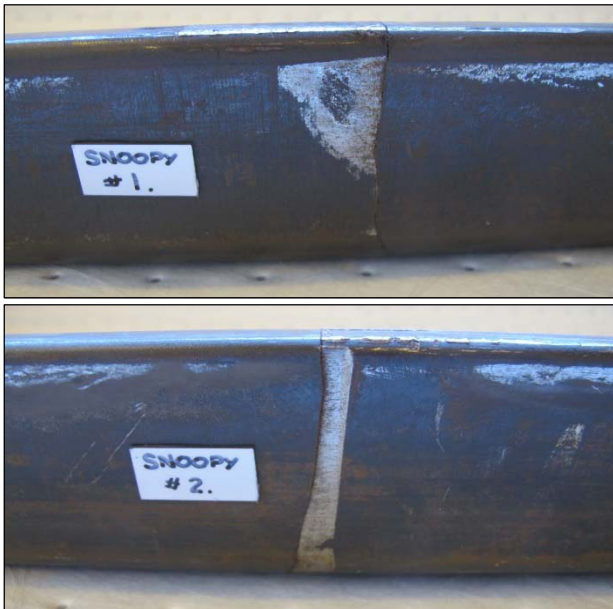
Figure 4. Indentation at Joint Bar/Rail Contact

1. Analysis of both fracture surfaces indicates that both cracks originated at the surfaces and progressed into the joint bars as fatigue cracks until critical failure.
2. The outside surfaces of both joint bars exhibited rough surfaces with material buildup (metal flow). Either one of these surface irregularities could have been a factor in the buildup of stress concentration during train operations. Stress concentration at the crack origin is most likely what led to crack initiation. Crack origination was close to metal flow or indentation due to rubbing against the rail base top surface. See Figure 4.

3. Cross-sectional metallography of the joint bars did not reveal any microstructural abnormalities. Both microstructures represent typical air cooled 4140 steel microstructures.
4. Hardness profiles in the cross sections directly below the crack origin did not indicate any hardness buildup close to the crack origin.
