Causes of Locomotive Wheel Climb at Switch Point Protectors

Huimin Wu and Scott Cummings

Summary

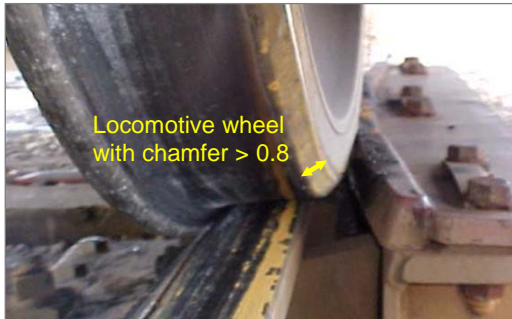
Figure 1. Locomotive Wheel Climbing a Field Side SPP

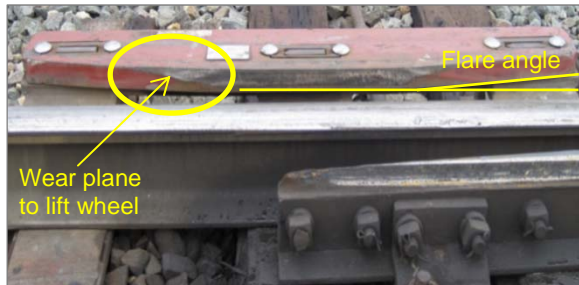
Figure 2. SPP Developing a NonVertical Wear Plane

Over time, the surface of the protector may wear into a plane with a lower angle, especially at the entry location where the flare and the center section of the SPP connect (marked with a yellow circle in Figure 2 and illustrated in Figure 5). When the wheel is at location 1 in Figure 4, this plane may serve as a ramp to assist wheel climb, as Figure 5 shows. With a large 45-degree wheel chamfer from wheel truing, and a

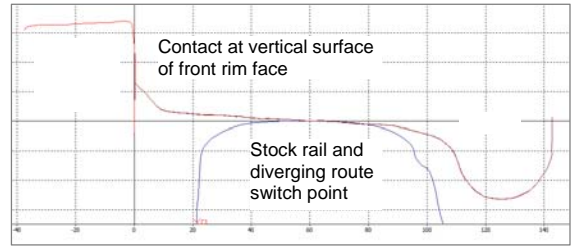
One commonly used SPP is installed with 3.9375 inches between the face of the protector and the gage face of the nearest rail. The top surface of the SPP is 1.25 inches above the railhead. Figure 3 shows a condition of ideal contact between vertical surfaces of the SPP and the wheel. This ideal condition can only occur if the wear surface of the SPP is vertical and there is zero angle-of-attack between the wheelset and the SPP. As a practical matter, this ideal contact rarely occurs. Even if the wheelset has zero angle-of-attack with

Figure 3. Ideal Contact Condition of SPP

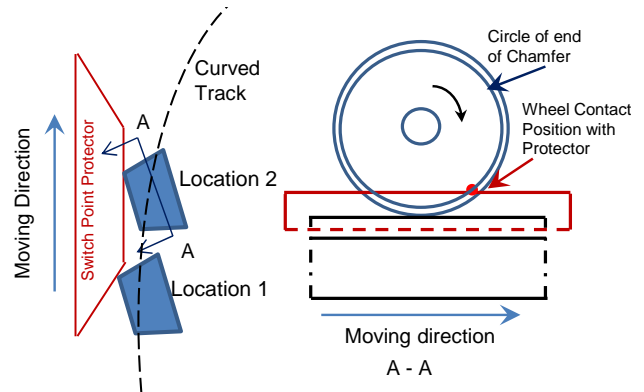
respect to the track, the flare angle (see Figure 2) of the SPP creates an angle-of-attack with the wheelset. An angle-of-attack moves the contact between the wheel rim and the SPP ahead (in the direction of travel) of the contact patch between the wheel tread and rail. This effectively creates a non-vertical contact between the rim of the wheel and the SPP. Figure 4 illustrates these contact conditions.

Figure 4. Contact Positions of Wheel with SPP

large wheelset angle-of-attack, this plane can provide undesired stable support for wheel climb. Larger chamfers give larger potential contact area with the worn plane of the protector, increase the rolling radius difference, and increase the risk of wheel climb. Location 1 in Figure 4 (transition between the flare and the center portion of the SPP) is the most likely position for wheel climb.

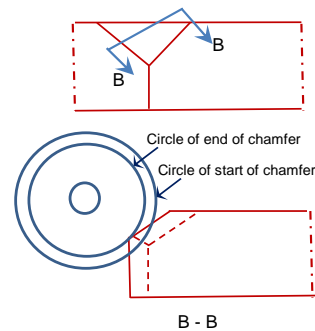
Figure 5. Illustration of Wheel Climbing Worn SPP

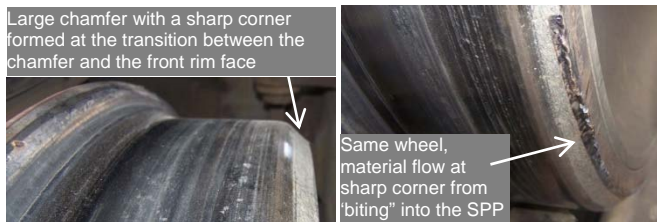
In addition to a large chamfer, some freshly trued locomotive wheels have a convex shape ending in a sharp discontinuity at the transition between the chamfer and the front rim face. Wear plates of SPPs are typically constructed of manganese steel, a material that is relatively soft immediately after manufacture, but work hardens during service. The sharp corner at the wheel chamfer/rim transition may have a tendency to “bite” into newer, softer SPPs and promote wheel climb. Figure 6 shows photos of one such wheel that derailed at a SPP.

Figure 6. Photos of a Locomotive Wheel that Climbed a SPP

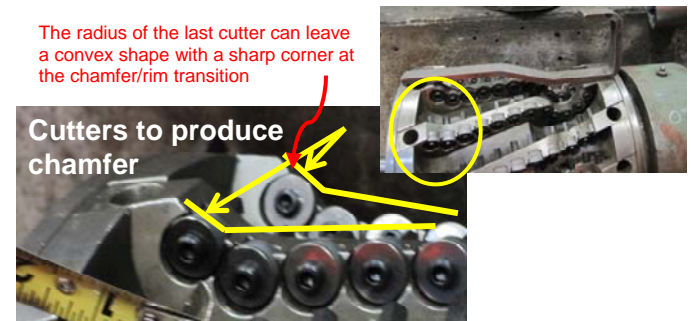
Most locomotive wheelsets are trued using a milling-type machine with a head that cuts a fixed profile. Figure 7 illustrates the cutting head, on which the arrangement of small circular cutters forms the wheel profile. The transition from the tread surface to the front rim face is made at a 45 degree chamfer. The size of the chamfer is a function of three variables: cutter head design, wheel width, and lateral alignment of the cutter head. The chamfer is not produced on freight car wheelsets due to the use of truing lathes with much higher wheelset rotational speed that can quickly cut a profile from a single cutting tool. Thus, truing lathes for freight car wheelsets can cut a radius (rather than a chamfer) at the

Figure 7. Cutting Head of Locomotive Truing Machine

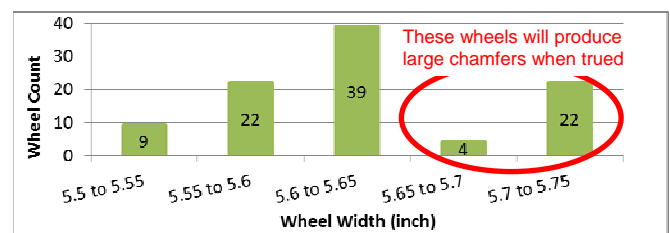
The measured locomotive wheel widths had a range of 0.236 inch, from a minimum of 5.512 inches to a maximum of 5.748 inches. Figure 8 shows a histogram of wheel widths measured at the wheel shops of two different railroads. Interestingly, all 22 of the wheels with width greater than 5.70 were grouped together in four locomotive trucks. As a reference, standard freight car wheel width is specified at 5.7188 ±0.125 inch.

Figure 8. Histogram of Locomotive Wheel Width Measured at Two Different Wheel Shops

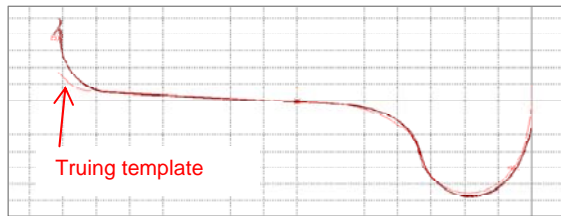
Figure 9 shows profiles from new wheels installed in new locomotive trucks. If the wheel width does not exceed the design cutting width limit and the cutter head is correctly positioned, the chamfer size would be as shown on the template (about 0.275 inch). Larger wheel tread chamfers are produced when truing wheels that are wider than the designed cutting width limit. Figure 10 shows the result of truing wheels having a width of 5.75 inch with a cutting head designed for a wheel width of 5.5625 inch: chamfer size of 0.62 to 0.66 inch and a sharp corner at the end of the chamfer.

Figure 9. Profiles of New Wheels that are Close to the Designed Cutting Width of 5.5625 inch

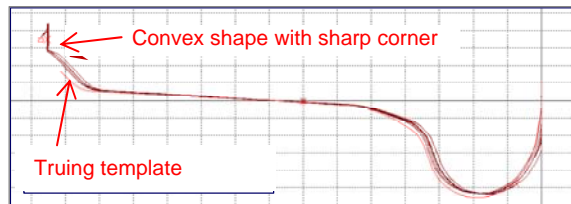
Figure 10. Measured Wheel Profiles after Wheel Truing

Figure 10 shows several instances where the cutting head was positioned toward the back of the wheel. In comparison to the template (in red color), the flanges of the trued wheels are shifted toward the back side of the wheels. In addition to a large chamfer, a small convex shape can be observed at the end of the chamfer on some of these wheels. This shape indicates that the last cutting tool engaged beyond its designed location.

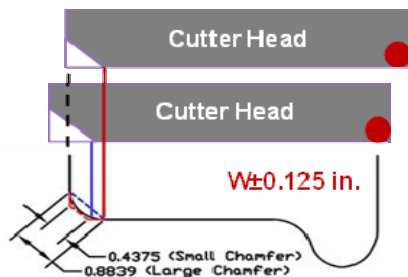
The lateral alignment of the cutting head influences the wheel chamfer size. A cutting head positioned too far to the front side of the wheel will produce an undesirable discontinuity on the back of the flange. On the other hand, a cutting head positioned too far to the back side of the wheel will produce a chamfer that is larger than necessary with a sharp corner at the chamfer/rim transition. Figure 11 illustrates the effect of cutter head lateral position.

Figure 11. Lateral Position of Cutter Head Position Affects Chamfer Size

Additional training regarding optimal locomotive wheel cutter head lateral positioning and its importance should be considered as a short-term means to help reduce risk of locomotive wheel climb at SPPs.

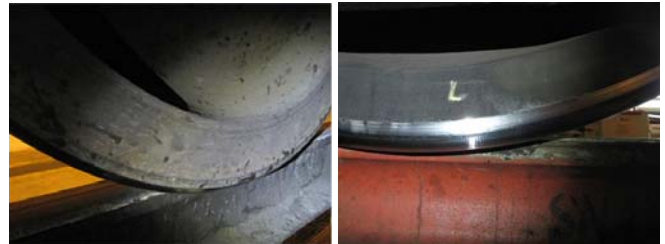
Figure 12 shows photos of the back side of the wheel flanges of two wheels after truing. The cutting head was positioned too far to the back side of the wheel in the photo on the left, as evidenced by almost no flange back contact with the cutters. The photo on the right of Figure 12 shows clear cutter contact with the flange back and is the result of positioning the cutter head toward the front of the wheel.

Figure 12. Indications of Variation in Cutter Head Position
