Half-Frame Concrete Tie Performance under HAL Traffic: Selected Applications

Summary

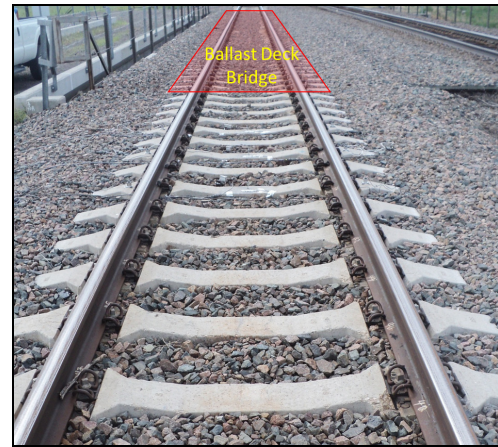
Figure 1. HFTs on the East Approach near Oshkosh, NE

Two ballasted deck bridges, located on tangent track on the loaded HAL coal route, were selected for this study. Fifteen ties were installed during summer 2011 at the east and west approach of the bridge near Oshkosh, Nebraska (the former of which is shown in Figure 1) and at the west approach of the bridge at near Paxton, Nebraska. The test ties were installed using an excavator with a grapple attachment (Figure 2) and a standard production switch tamper with split work heads.

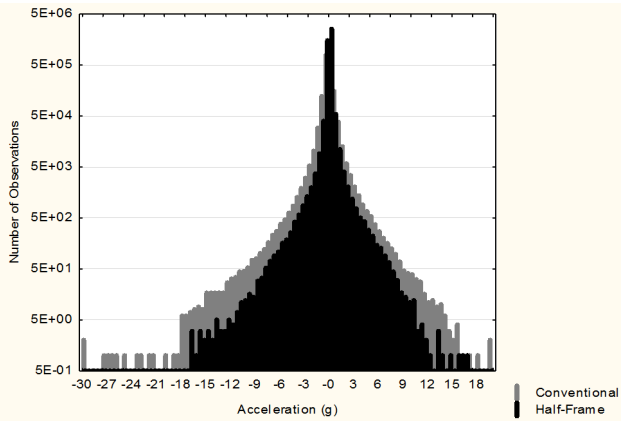
Figure 4. Frequency Distribution of Tie Accelerations

Figure 4 shows the frequency distribution for all tie acceleration channels collected under five HAL unit coal trains at each approach. Results presented in the figure show a significant reduction in vibration on the HFTs over conventional concrete ties in a similar dynamic environment.

*Significant difference (p < 0.005)

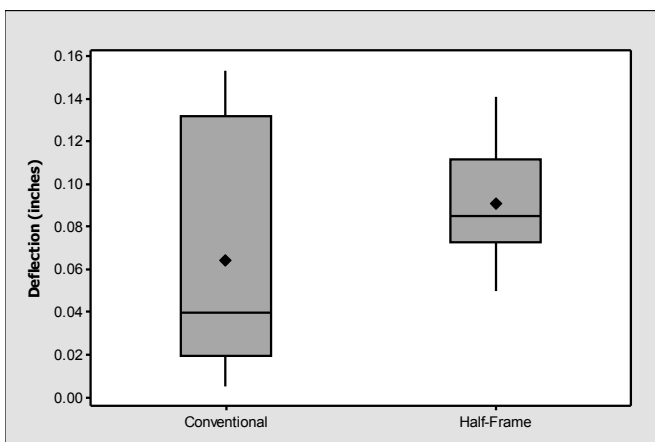
Figure 5. Box Plot of Tie Deflection for Three Representative HAL Train Passes over Each Approach

Test results for the conventional ties show lower, but more variable, deflections under HAL wheel loads. The larger deflections observed for the HFTs are likely attributed to the

lower overall track modulus provided by HFT's under-tie pads. There is a significant reduction in deflection variability, suggesting more consistent deflection for the HFTs under HAL traffic than the conventional concrete ties, as Figure 5 shows.

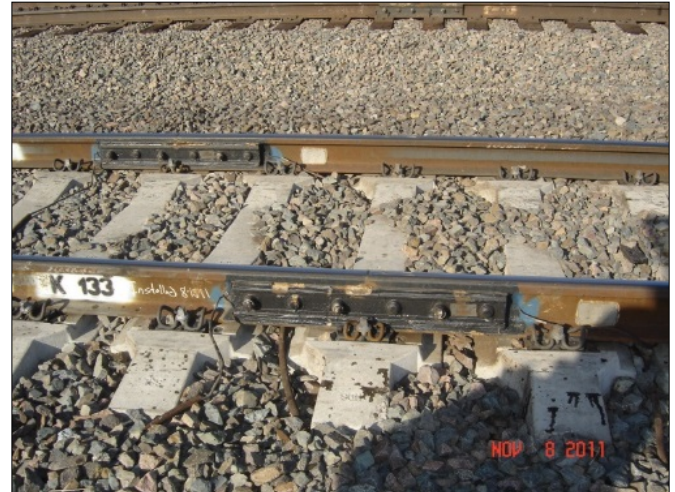
Figure 6. HFTs supporting a Pair of IJs at a Control Point

The increased footprint and larger rail seat of the HFT were also desirable characteristics for the support of impact loads such as those observed at IJs. To test performance in this area, 14 HFTs were installed on the western mega site in 2011 to support two IJs at a mainline control point. The joints were installed fully supported above the larger rail seat, as Figure 6 shows. These HFTs have accumulated 690 MGT as of

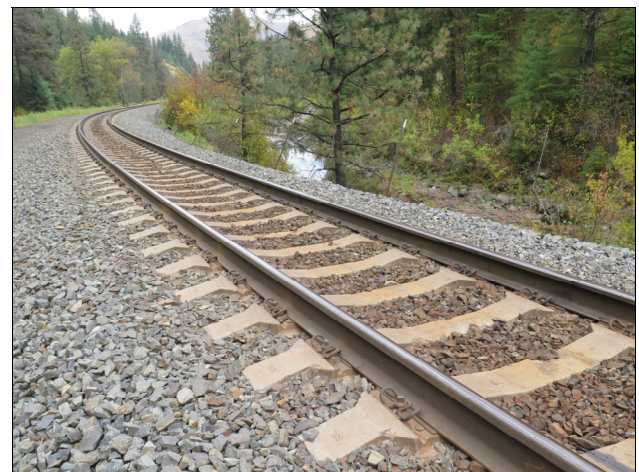
Figure 7. HFT Test Zone near Pendleton, OR

Another revenue service HFT test zone has been installed on the La Grande subdivision of the Union Pacific Railroad near Pendleton. Due to the high lateral strength of the HFT seen at FAST, the HFTs were selected for installation in a high degree curve to reduce curve movement and maintain track geometry. Figure 7 shows the test zone where the 207 HFTs were installed in a 7.2-degree curve.

The installation of these ties was completed in the fall of 2012. The ties were installed in a similar manner as the bridge approaches on the western mega site. The zone has accumulated about 90 MGT through September 1, 2014. Moving forward, track geometry, vehicle-track interaction, and lateral curve shift data will be collected as tonnage is accumulated and a performance comparison will be made with an adjacent conventional concrete tie control zone.

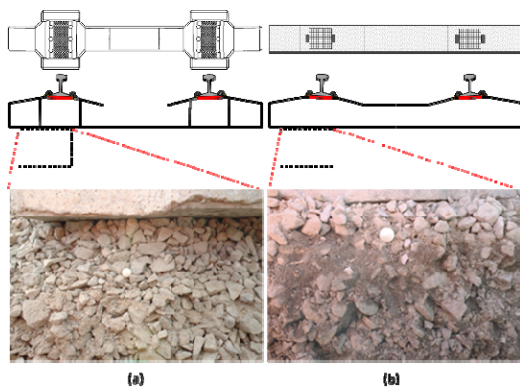
Figure 8. (a) Ballast Image 171 – Below the Inside Rail of HFT and (b) Ballast Image 150 – Below the Inside Rail of Conventional Concrete Tie

To this end, lateral cross trenches were dug across the tie zones and images were collected of the trench sidewalls that corresponded to the ballast beneath the tie, as Figure 8 shows. FAST provides a better environment for this type of intrusive data collection as it is a more controlled test site compared to revenue service.

In collaboration with the University of Illinois at Urbana-Champaign, these images were processed using a segmentation analysis that allows individual ballast particles to be identified and their size relatively quantified.² From this technique, an image-based fouling index (IBFI) is calculated for each image. Based on the images collected for this analysis, an IBFI of 40 to 80 is assumed to characterize the range of realistic ballast conditions (from new ballast to ballast sufficiently degraded to warrant undercutting/cleaning). Figure 9 shows where the average IBFI beneath the HFTs and the conventional concrete ties falls on the spectrum of ballast condition after 645 MGT. Estimates from the images suggest that 52 percent compared to 20 percent of ballast life is remaining for the ballast beneath the HFTs and conventional concrete ties, respectively.
