FAST Intermediate Strength Rail Test Results: 2012-2014

Daniel Szablewski, Joseph LoPresti, and Miles Lucero

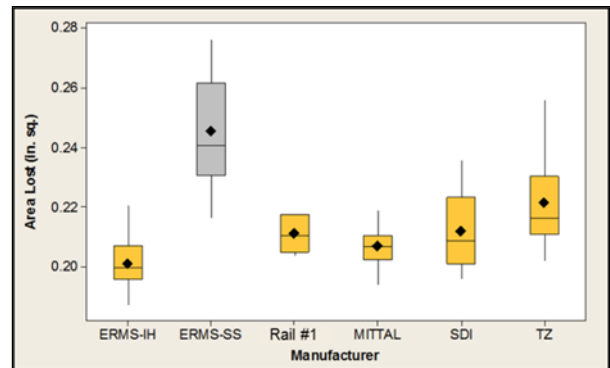
Rail profiles were measured at five locations on each 40-foot rail type approximately every 60 MGT. A two sample t-test wear analysis of rail wear that compared ERMS-SS rail type to other rails in the test zone at 348 MGT indicated all of the other rail types tested (EVRAZ-IH, Type 1, ArcelorMittal Steelton, SDI, and TZ) have statistically less wear than the ERMS-SS rail. Note the ERMS-SS rail has approximately 320 HB head hardness, whereas all other rail types tested in the curve are IS rail grades ranging in hardness from 330 to 360 HB. The IS rails are being compared to the SS rail, because it is widely used and its revenue service performance is known. Area loss is shown in the box plot in Figure 2.

Figure 2. Two sample t-test rail wear comparison between tested rail types and ERMS-SS rail at 348 MGT. Orange color indicates less wear than ERM-SS rail.

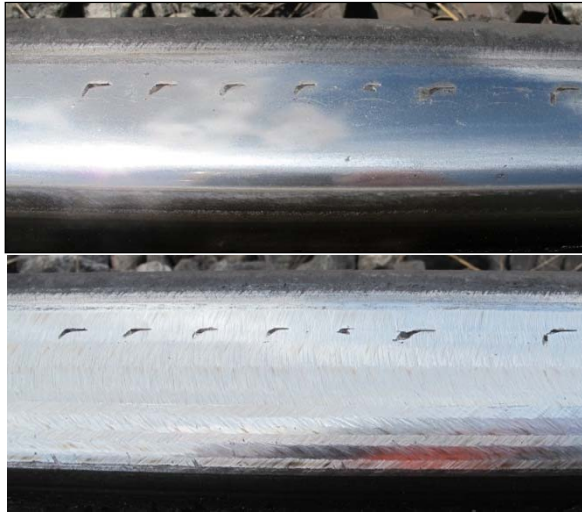
However, some exceptions to this include deep RCF markings on top of the high rail (Figure 3).

Figure 3. RCF markings on top of high rail at 300 MGT of accumulated tonnage in the IS rail curve. Top image shows rail before grinding and bottom image indicates rail after grinding.

The grinding mentioned above (and shown in Figure 3) was implemented in this test for two reasons: (1) to remove RCF from the running surface while maintaining the proper rail profile, and (2) to prevent deep seated shelling (DSS) gage-corner defects from occurring. There were 18 DSS defects in the high rail during the previous IS rail test at FAST,² which resulted in the early termination of the test.

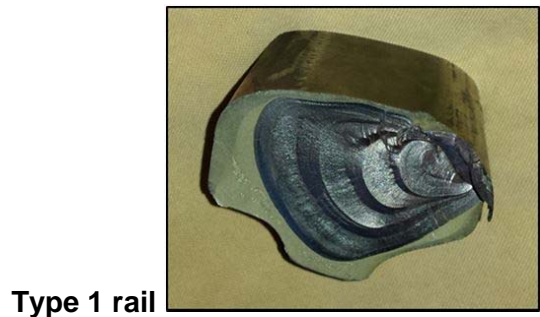
Type 1 rail

Shelling in the high rail began at approximately 280 MGT of accumulated tonnage during the current test. The first shell occurred in the Type 1 rail. This was the rail type to first develop shelling in the 2010–2012 IS rail test.² In the previous rail test, 18 total shell defects developed in all rail types between 340 and 380 MGT. None of the shells resulted in transverse defects. In the present IS rail test, the shell initiated in approximately the same location in the gage corner as the previous test, approximately 0.3 inch down from the top of the rail and 0.4 inch in from the gage face of the rail. As with most shells, there was longitudinal growth (parallel with the running surface of the rail). In addition, a transverse defect initiated from the shell surface, which then grew perpendicular to the rail running direction (see Figure 5), and it was not discovered until a service failure took place.

Figure 5. IS high rail shelling leading to transverse defect development in Type 1 and TZ rail. ERMS-SS rail type did not indicate a developing transverse defect underneath the shell.

The growth patterns shown in Figure 5 in both Type 1 and TZ rail appear to be in periodic step formation. This periodic reversal in growth direction is associated with reversal of FAST train operations (two nights of running clockwise followed by two nights of running counterclockwise).

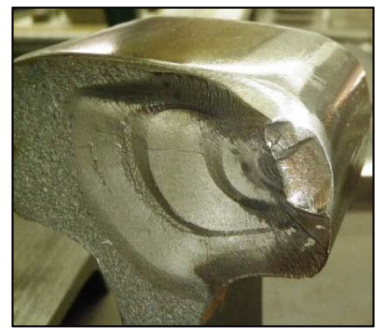
Another shell and transverse defect occurred at 310 MGT in the TZ rail type (Figure 5). The mechanism of this transverse defect was very similar to the previous shell and transverse defect in Type 1 rail, and it was not discovered until a service failure occurred. Shell defects can mask transverse defects that develop directly below the shell. Since the transverse defects in the Type 1 and TZ rails were directly below the formed shell, ultrasonic inspection did not detect these transverse defects.

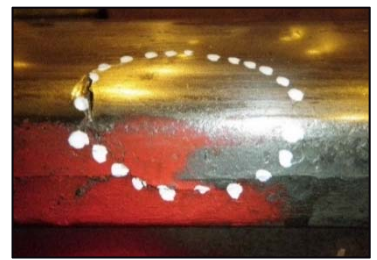
A third shell defect was identified in the IS test curve at 320 MGT of traffic. This time the shell was found in ERMS-SS rail type (Figure 5). Since the defect was found during an ultrasonic inspection (prior to a service failure) it is not known whether a transverse defect would have developed from this shell.
